# Llandudno Beach Management Plan

Appraisal of Options for the future management of  
Llandudno's Beaches

Conwy County Borough Council

Project Number: 60525387

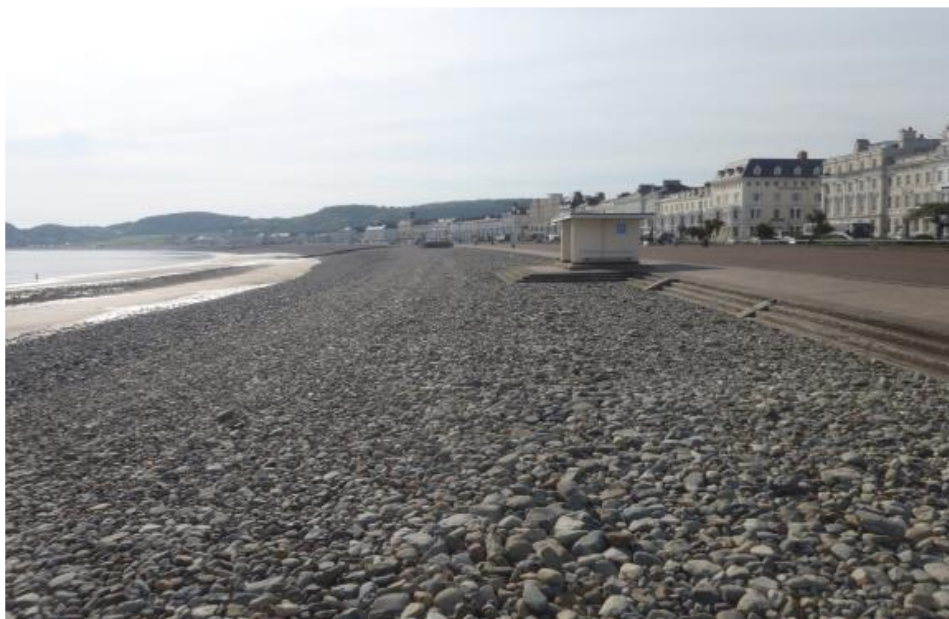
**Figure 1-3. View of the North Shore (facing east) following the beach replenishment works in 2014 (CCBC, 2016)**

The emergency works conducted after the winter storms of 2013/14 (Figure 1-2) resulted in 30,000 m<sup>3</sup> of shingle being placed on the North Shore over a five week period (Figure 1-3). The Llandudno Coastal Forum (LCF) was established in response to the public concerns surrounding the large scale shingle replenishment. The LCF, in conjunction with CCBC, canvassed local opinion regarding future defence requirements which provided the stimulus for the development of this Beach Management Plan. Nearly 3 000 people took part in this consultation process which highlighted the desire locally for public feedback to be incorporated into any future plans. The LCF identified a number of concept options for the management of the frontage and developed further by CCBC. These concept options have been considered as part of this BMP study.

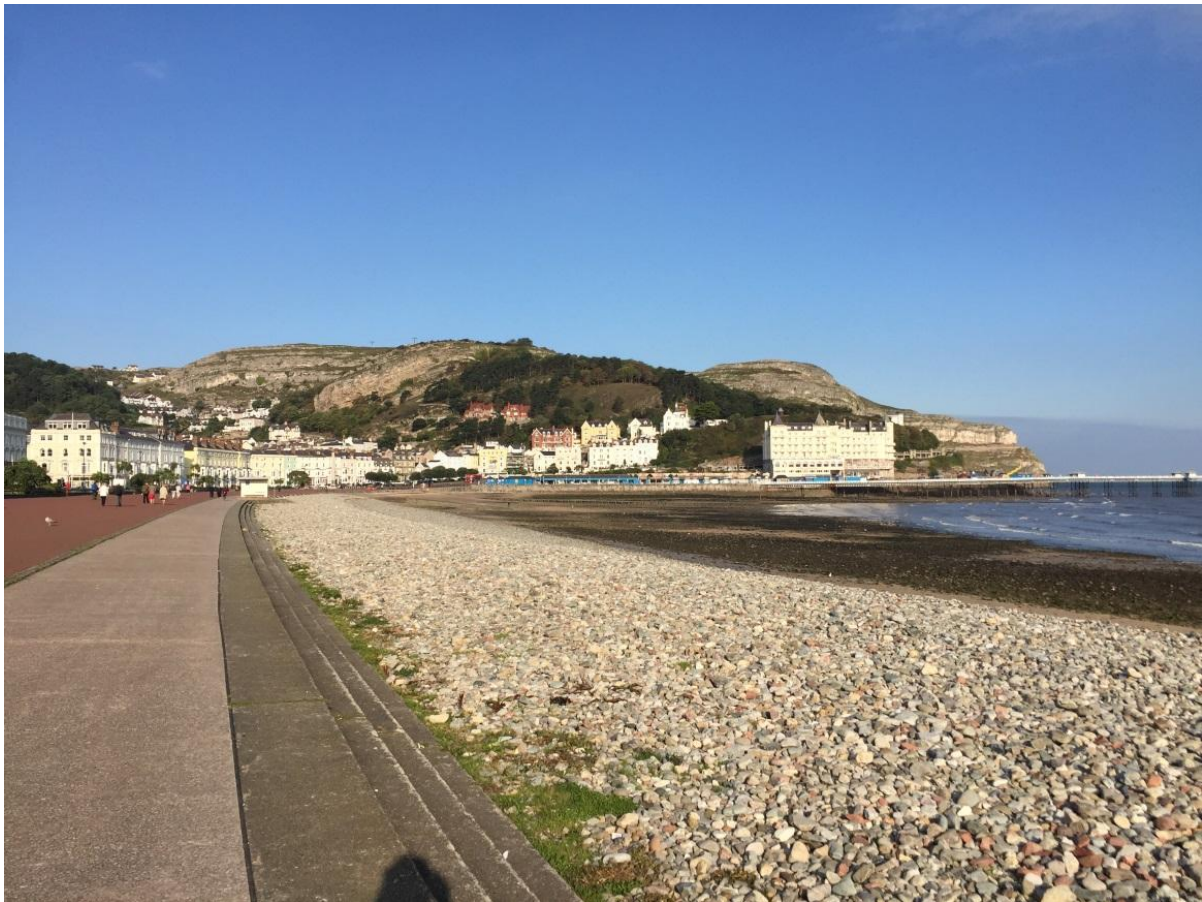
**Figure 3-1. View from east to west of the current North Shore profile (AECOM, 2016)**

The North Shore is protected by a steep upper shingle beach and a flatter, lower sand beach. There is also a wide tarmac surfaced promenade with a low level wall fronted by a stepped concrete revetment on toe piles. The shingle was imported onto the foreshore over a 5 week period following the 2013/14 winter storms as the existing shingle beach protection levels had fallen below previously determined trigger levels required to protect the structures. Figure 3-1 shows the current North Shore profile following the re-nourishment works in 2014. The variations in the frontage profile over a number of years, including the 2014 post storm profile, are illustrated in Figure 3-2. This highlights the extreme erosion that occurred as a result of the 2013-14 storm events and the increased flood risk which resulted from this lower defence standard.

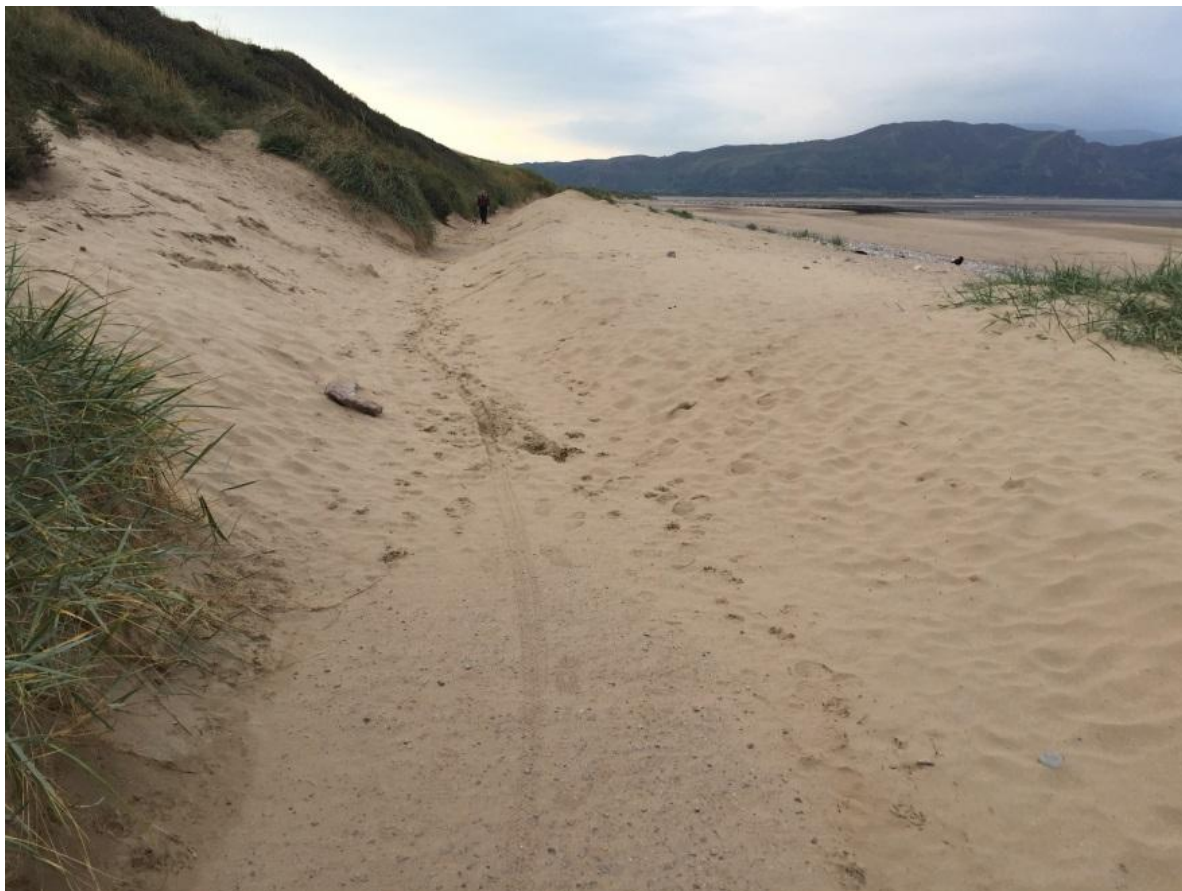
**Figure 3-3. Build-up of material along the West Shore cycle path (AECOM, 2016)**

Along the West Shore the defences consist of a stepped concrete seawall supported on a sheet piled toe with a promenade and a rear wave return wall along the crest. In addition there are 3 shore connected breakwaters located at Cerrig Duon, opposite Lloyd Street and at Gogarth. The main issue along the West Shore is the effect of windblown sand. This causes a build-up of material in front of properties and along the cycle path and requires regular removal (Figure 3-3).

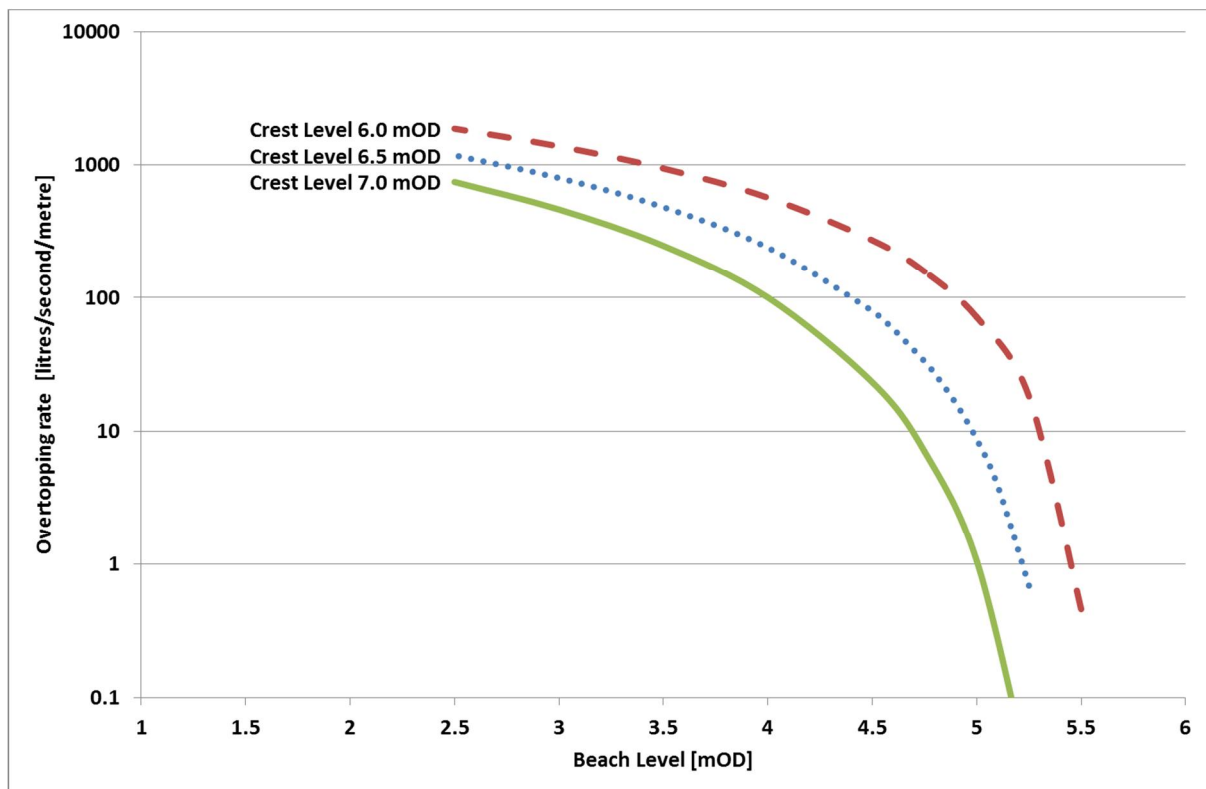
**Figure 3-7. Estimated overtopping rates for the 1 in 100 year wave and water level condition for a range of sea wall crest elevations and beach levels at the toe of the stepped revetment such as on the North Shore.**

The consequence of the beach lowering in front of a sea wall is significant. Firstly, if the beach levels simply lower the potential for overtopping is increased (Figure 3-7).

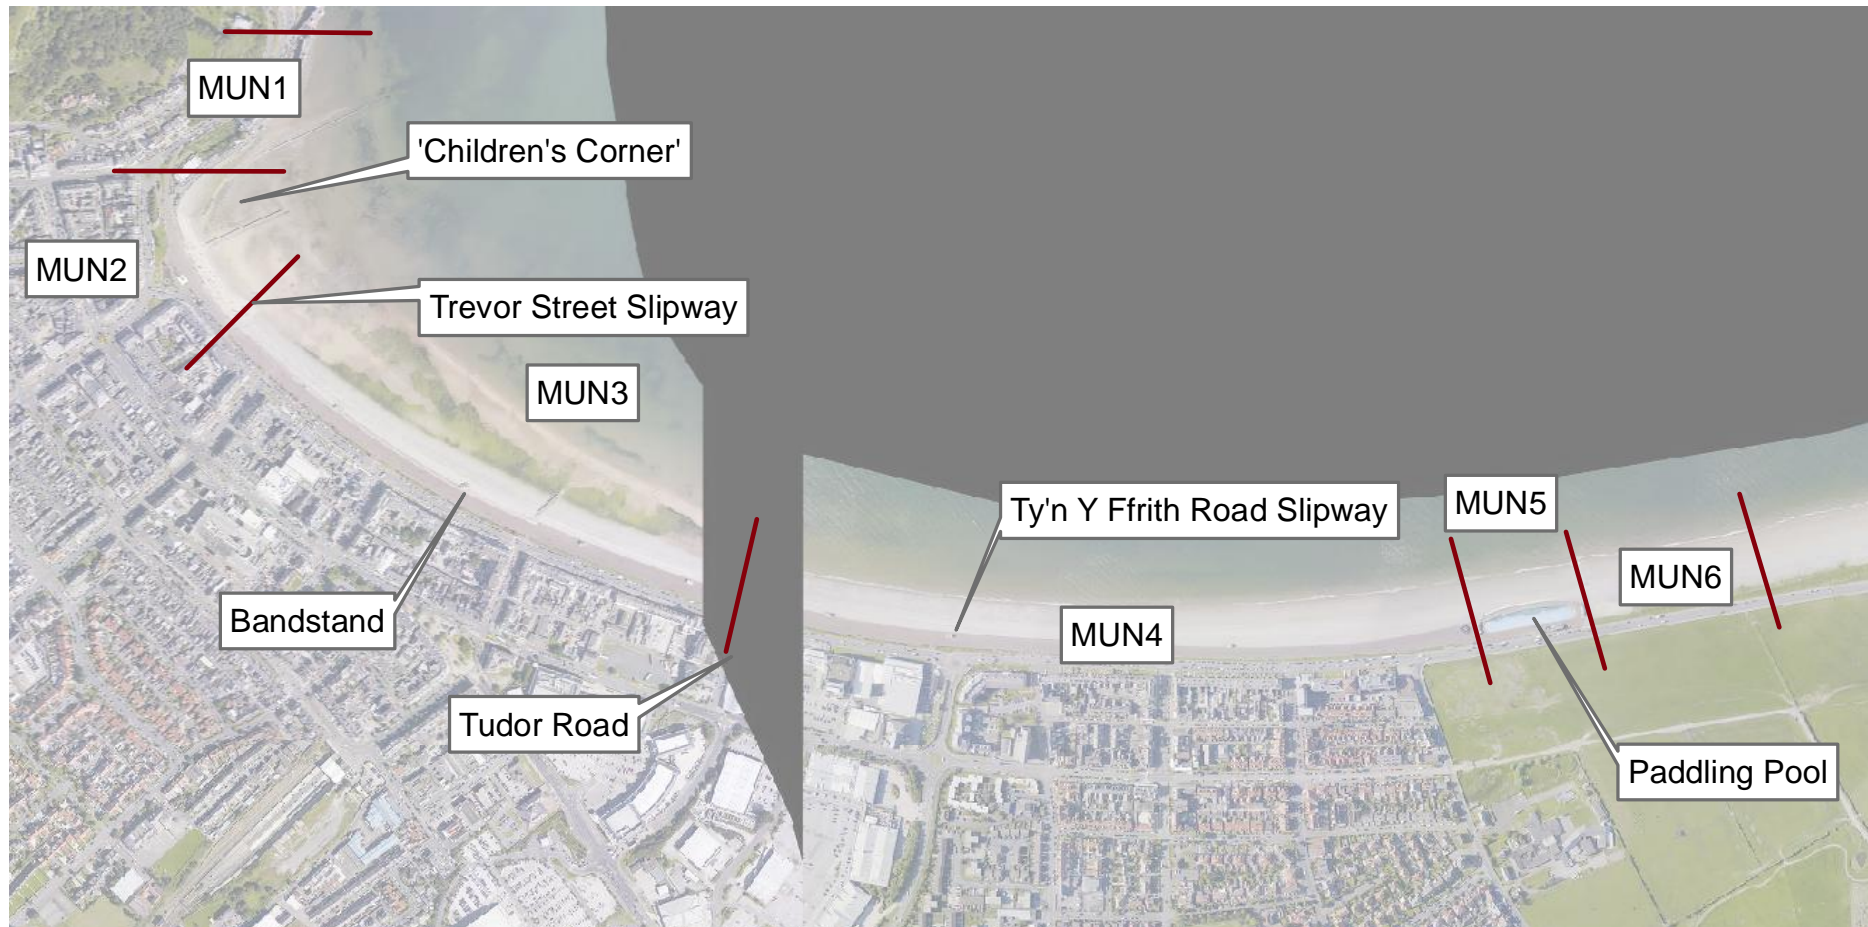
**Figure 4-2. Aerial view of the North Shore with key features and Management Units shown**

The LCF identified a number of Strategic Management Zones for the North Shore as shown in Figure 4-1. This subdivides the frontage into its different uses and has influenced the selection of the management units. The proposed management units for the North Shore are shown in Figure 4-2 and listed in Table 4-1.

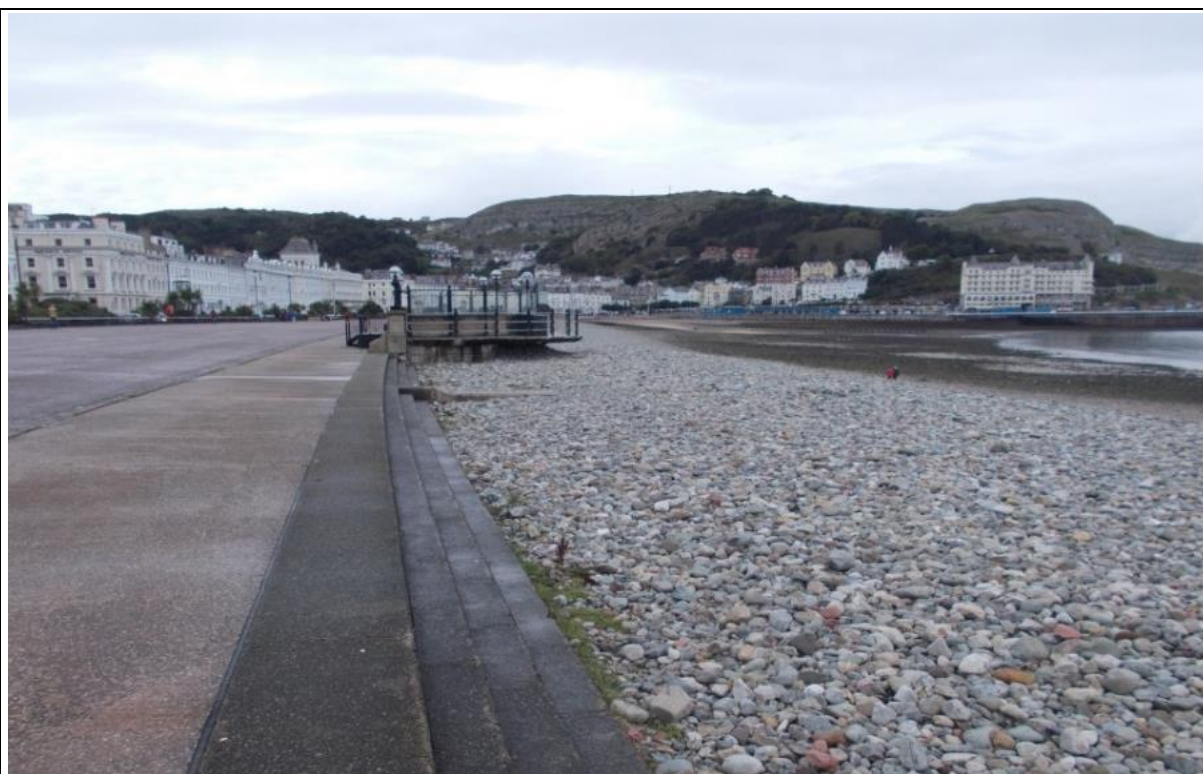
#### 4.2.5 MUN4: Tudor Road to the west edge of the Craig-y-Don paddling pool

This unit consists of a steep upper shingle beach and a flatter, lower sand beach. The beach is backed by a stepped concrete revetment and wide promenade. The northern limit is bounded by the border between the beach zone and the boating zone at Tudor Road and the southern limit by the western edge of the paddling pool.

This management unit is significantly exposed to wave energy and is highly dynamic. The damage to the bandstand is as a consequence of beach lowering and attrition by shingle.

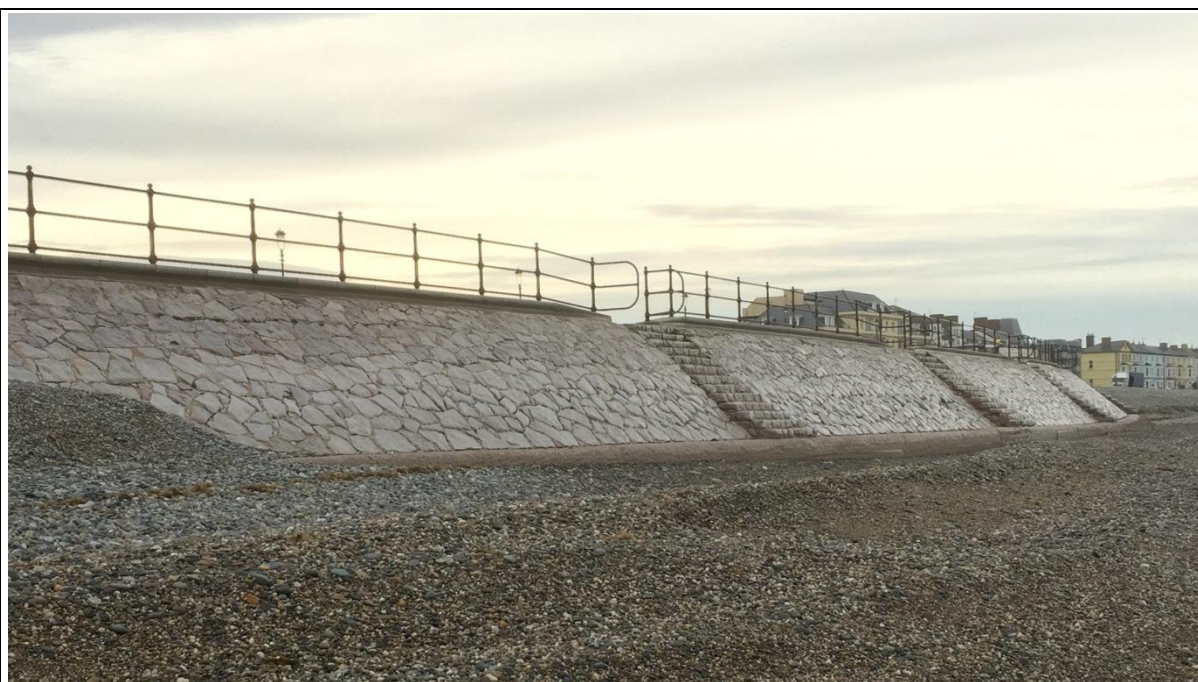
## 4.2.6 MUN5: Craig-y-Don paddling pool

The paddling pool consists of a sloping stone wall on the seaward side with a dwarf crest wall and a rear promenade. The limits of this management unit are bounded by the extents of the paddling pool.

The sloping front wall allows waves to run up the face and overtop into the paddling pool. This results in significant overtopping by waves and large amounts of shingle being thrown onto the pool and surrounds. Damage from the stones is possible and the mix of water and stones overtopping in a storm event could present a risk to life.

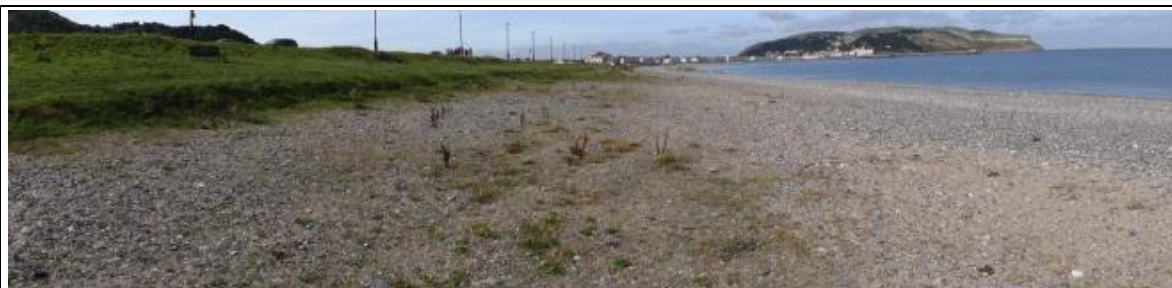
#### 4.2.7 MUN6: East edge of the Craig-y-Don paddling pool to the start of the Fishing Zone at Colwyn Road

This unit consists of a steep upper shingle beach and a flatter, lower sand beach. The beach is backed by a vertical wall. The western limit is bounded by the eastern limit of the paddling pool and the eastern limit by the boundary between the boating and fishing zone at Colwyn Road.

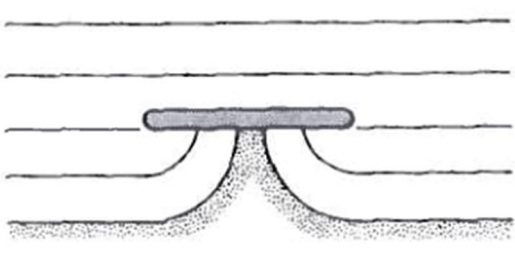
<p data-bbox="778 636 1259 685">Equilibrium depositional feature behind offshore breakwater, <math>l/s &gt; 2</math>, tombolo formed</p>

(Figures after Figure 6.2, "Rock Manual" (CIRIA, 2007))

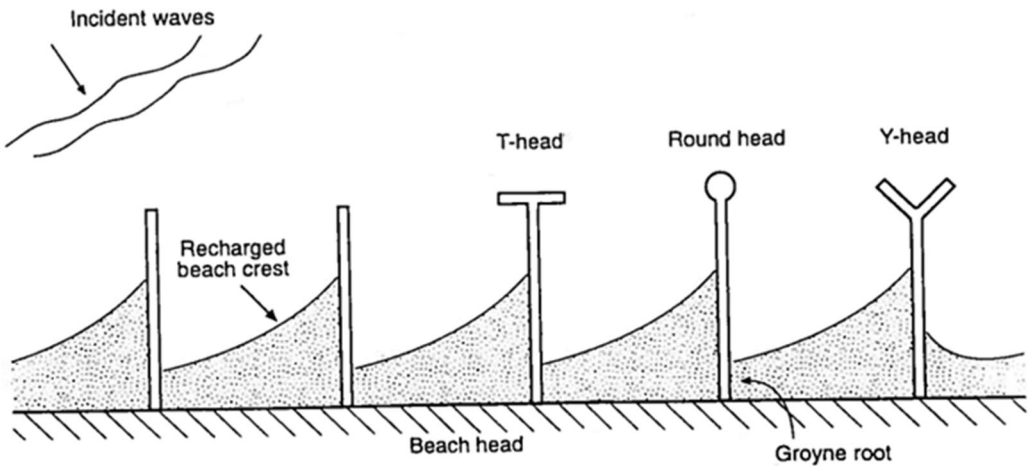
The diagram illustrates the effects of different groyne types on beach profiles. Incident waves are shown approaching from the left. Three groyne types are shown: T-head, Round head, and Y-head. The T-head groyne results in a 'Recharged beach crest' and a 'Beach head'. The Round head groyne results in a 'Groyne root' where erosion occurs. The Y-head groyne also results in a 'Groyne root'. The beach profiles are shown as shaded areas between the groyne structures.

Figure after Figure 8.2, CIRIA, 1996

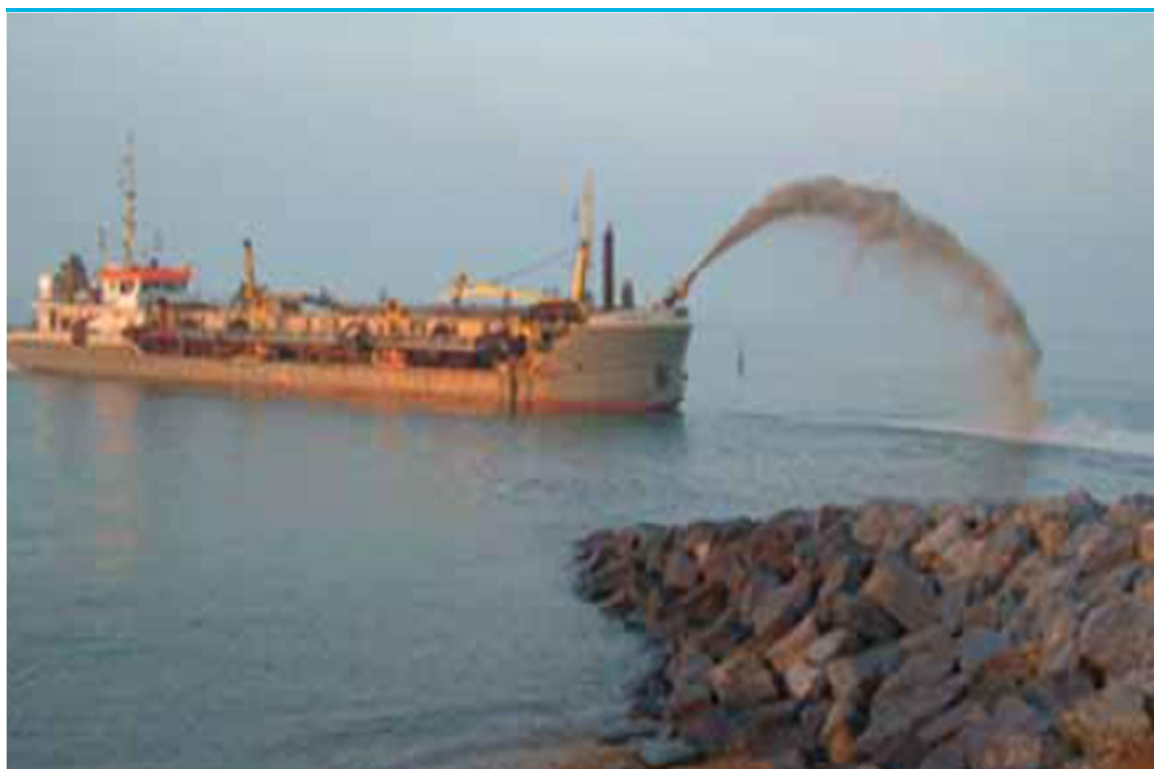
(Photograph of a small hopper dredger after Figure 14.7, CIRIA, 2010)

A soft-engineering approach to coastal protection with the aim of replacing or recharging the existing beach with similar or different sediment. The new material may be used to raise the beach crest level or widen the beach.

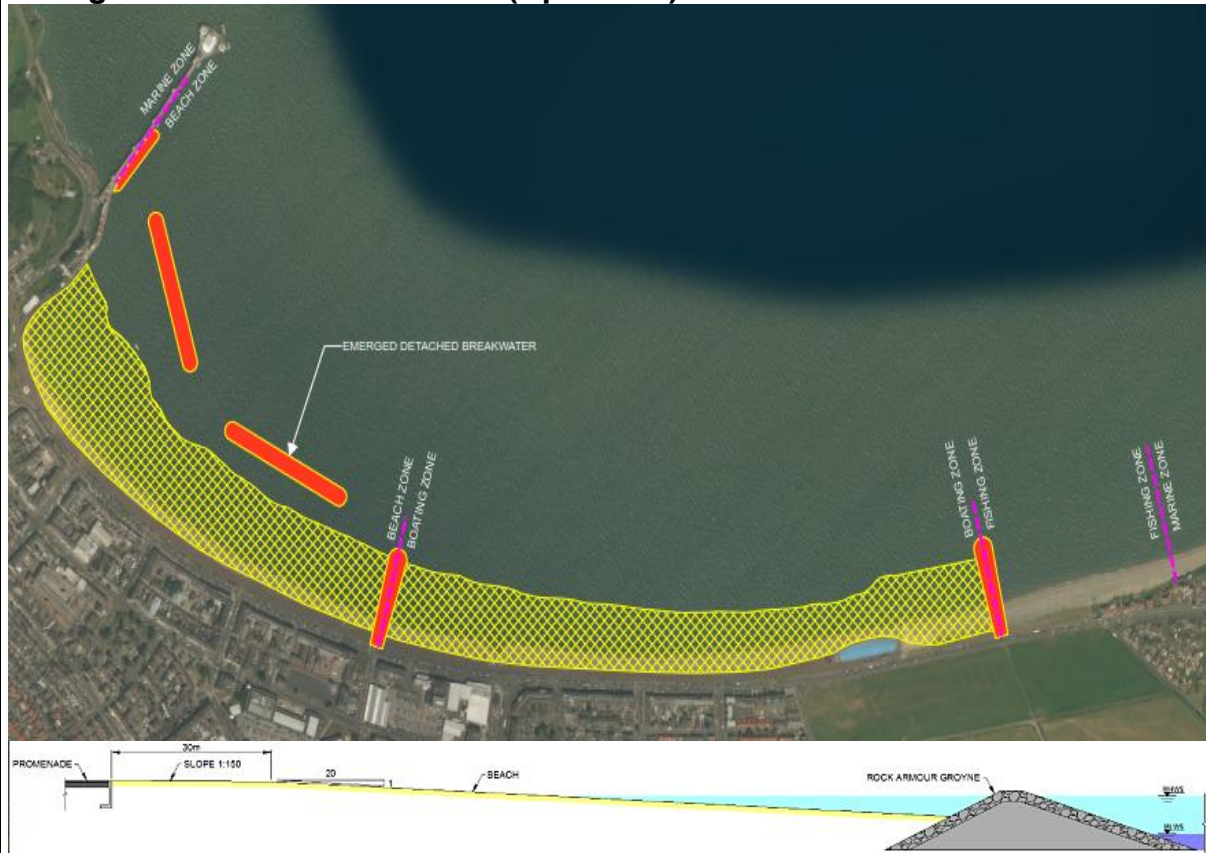
#### Emerged Detached Breakwaters (Option 1A)

<b>Description</b>	
<p>Two breakwater variations have been considered as part of this long list of options; emerged detached breakwater and submerged detached breakwaters in combination with beach nourishment. The beach protected by the breakwaters will be recharged with sand (and any existing shingle cobbles removed).</p> <p>The specific arrangement of breakwaters will need to be determined through extensive numerical and physical modelling to identify the new beach plan shape with specific attention to the formation of a salient or tombolo.</p>	
<b>Advantages</b>	<b>Disadvantages</b>
<ul style="list-style-type: none"> <li>• Breakwaters will reduce the amount of wave energy reaching the shoreline and therefore reduce the loss of material offshore or alongshore.</li> <li>• Groynes will limit the amount of material moved along the beach.</li> <li>• May create a salient or a tombolo – these are coastal formations of beach material which may or may not be connected to the coastline depending on the feature being considered.</li> <li>• Allow some alongshore material drift.</li> <li>• Stable pocket beaches will be created on the landward side of the groynes.</li> <li>• Allows the existing shingle in MU3 to be removed potentially improving the aesthetics of the beach for some people.</li> </ul>	<ul style="list-style-type: none"> <li>• Large engineering works with potential impacts on local area during construction.</li> <li>• Significant amount of rock armour material required.</li> <li>• High construction cost.</li> <li>• Significant visual impact, particularly for the emerged breakwater.</li> <li>• Requires removal of the existing shingle in MU3 incurring a high cost although material could be recycled to other parts of the beach.</li> <li>• Some work is on privately owned frontage and therefore may require additional agreements/approvals.</li> </ul>

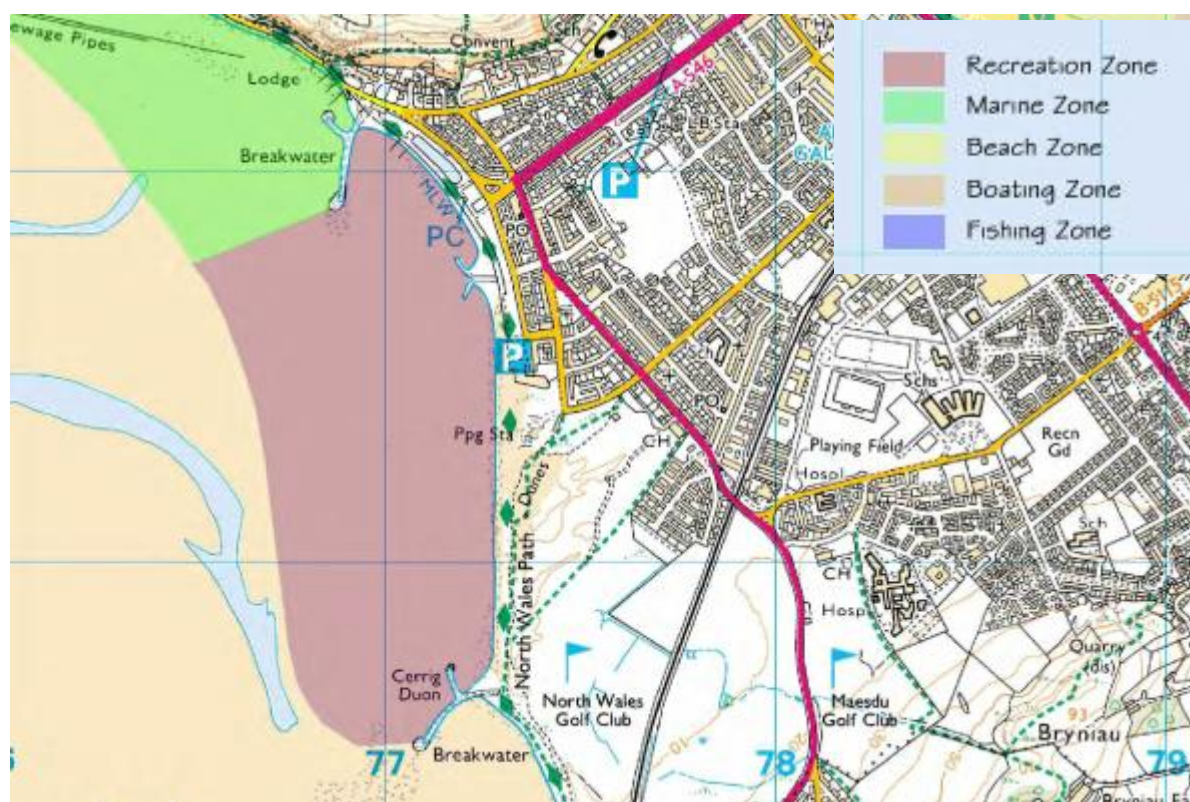
**Figure 5-1. Strategic Management Zones for West Shore, Llandudno (Llandudno Coastal Forum 2016)**

The LCF has identified a number of Strategic Management Zones within the West Shore. The uses for each of these locations are shown in Figure 5-1 below. This map shows that the West Shore is predominately designated as a recreation zone, with a Marine Zone located to the north of the frontage.

To be able to consider the different combinations of land use, shoreline features and exposure to waves the frontage was split into a number of Management Units as described in Table 5-1 and shown in Figure 5-1.

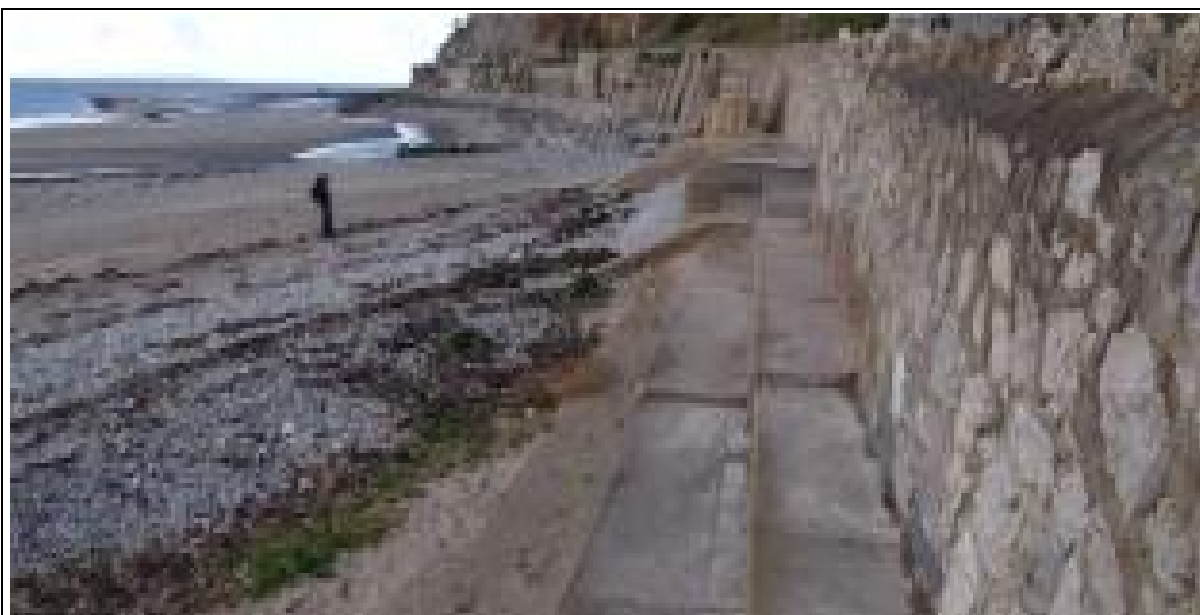
### 5.2.2 MUW1: Frontage along Marine Drive to Gogarth Breakwater

The relatively narrow beach in this area consists of a sand and shingle upper beach with a lower sand beach. This beach is backed by a stepped concrete sea wall with a rear vertical wall. The northern limit extends approximately 600m north of the Gogarth Breakwater while the southern limit is bounded by the breakwater itself.

The steps across this section are in poor condition and have been overlaid in the past. The beach is currently protecting them to a varying degree.

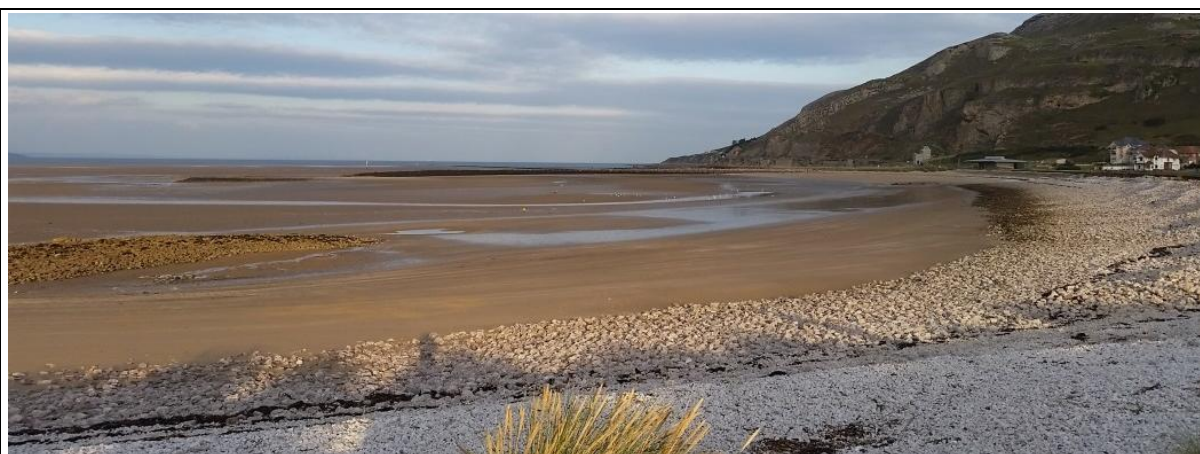
### 5.2.3 MUW2: Gogarth Breakwater to Lloyd Street Breakwater

The upper beach consists of shingle and cobbles with a lower sand beach. The beach is backed by a stepped concrete sea wall. The extents of this management unit consist of the Gogarth Breakwater to the north and the Lloyd Street Breakwater to the south.

The steps across this section are in poor condition and have been overlaid in the past. The beach is currently protecting them to a large degree but some steps remain exposed with spalls and exposed reinforcement evident

The condition of the sea wall is considered by JBA (2015) to be fair. MUW2 is the area of the West Shore considered to be most at risk of being overtopped in the future due to extreme still water levels (without waves) and therefore the wall will need to be improved in the future.

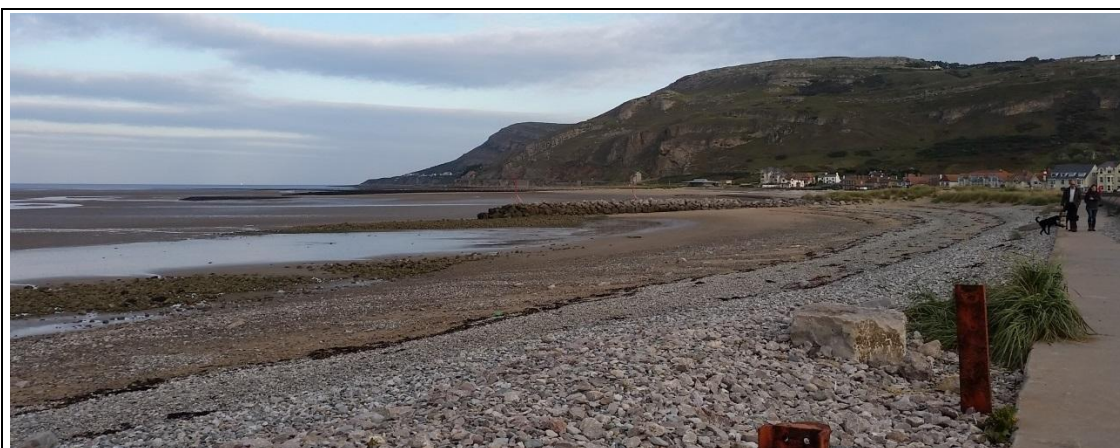
### 5.2.4 MUW3: Lloyd Street Breakwater to Dale Road car park

<p><b>Description</b></p> <p>Natural shingle bank on the upper beach, with a lower sand beach. The northern limit is bounded by the Lloyd Street breakwater while the southern limit extends to the Dale Road car park. The sea wall extends along the back of the beach and is well protected by the beach.</p>
<p><b>Issues and Objectives</b></p> <p>Wind-blown sand is an issue here due to the build-up of material behind the breakwater. Material removal is undertaken on an as required basis.</p>
<p><b>Constraints</b></p> <p>Beach levels must be maintained to prevent wave overtopping and scour of the toe of the sheet pile wall at the bottom of the steps.</p>
<p><b>Options</b></p> <p>The frontage wide options of periodic beach maintenance, dune regeneration, breakwater removal, rock placement and sand traps will affect this management unit (Options WS1-6 to WS8-9).</p>

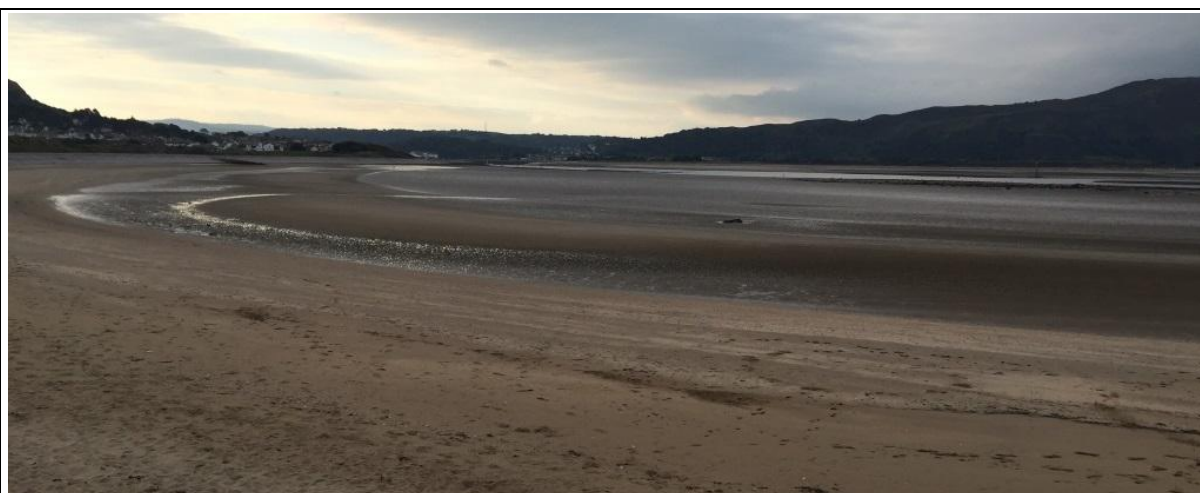
### 5.2.6 MUW5: Immediately South of Cerrig Duon Breakwater

The Cerrig Duon breakwater is the northern boundary of this management unit and it extends approximately 300m to the south of this breakwater. The beach is backed by the southern end of the dunes and the upper beach is well protected by the breakwater. The upper beach is sand and shingle however the area immediately behind the breakwater is very fine soft sand.

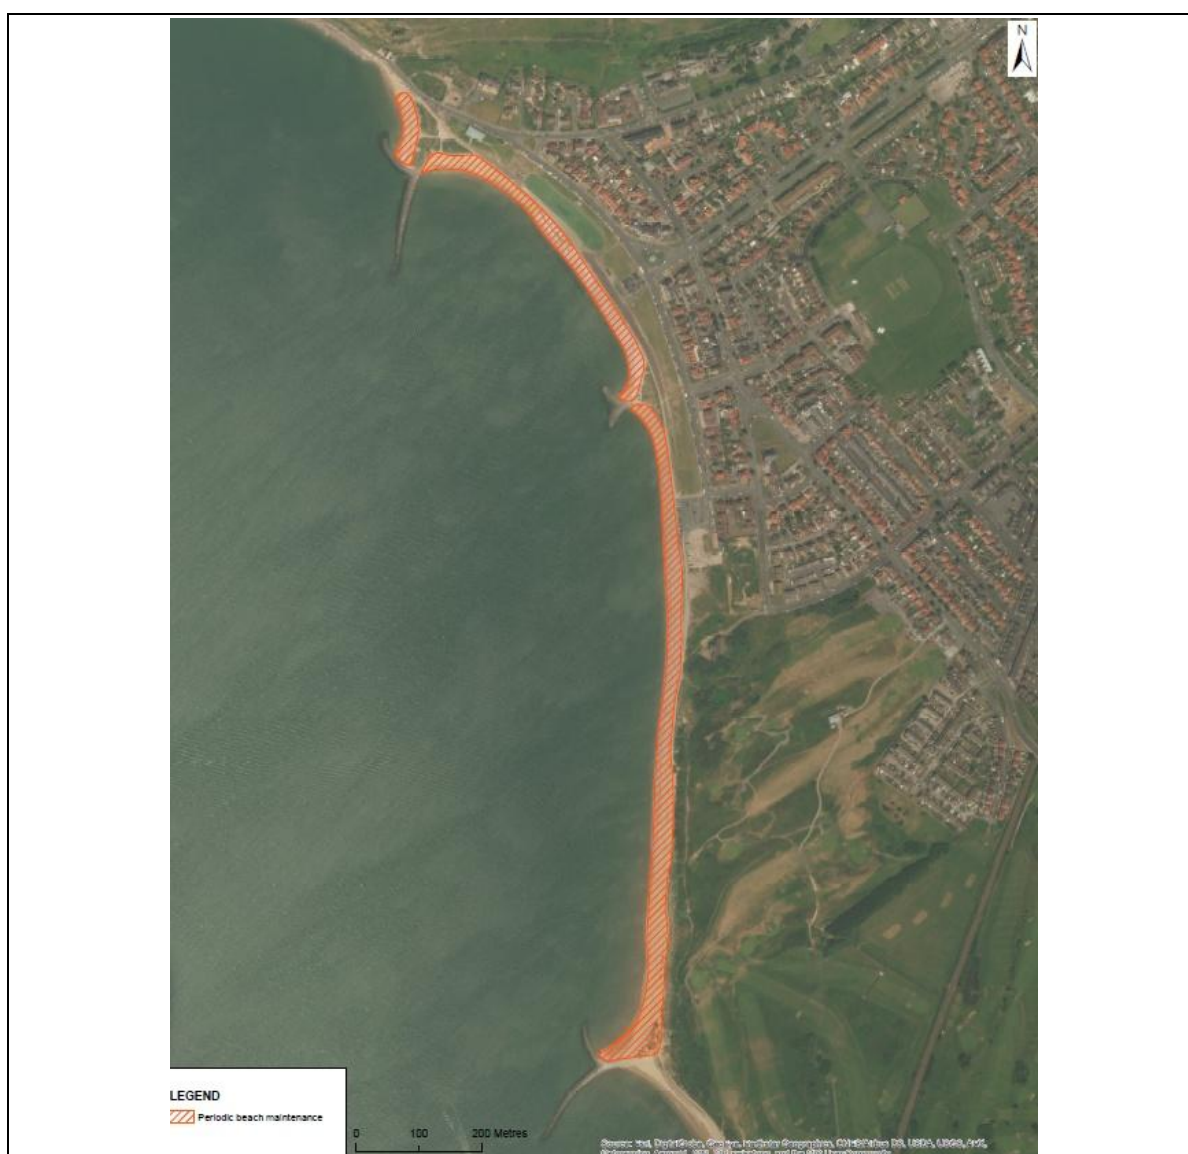
### 5.3.2 Option 1: Periodic Beach Maintenance (MUW1-5)

<b>Description</b>	
<p>This option assumes that the back of the beach is recharged with shingle and there is ongoing maintenance of the sand on the beach. Excess material will be removed frequently from the frontage and re-used in other areas (possibly the North Shore) where required.</p>	
<b>Advantages</b>	<b>Disadvantages</b>
<ul style="list-style-type: none"> <li>• Low impact on the environment</li> <li>• Surplus material can be re-used in other areas</li> </ul>	<ul style="list-style-type: none"> <li>• Variable standard of protection provided as beach moves</li> <li>• Losses occur in places (requires periodic re-nourishment)</li> <li>• Requires regular management</li> </ul>

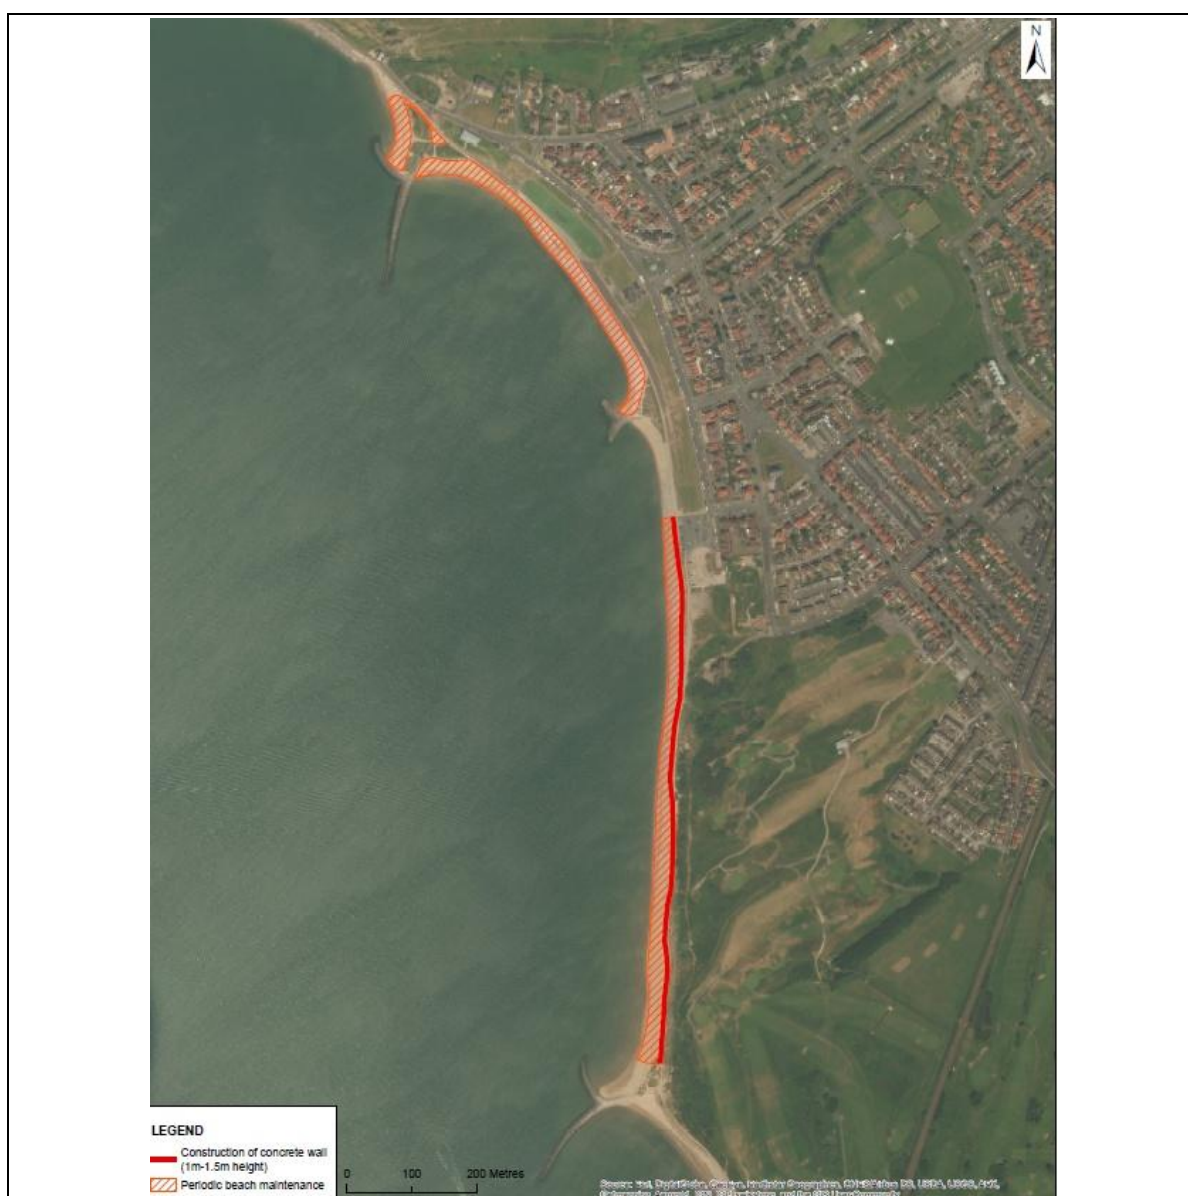
### 5.3.4 Option 3: Concrete wall and periodic beach maintenance (MUW1-5)

<b>Description</b>	
<p>A concrete wall will be constructed along the back of the beach from the Dale Road car park to the Cerrig Duon breakwater. Periodic beach maintenance will be undertaken across the entire frontage to remove excess material.</p>	
<b>Advantages</b>	<b>Disadvantages</b>
<ul style="list-style-type: none"> <li>Minimal impact on the environment</li> <li>Increased flood protection along the southern end of the frontage</li> </ul>	<ul style="list-style-type: none"> <li>Higher initial cost</li> <li>Will require some maintenance to remove excess material</li> <li>Requires regular re-investment</li> </ul>

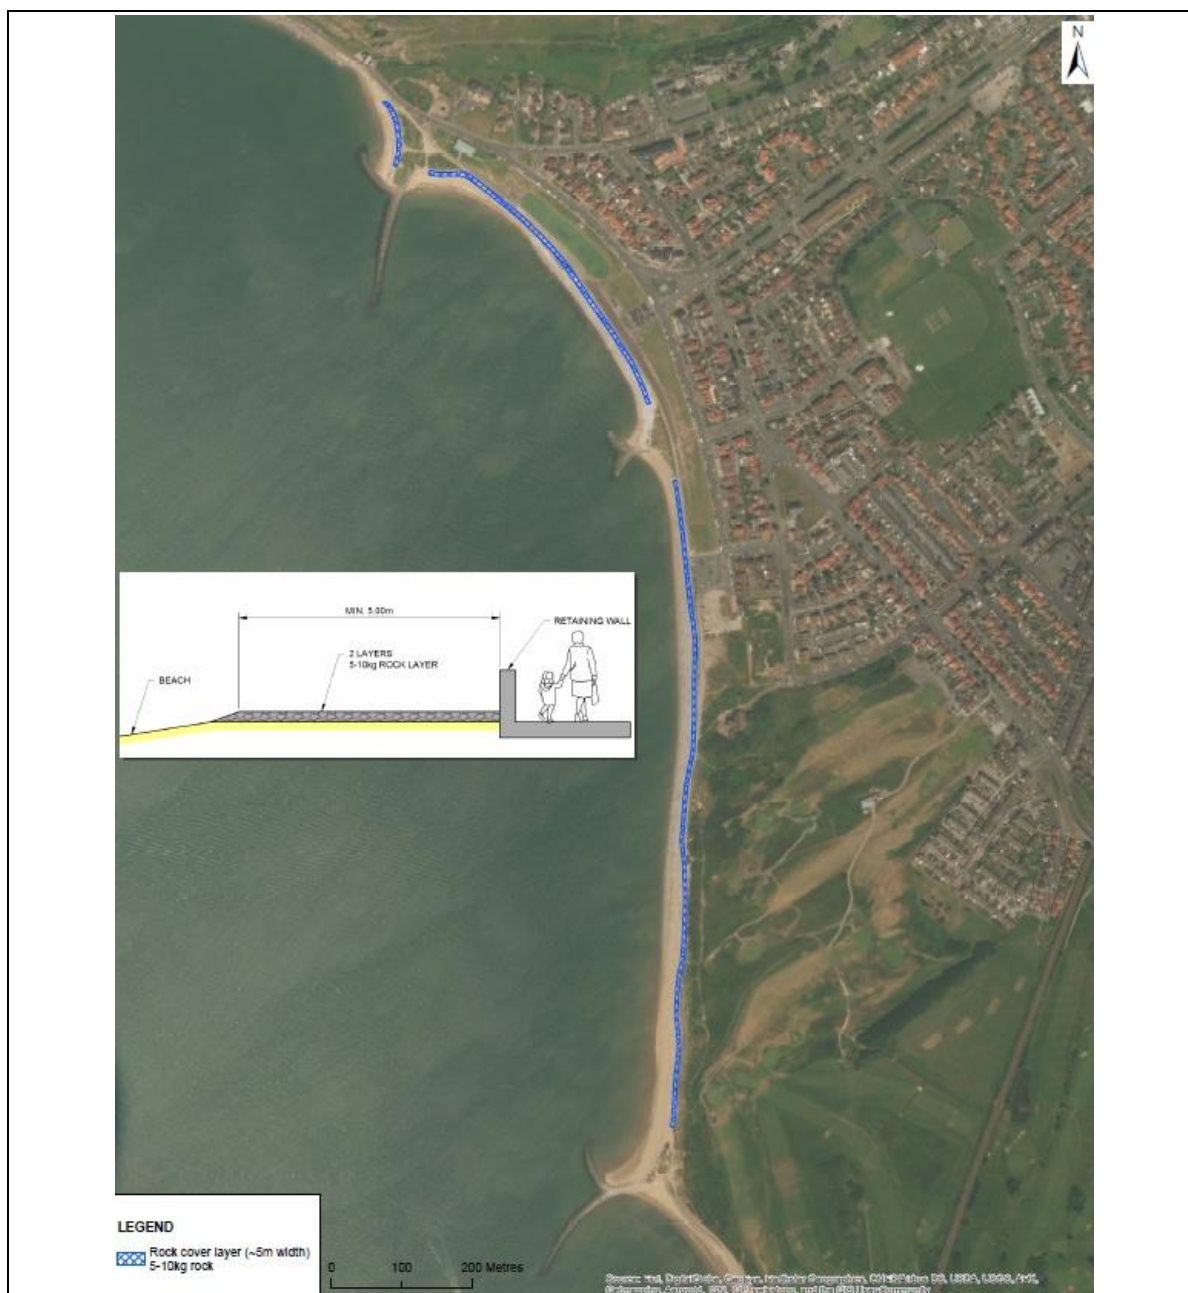
### 5.3.5 Option 4: Rock cover layer (MUW1-5)

<b>Description</b>	
A cover layer of 5-10kg rock will be placed over the existing beach material in order to prevent wind-blown sand. This will be backed by a retaining wall to prevent material loss.	
<b>Advantages</b>	<b>Disadvantages</b>
<ul style="list-style-type: none"> <li>Reduces the wind-blown sand effects initially</li> <li>Relatively low visual impact</li> <li>Rocks likely to be mobilised during storms and will require further engineering to retain.</li> </ul>	<ul style="list-style-type: none"> <li>High initial cost depending on rock size</li> <li>Requires ongoing maintenance to maintain material in place</li> <li>Rock may get clogged with sand. Over time this will build up and overtop the wall.</li> </ul>

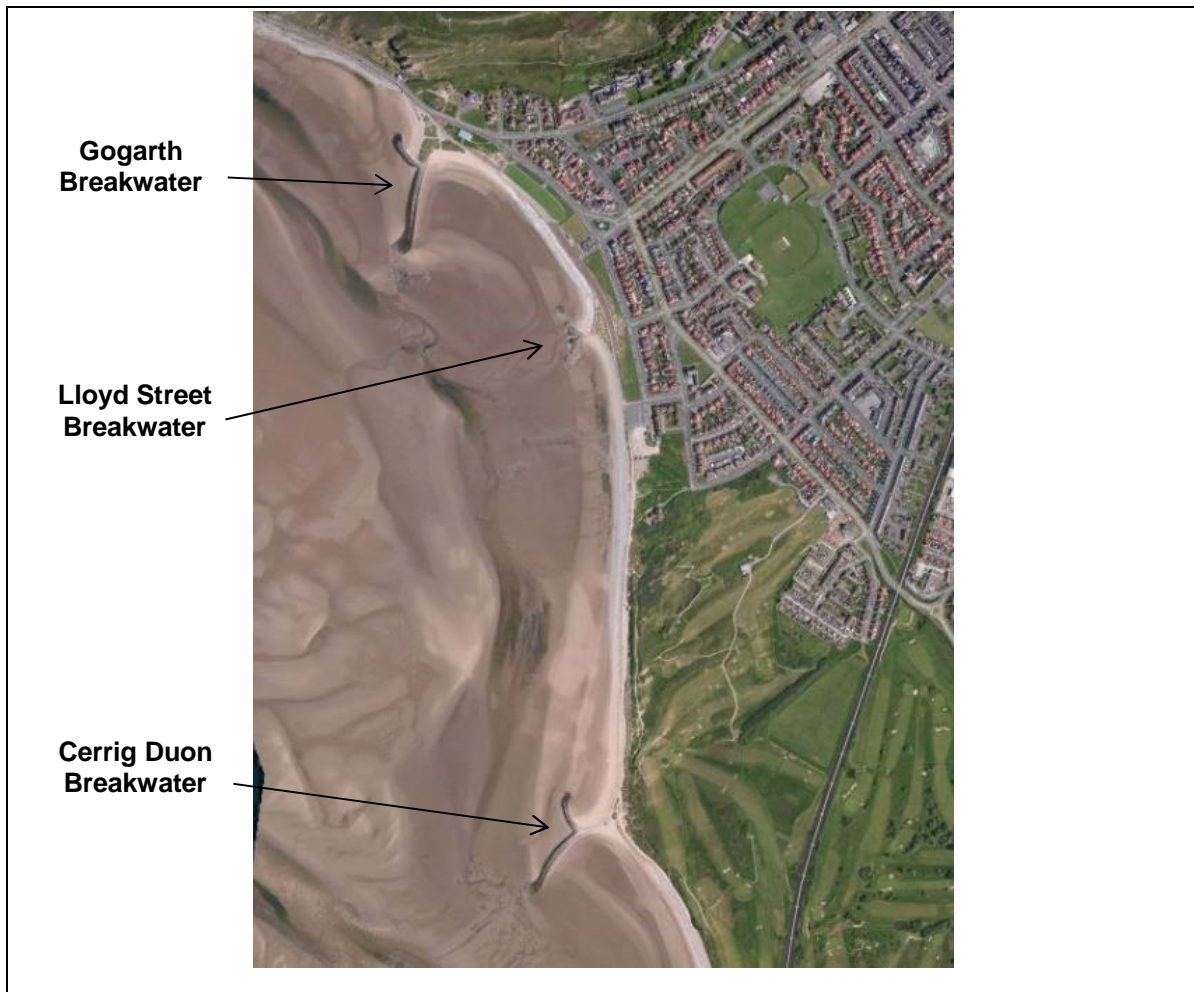
### 5.3.7 Option 6: Breakwater Removal (MUW1-5)

This option involves the removal of the three existing breakwaters which are located along the West Shore; the Gogarth breakwater, Lloyd Street breakwater and Cerrig Duon breakwater. The beach will be re-instated to a 'natural' state however there would not be any beach renourishment or enhancement of the sea wall.
