# Llandudno Beach Management Plan

Appraisal of Options for the future management of  
Llandudno's Beaches

Conwy County Borough Council

Project Number: 60525387

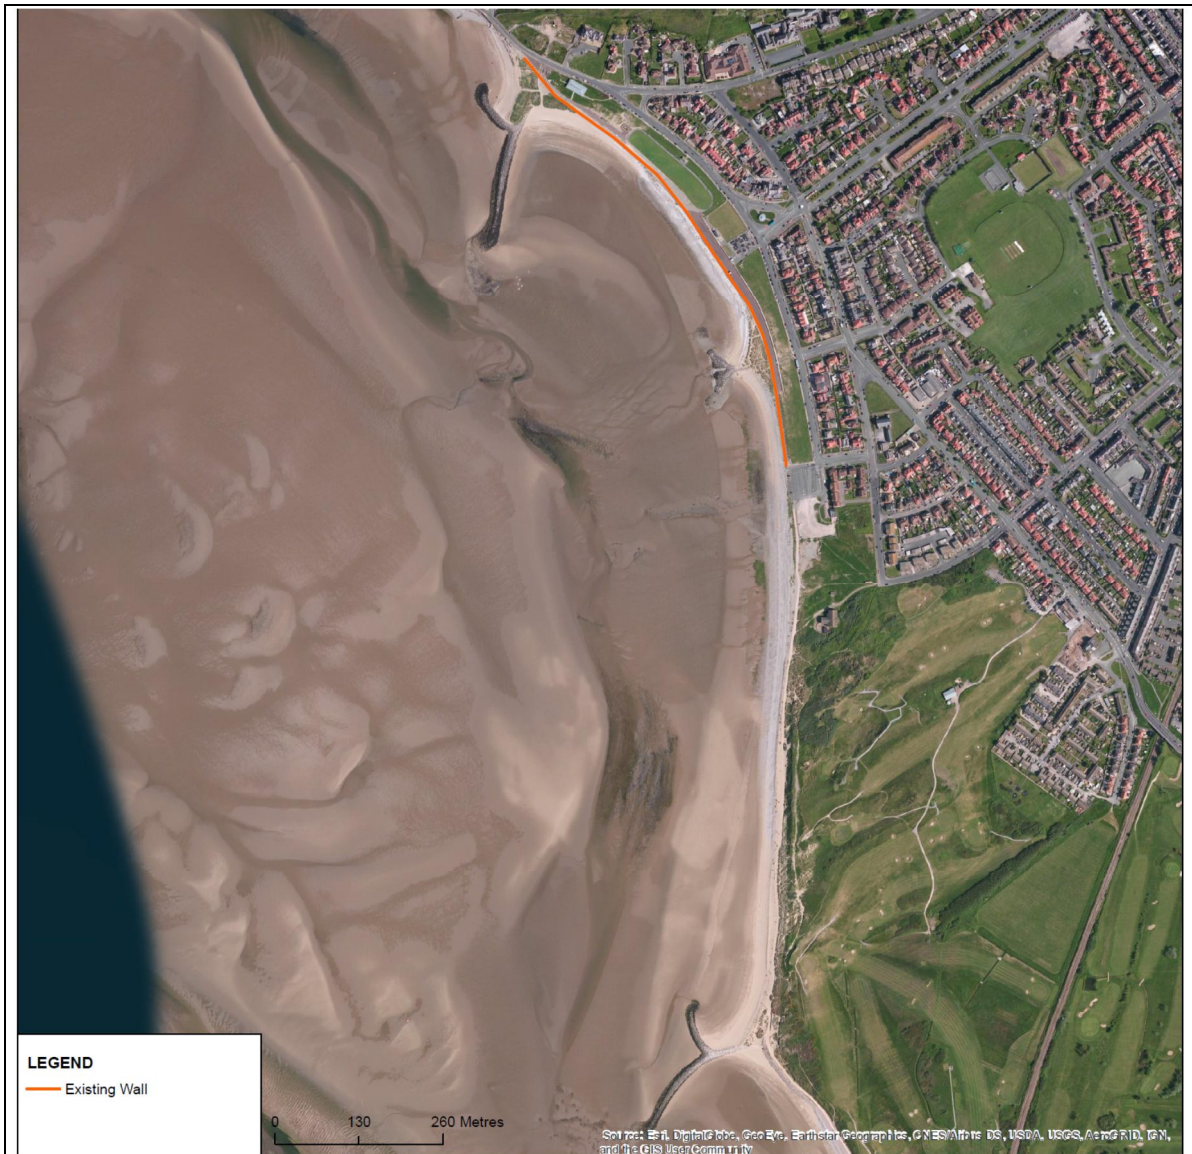
5.3.9 Option 8: Existing wall repairs / raising (MUW2-3)

It is proposed to undertake local repairs to the existing wall structure where it is currently in a state of disrepair.

There are signs of degradation to the existing promenade steps and wave return wall, which will require replacement (and potentially raising to adapt to climate change) at some time in the future, if flood protection is to be maintained.

Option	Notes
8: Wall repairs / raising	<p>The increase in flood protection is likely to be achieved most cost effectively through the enhancement of the existing sea defences. This could be through the replacement/raising of the existing wave return wall or the construction of a secondary defence behind the existing sea wall.</p> <p>It is likely that the wall will also need to be extended south across the car park.</p>

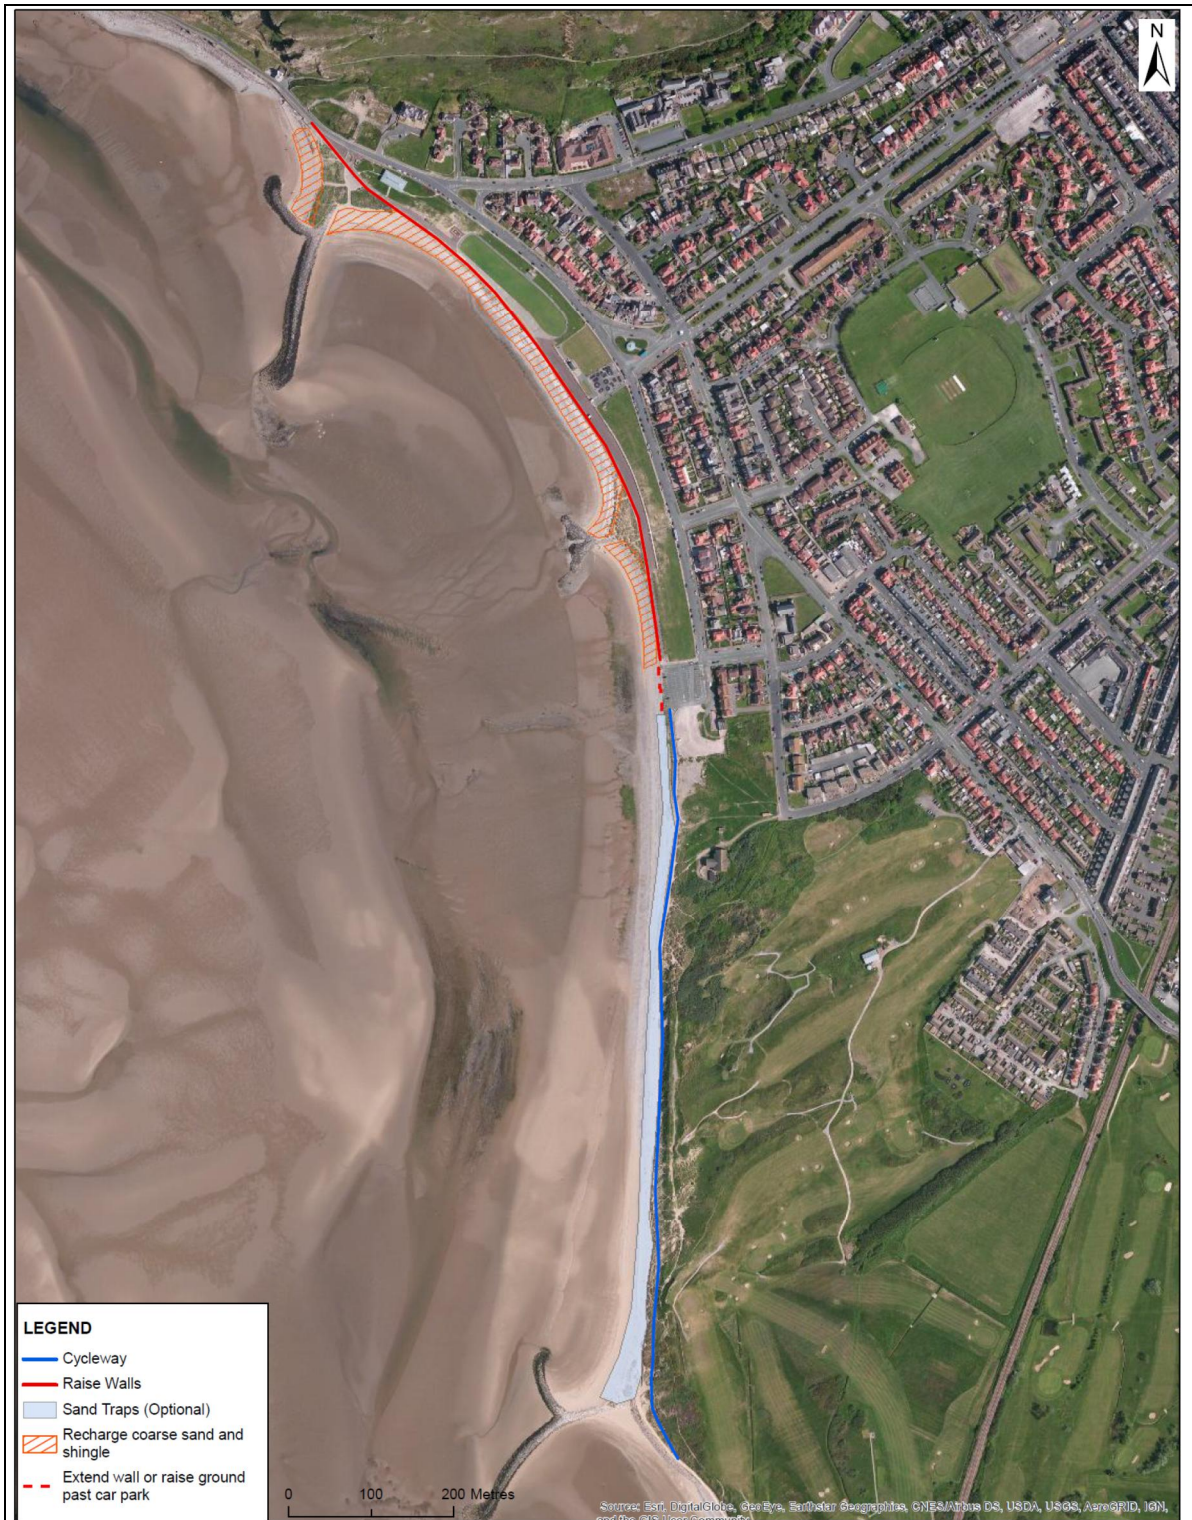
5.3.10 Option 9: Combined Scheme (MUW2-5)

The proposed options presented above have assumed that a single management option will fulfil the requirements; however the different MUs have different issues and require different solutions.

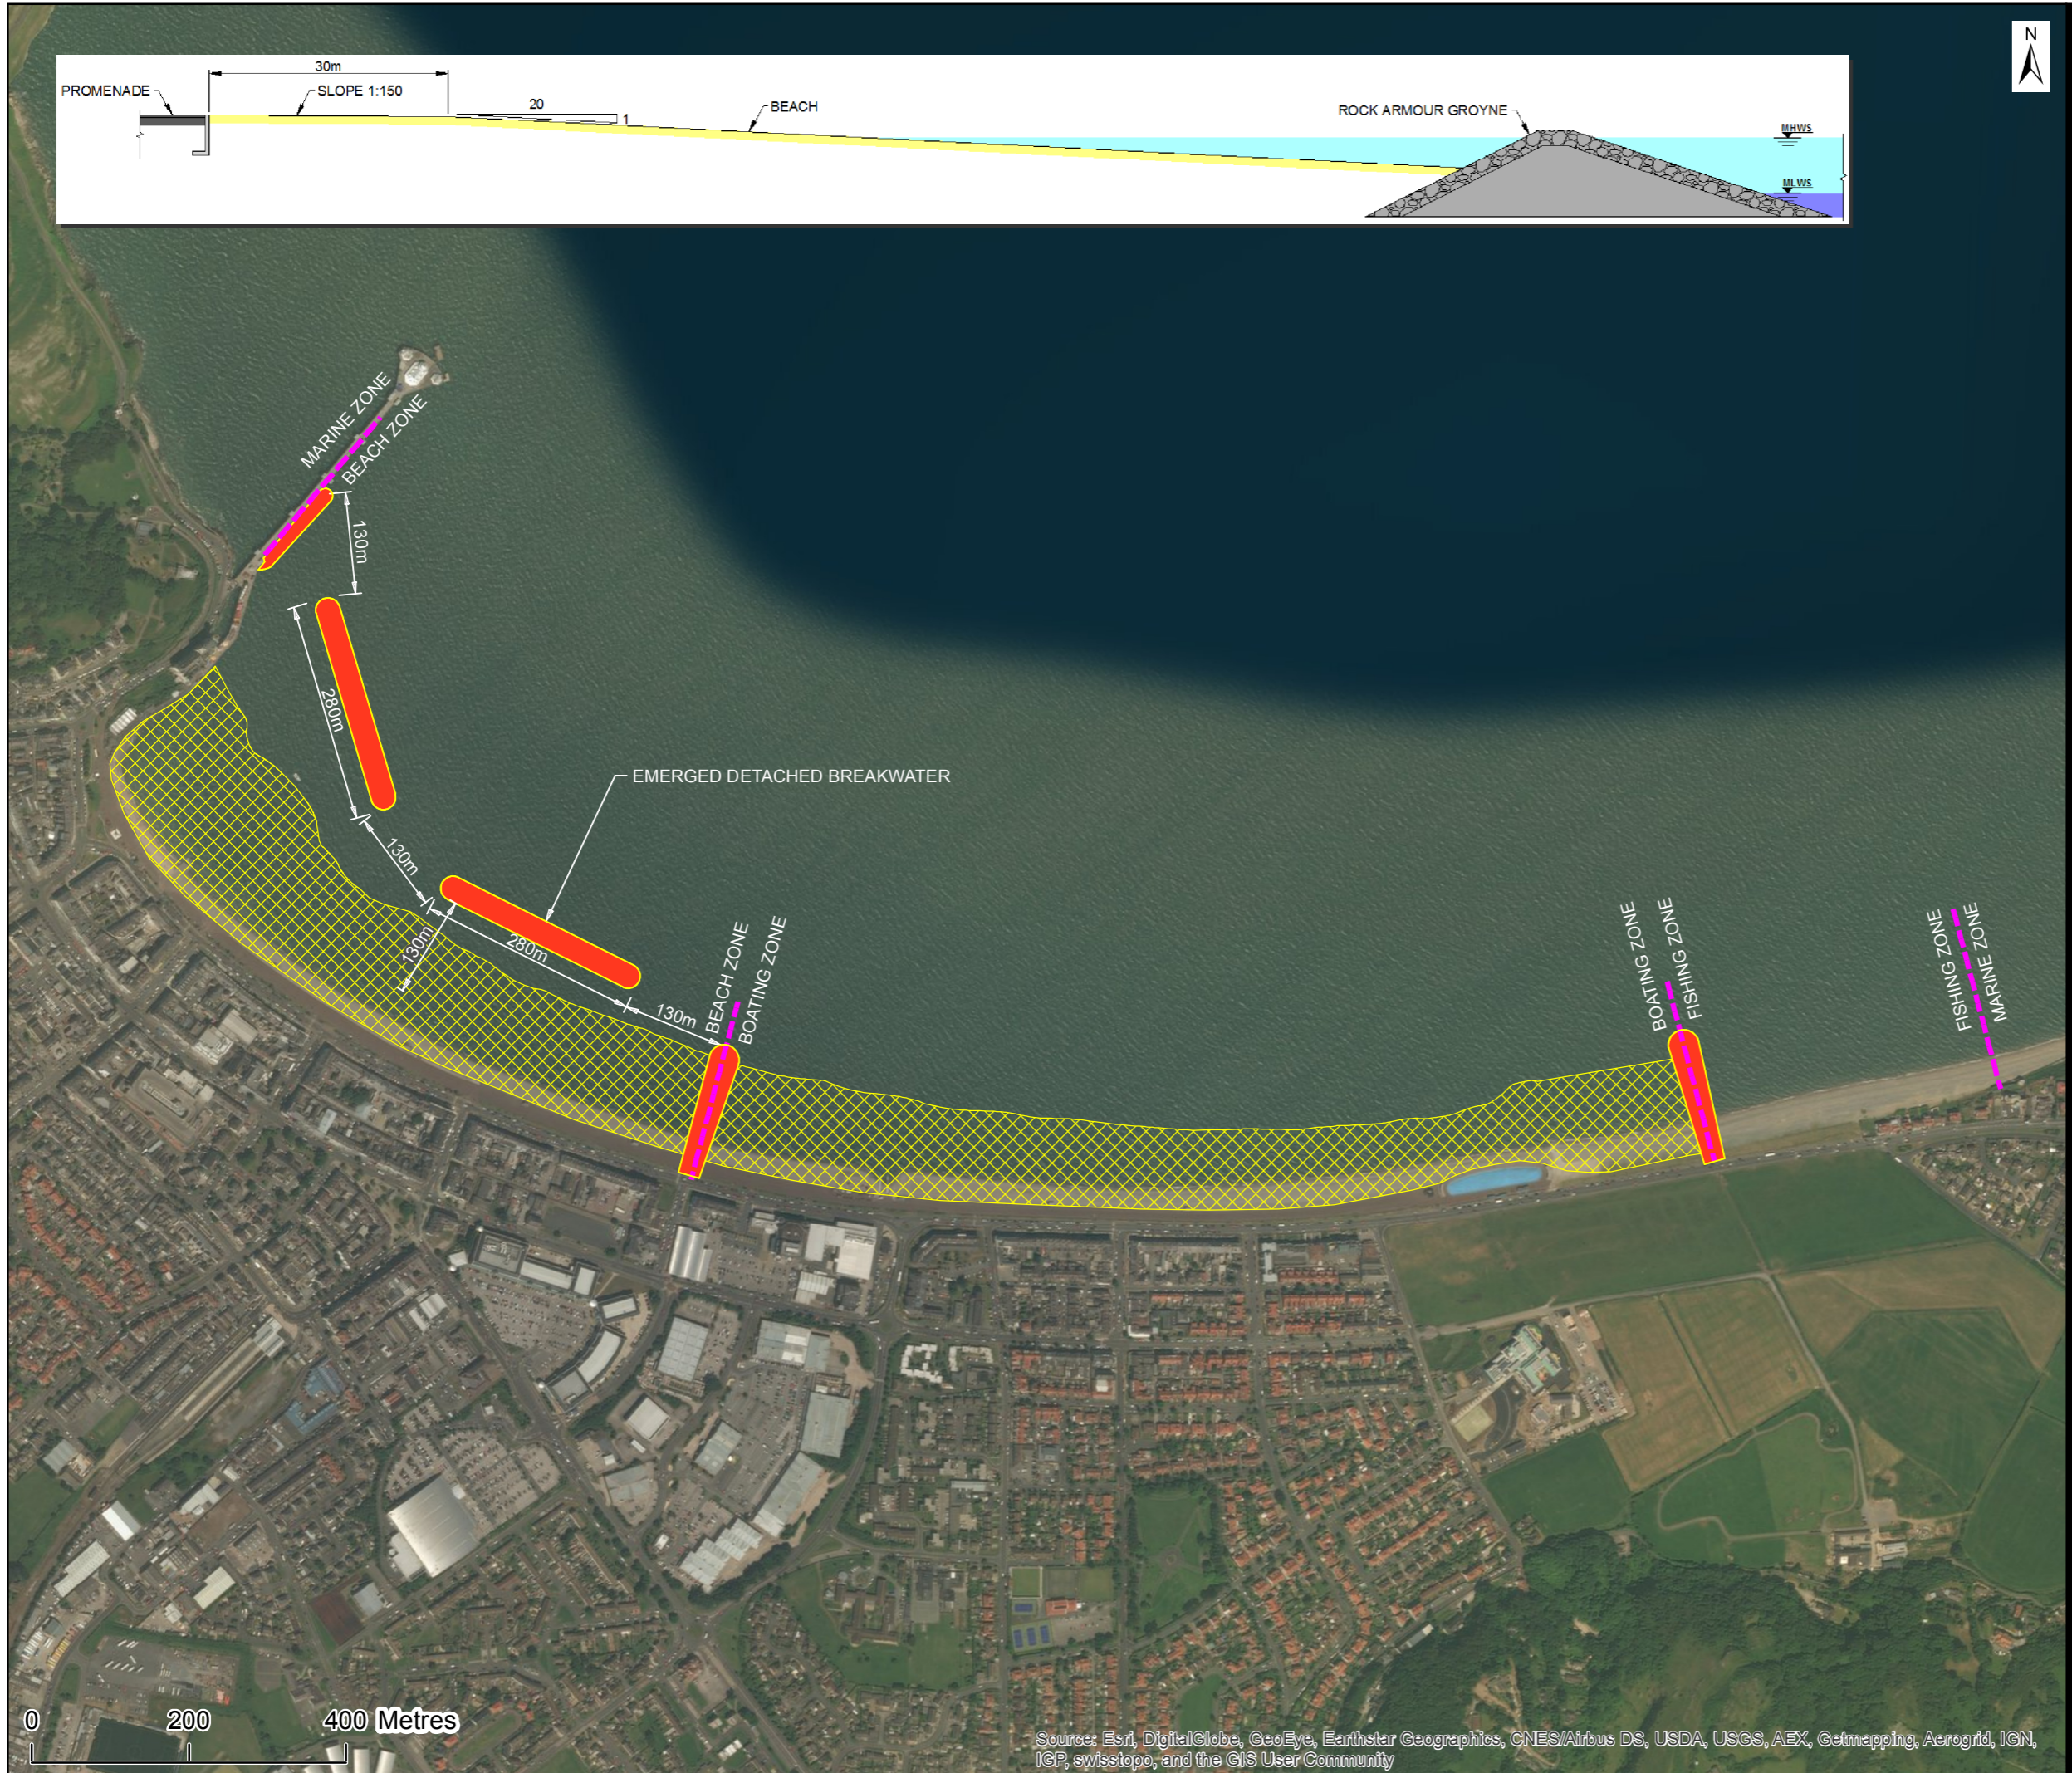
PROJECT NUMBER  
 60525387  
 SHEET TITLE  
 NORTH BEACH: OPTION 1A. BREAKWATERS  
 DRAWING NUMBER  
 60525387-SKE-00-0000-C-1150

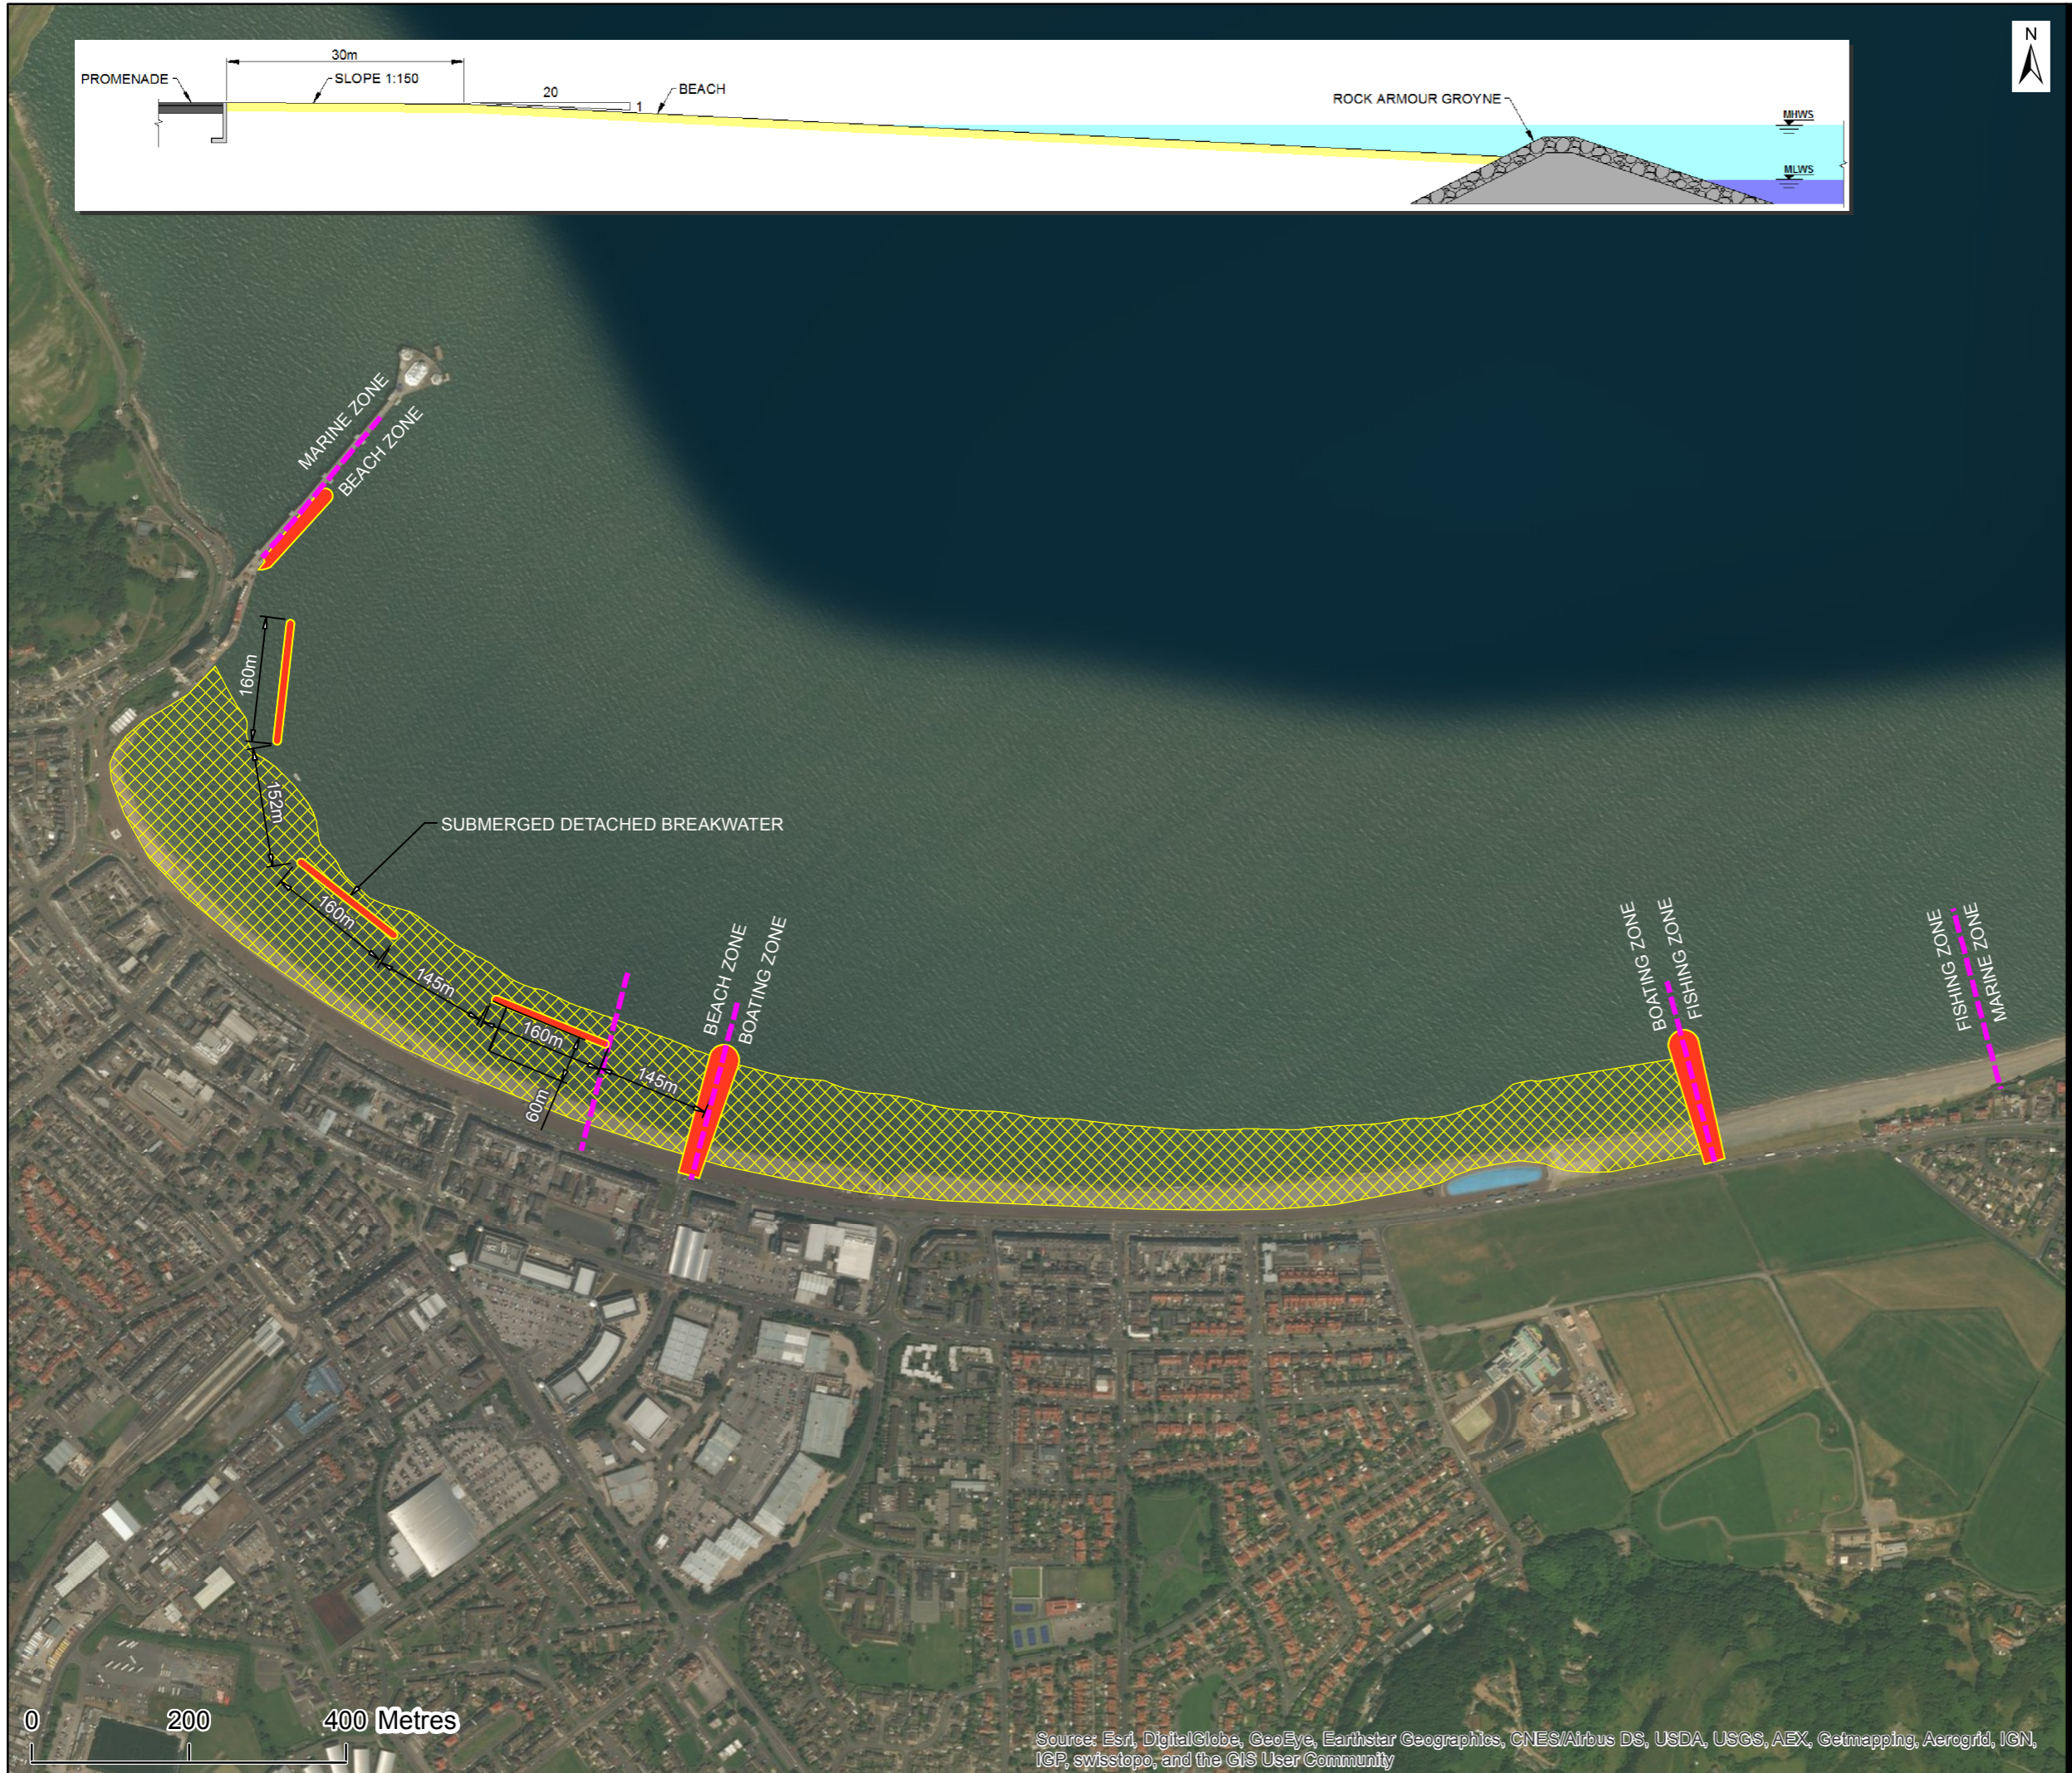
PROJECT NUMBER  
 60525387  
 SHEET TITLE  
 NORTH BEACH: OPTION 1B. BREAKWATERS  
 DRAWING NUMBER  
 60525387-SKE-00-0000-C-1151

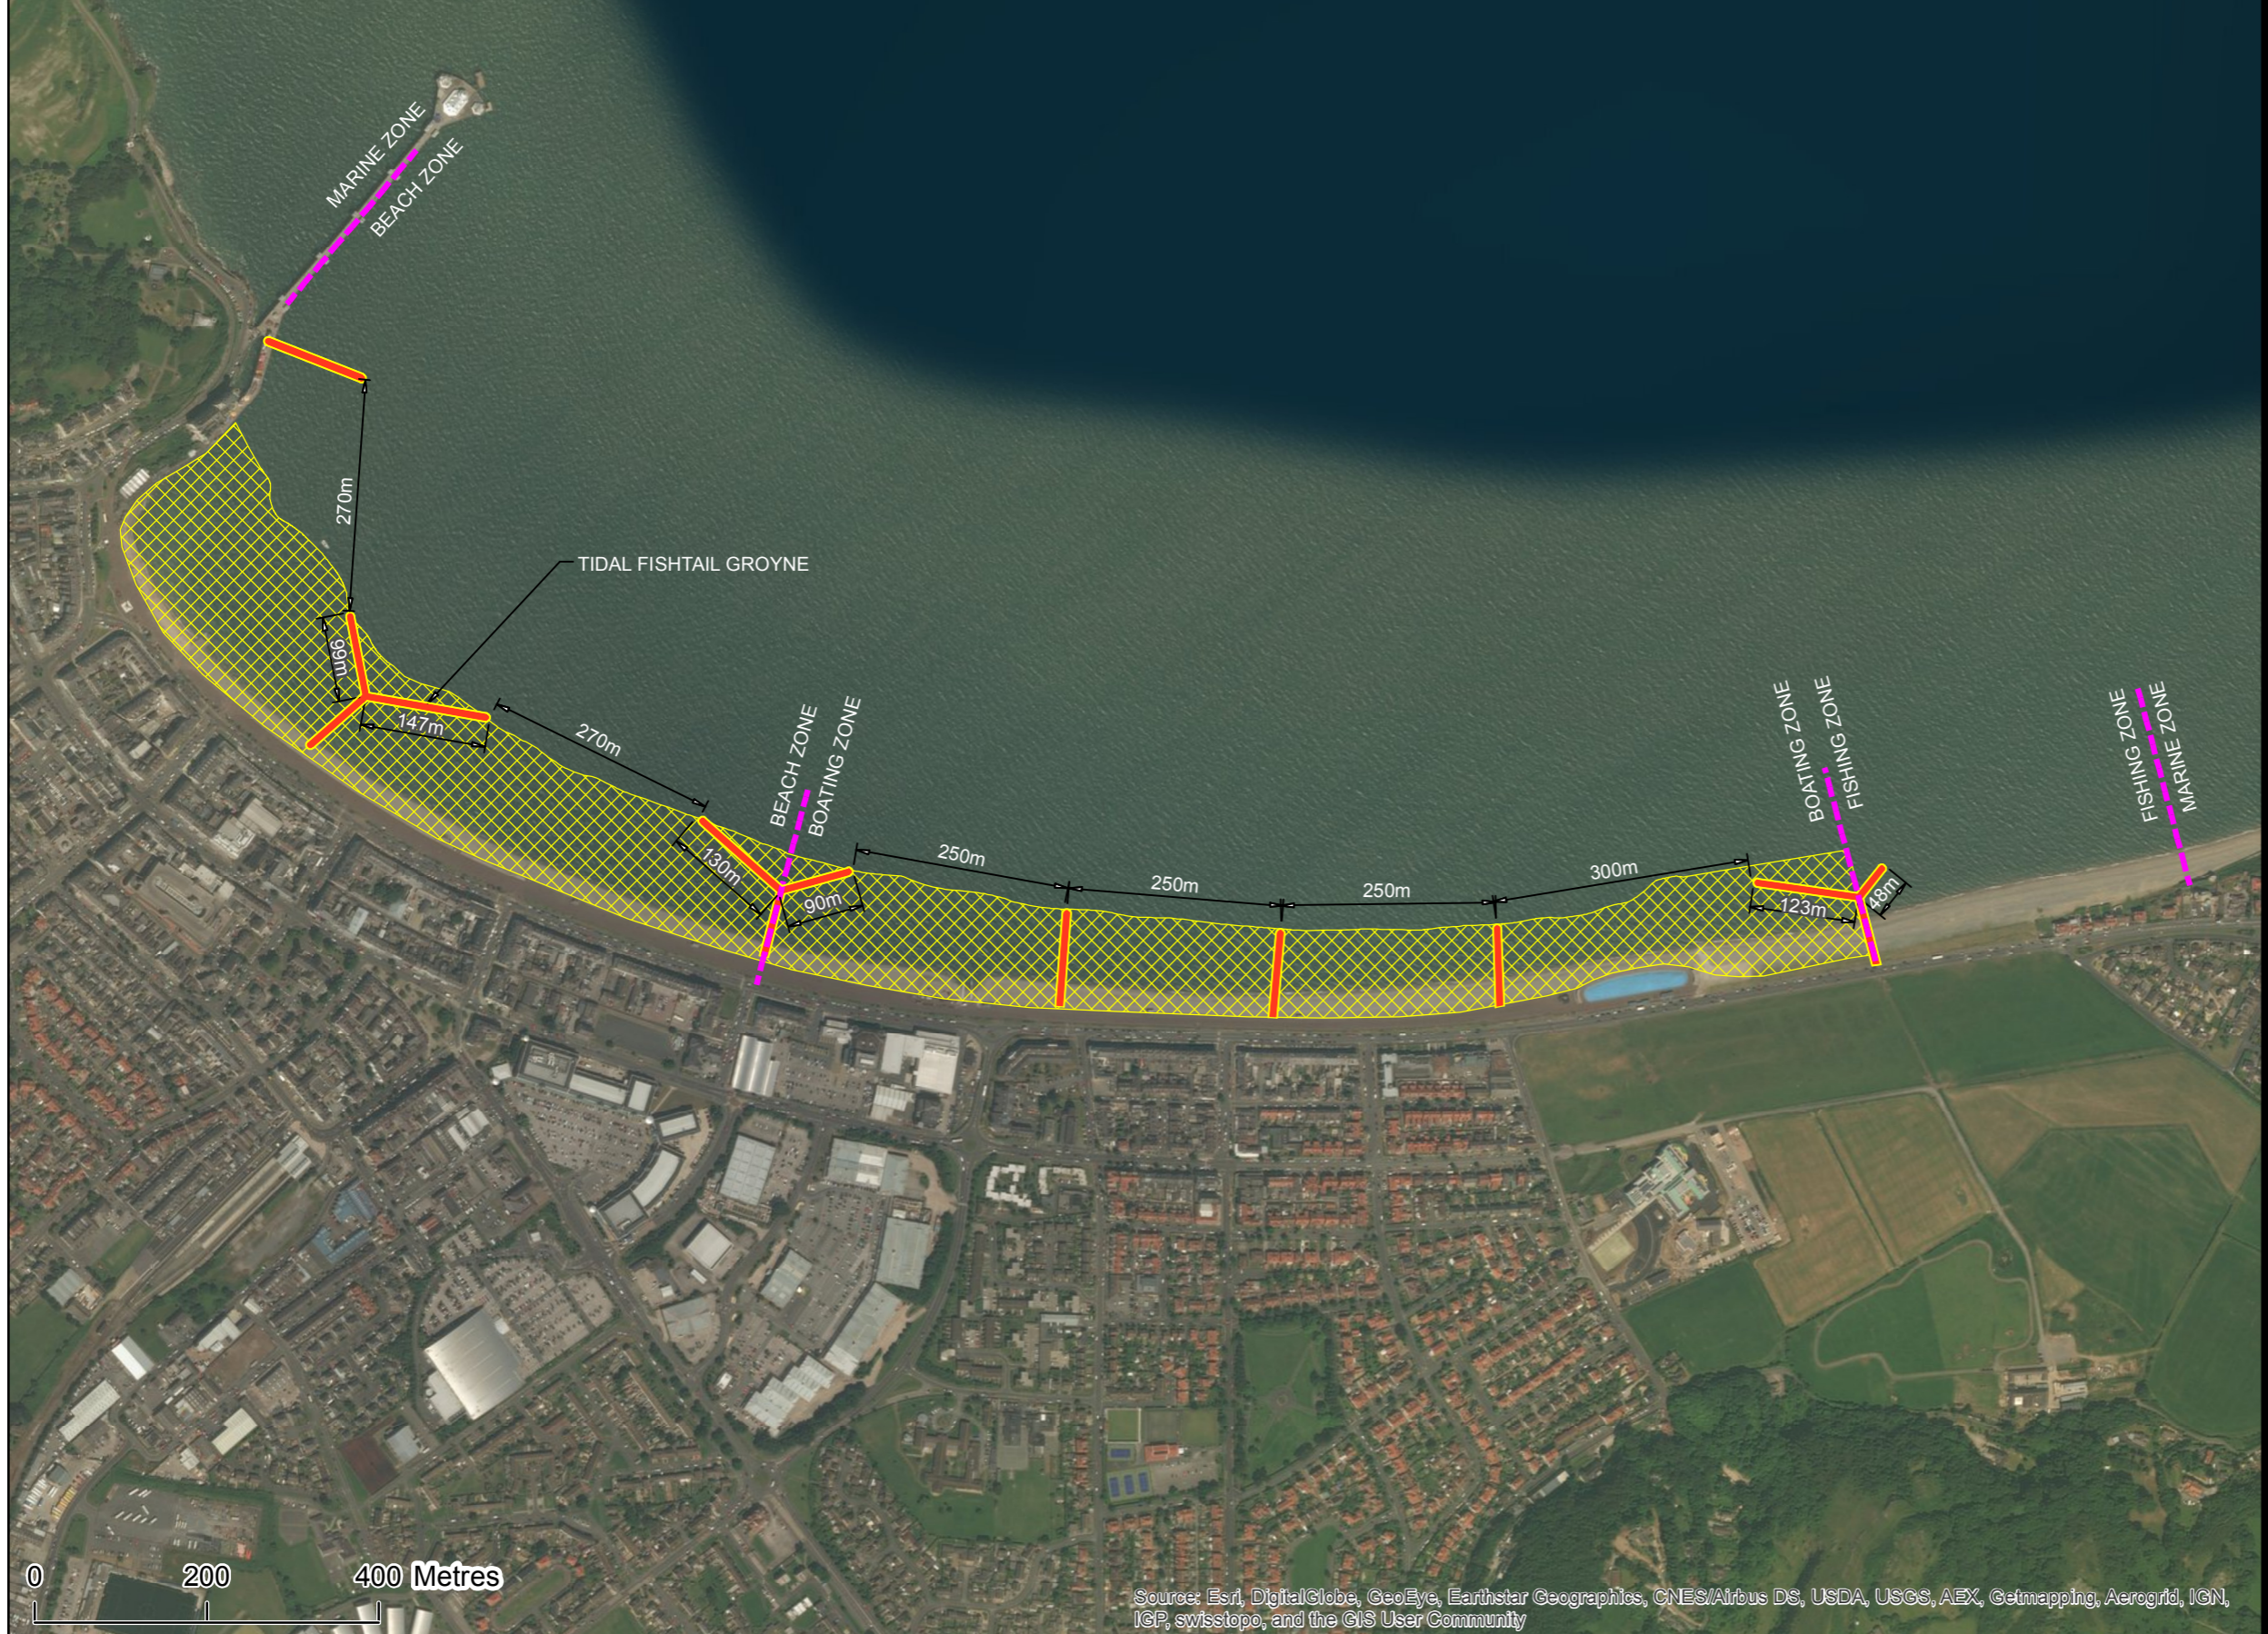
PROJECT NUMBER  
 60525387  
 SHEET TITLE  
 NORTH BEACH: OPTION 2A.  
 FISHTAIL GROYNES  
 DRAWING NUMBER  
 60525387-SKE-00-0000-C-1152

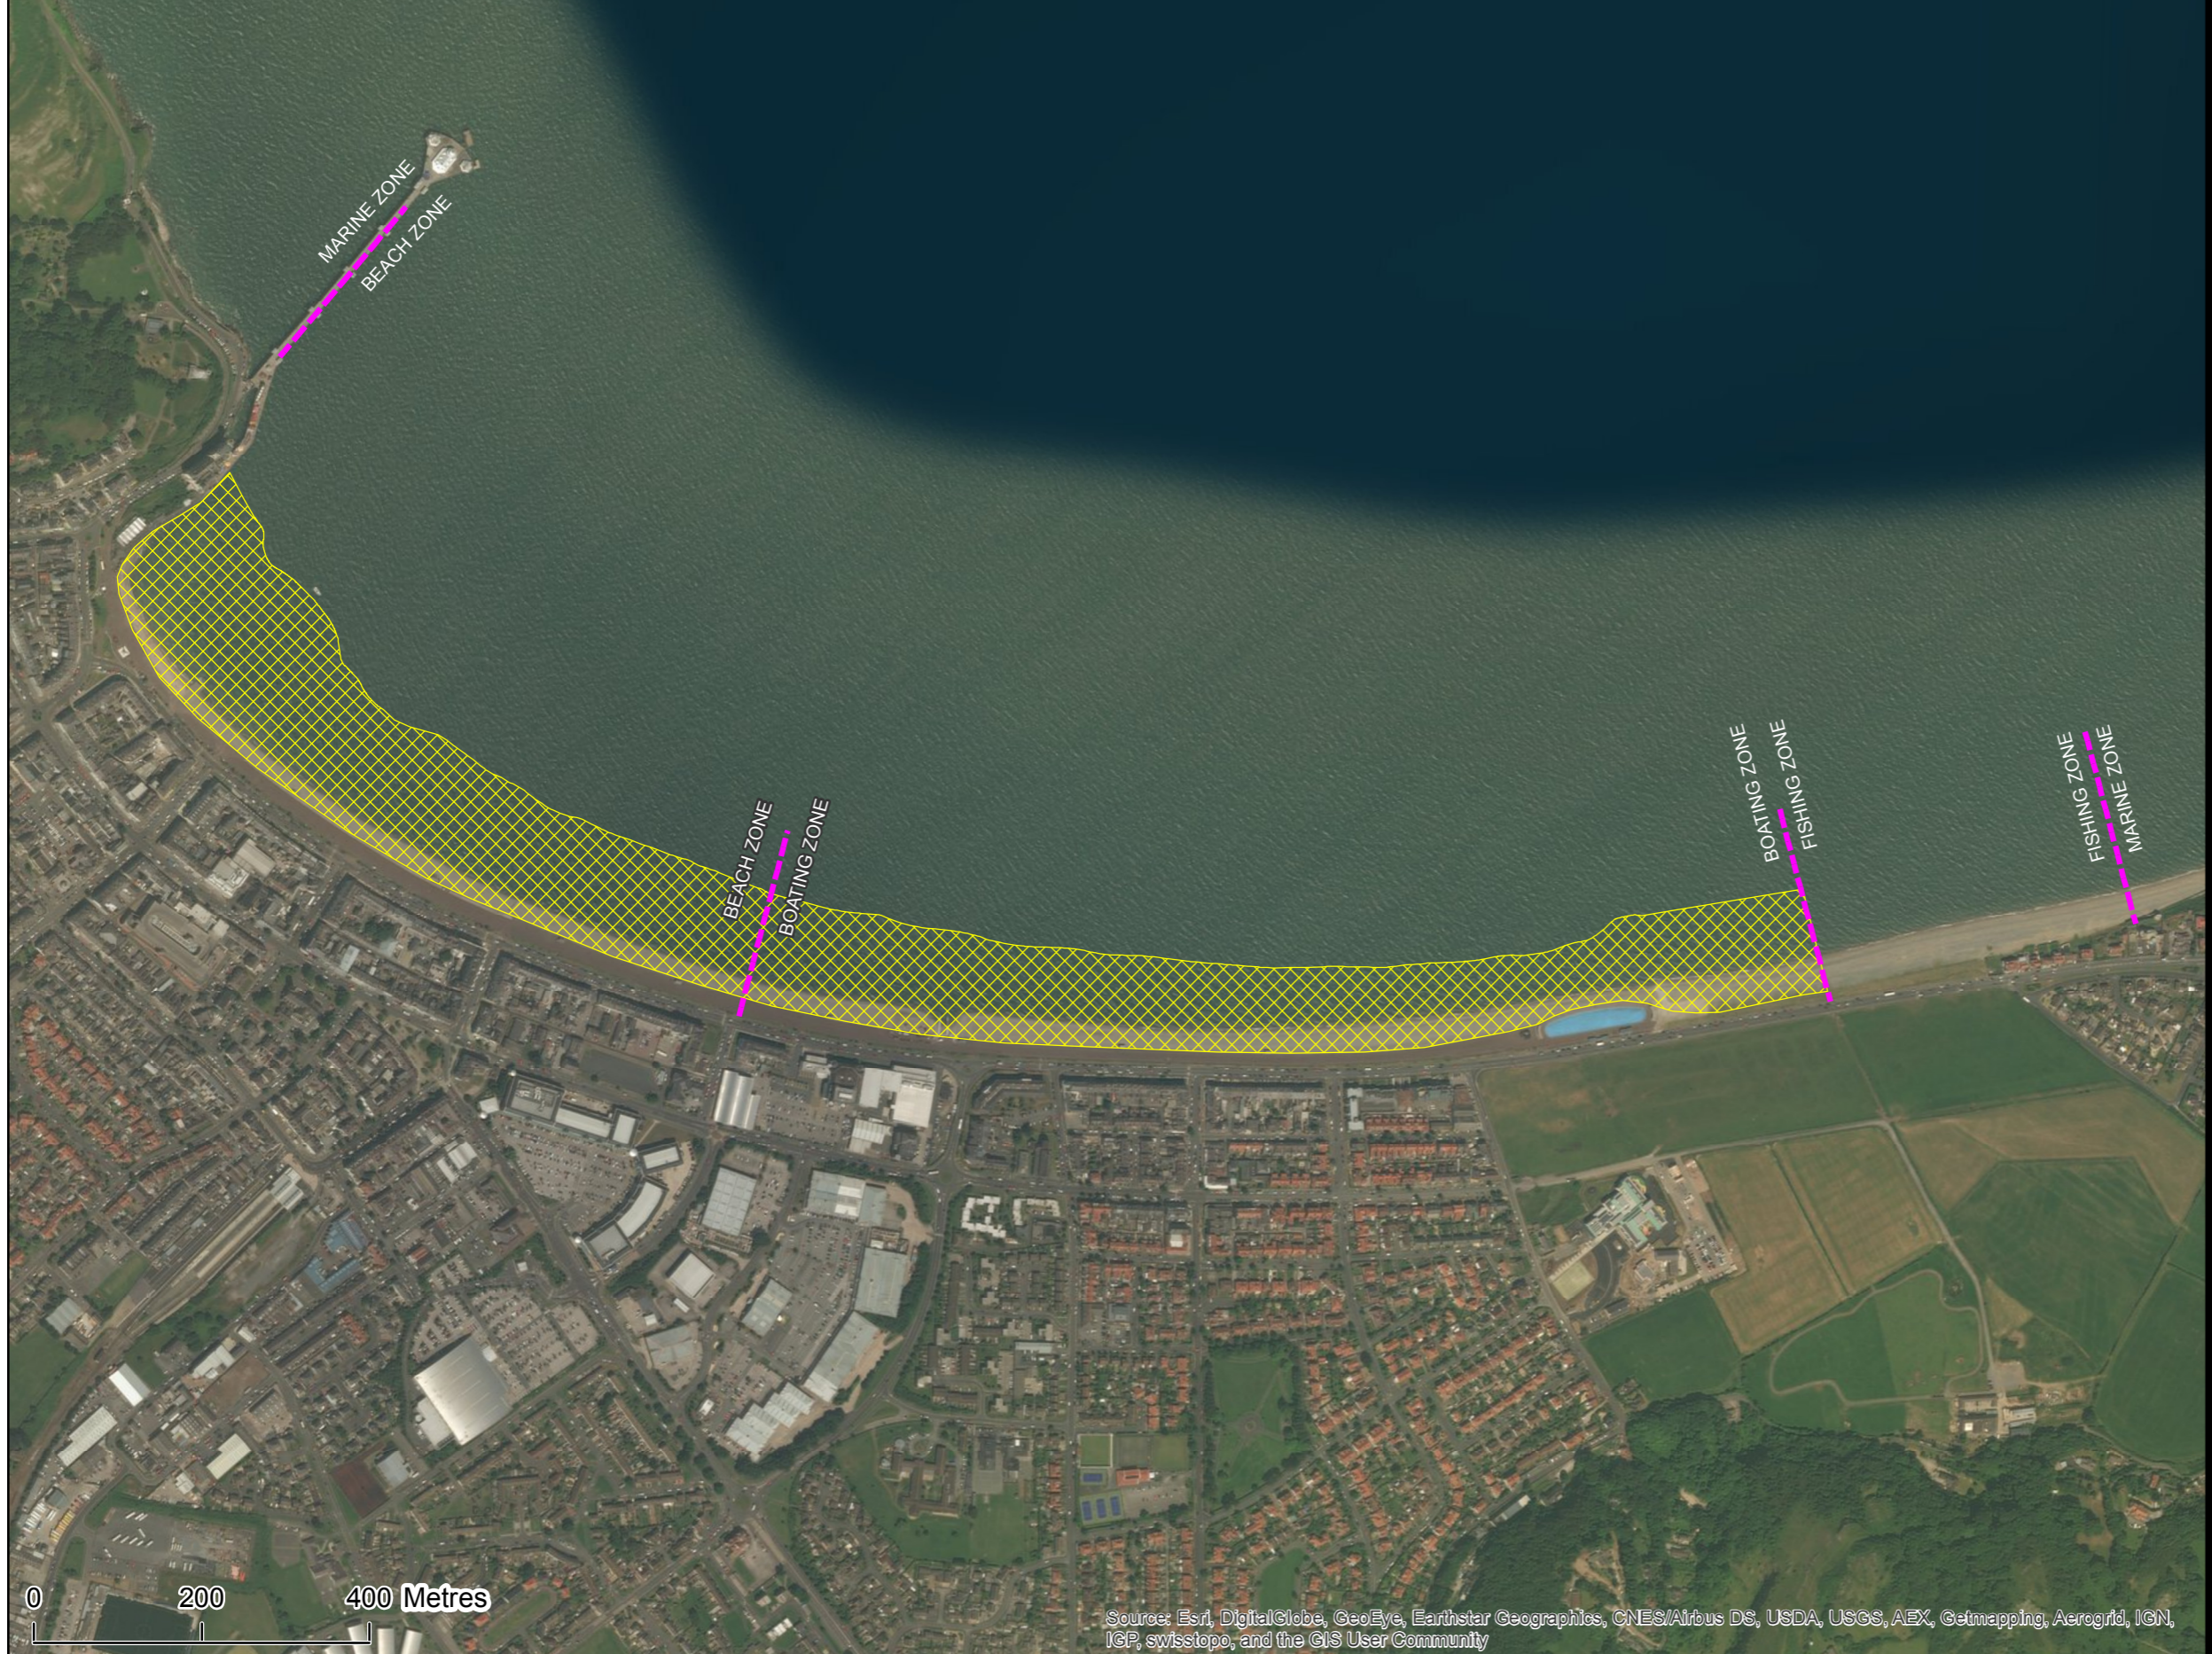
PROJECT NUMBER  
 60525387  
 SHEET TITLE  
 NORTH BEACH: OPTION 4.  
 BEACH NOURISHMENT  
 DRAWING NUMBER  
 60525387-SKE-00-0000-C-1155

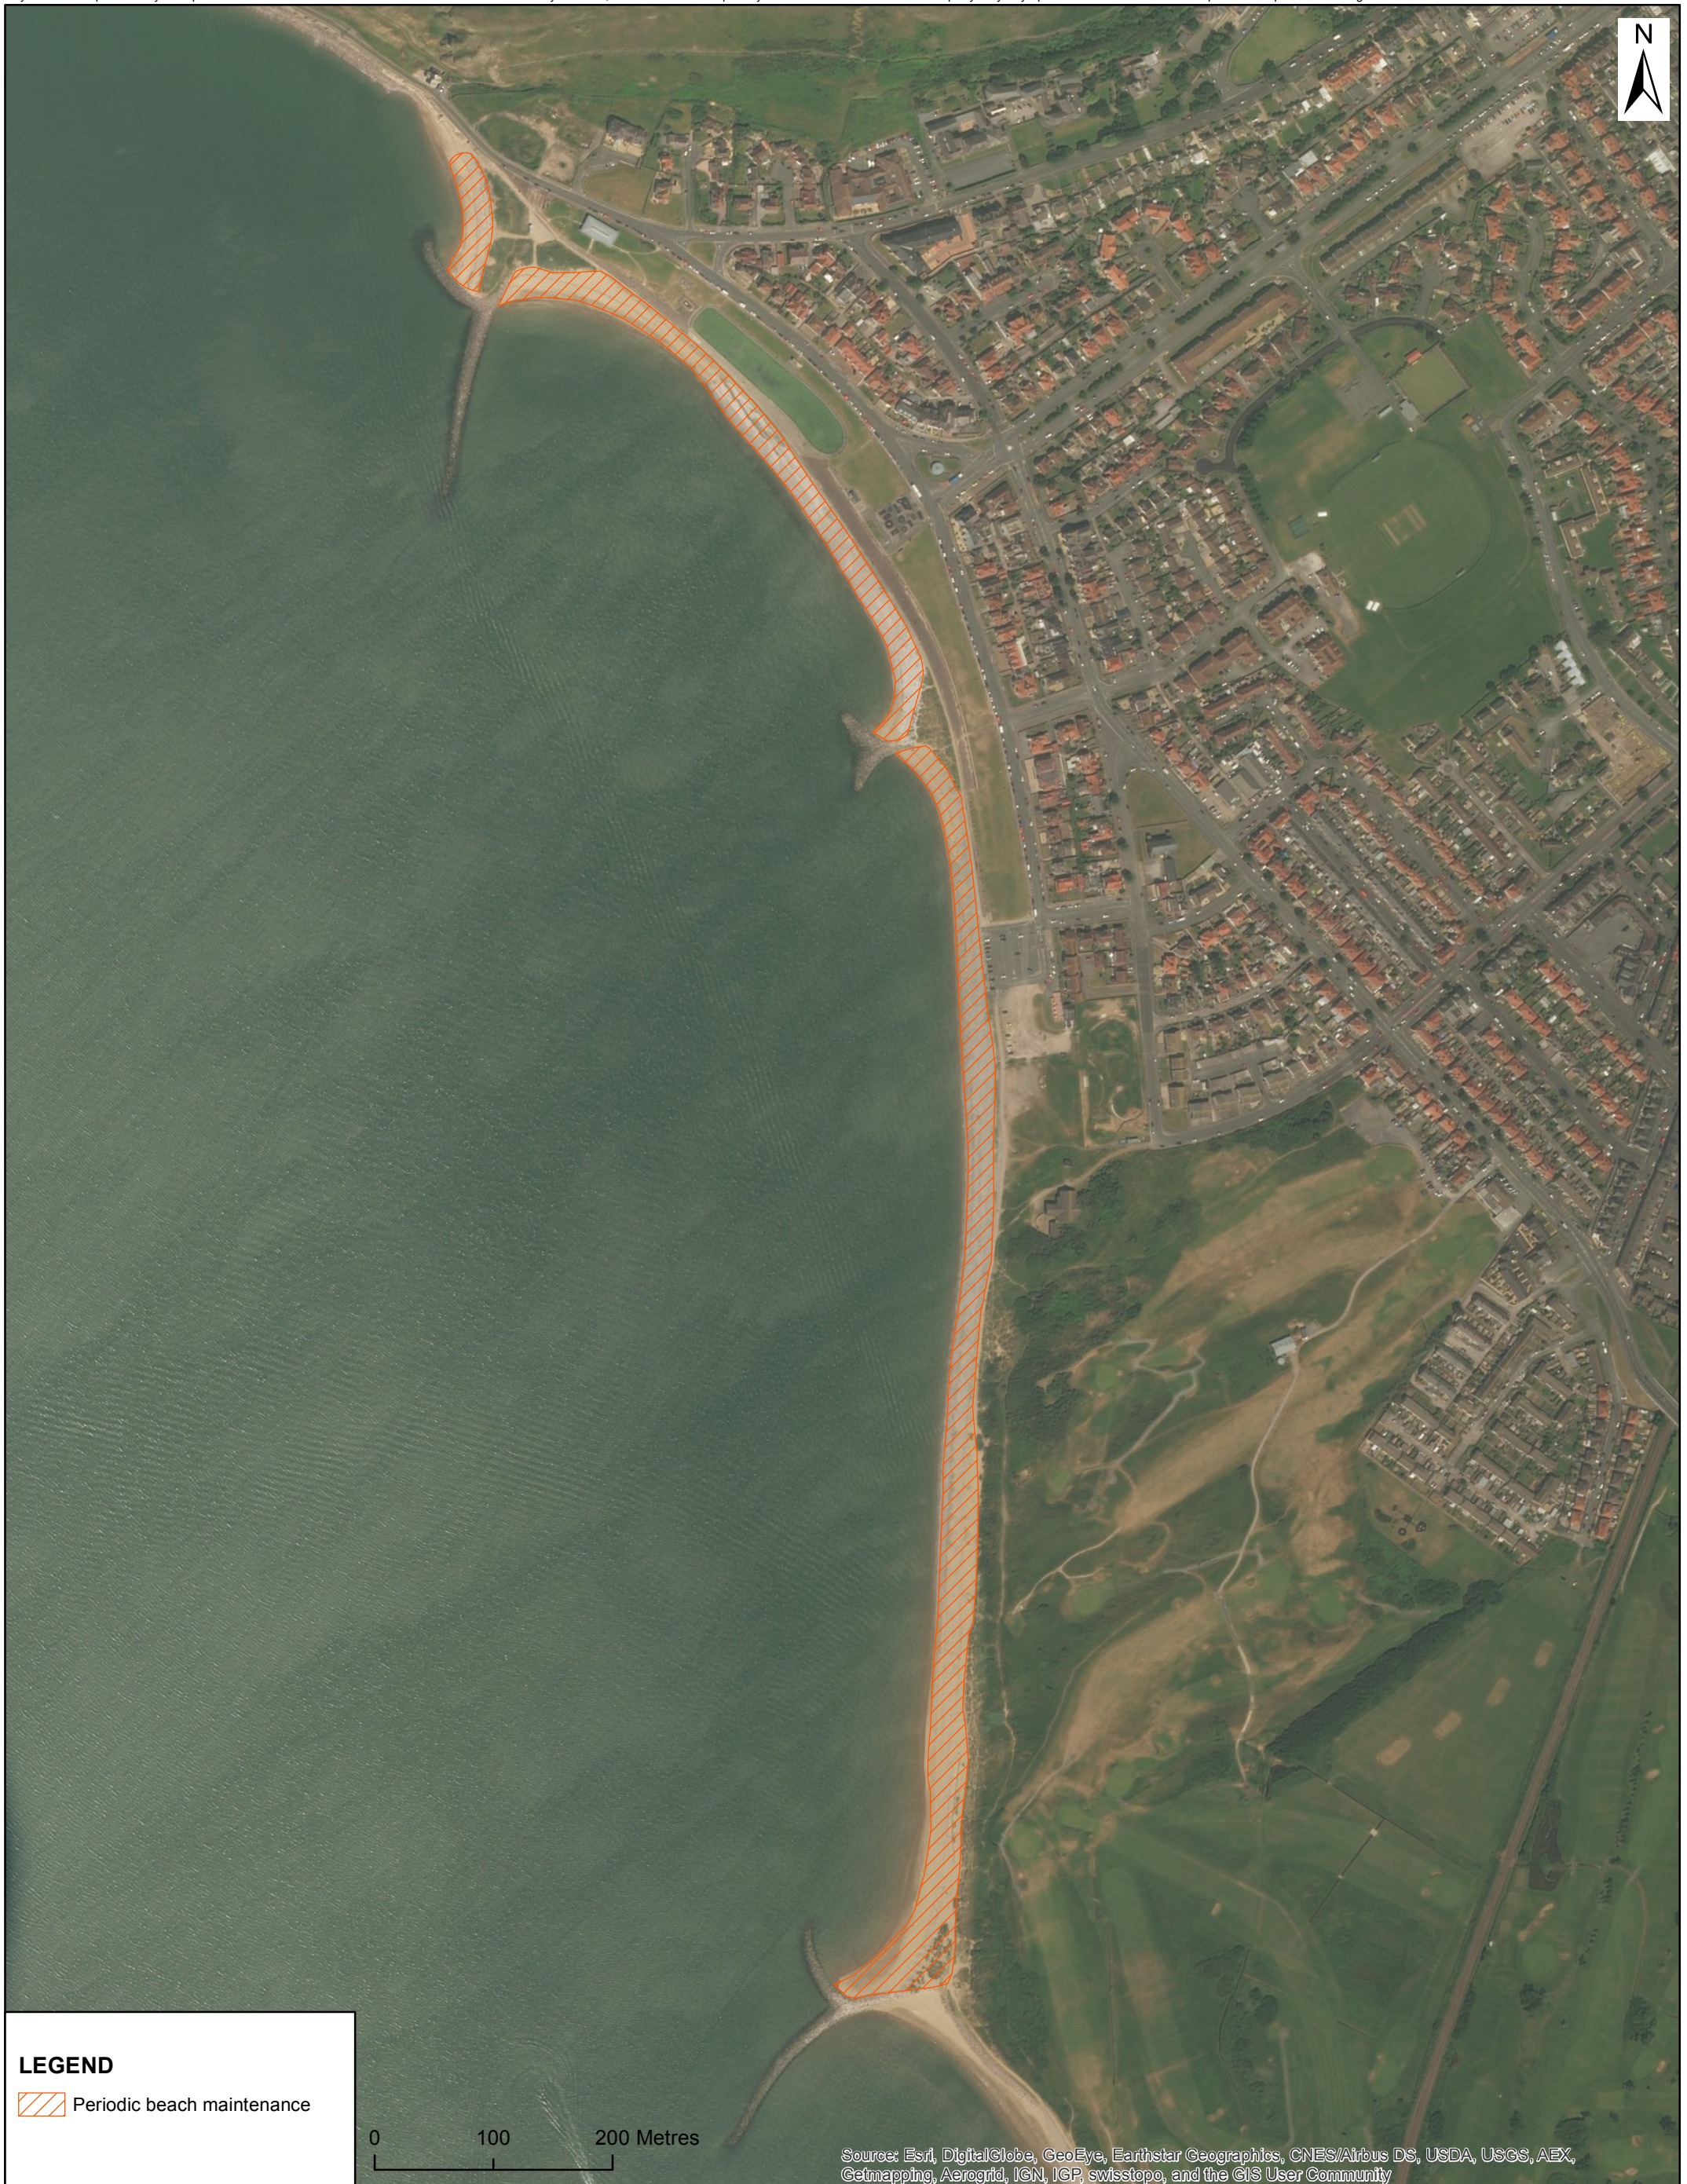
Copyright: © Crown copyright. All rights reserved 2016.	Client: CLIENT	Title: WEST BEACH: OPTION 1. PERIODIC BEACH MAINTENANCE	<b>AECOM</b>	Drawn: BM	Chk'd: DC
	Project: PROJECT			App'd: XX	Date: 10/11/2016
			Sunley House 4 Bedford Park Croydon CR0 2AP	Tel: +44 (0)20 8639 3500 Fax: +44 (0)20 8639 3599 www.aecom.com	Scale at A3: 1:5,000
