# Llandudno Beach Management Plan

Appraisal of Options for the future management of  
Llandudno's Beaches

Conwy County Borough Council

Project Number: 60525387

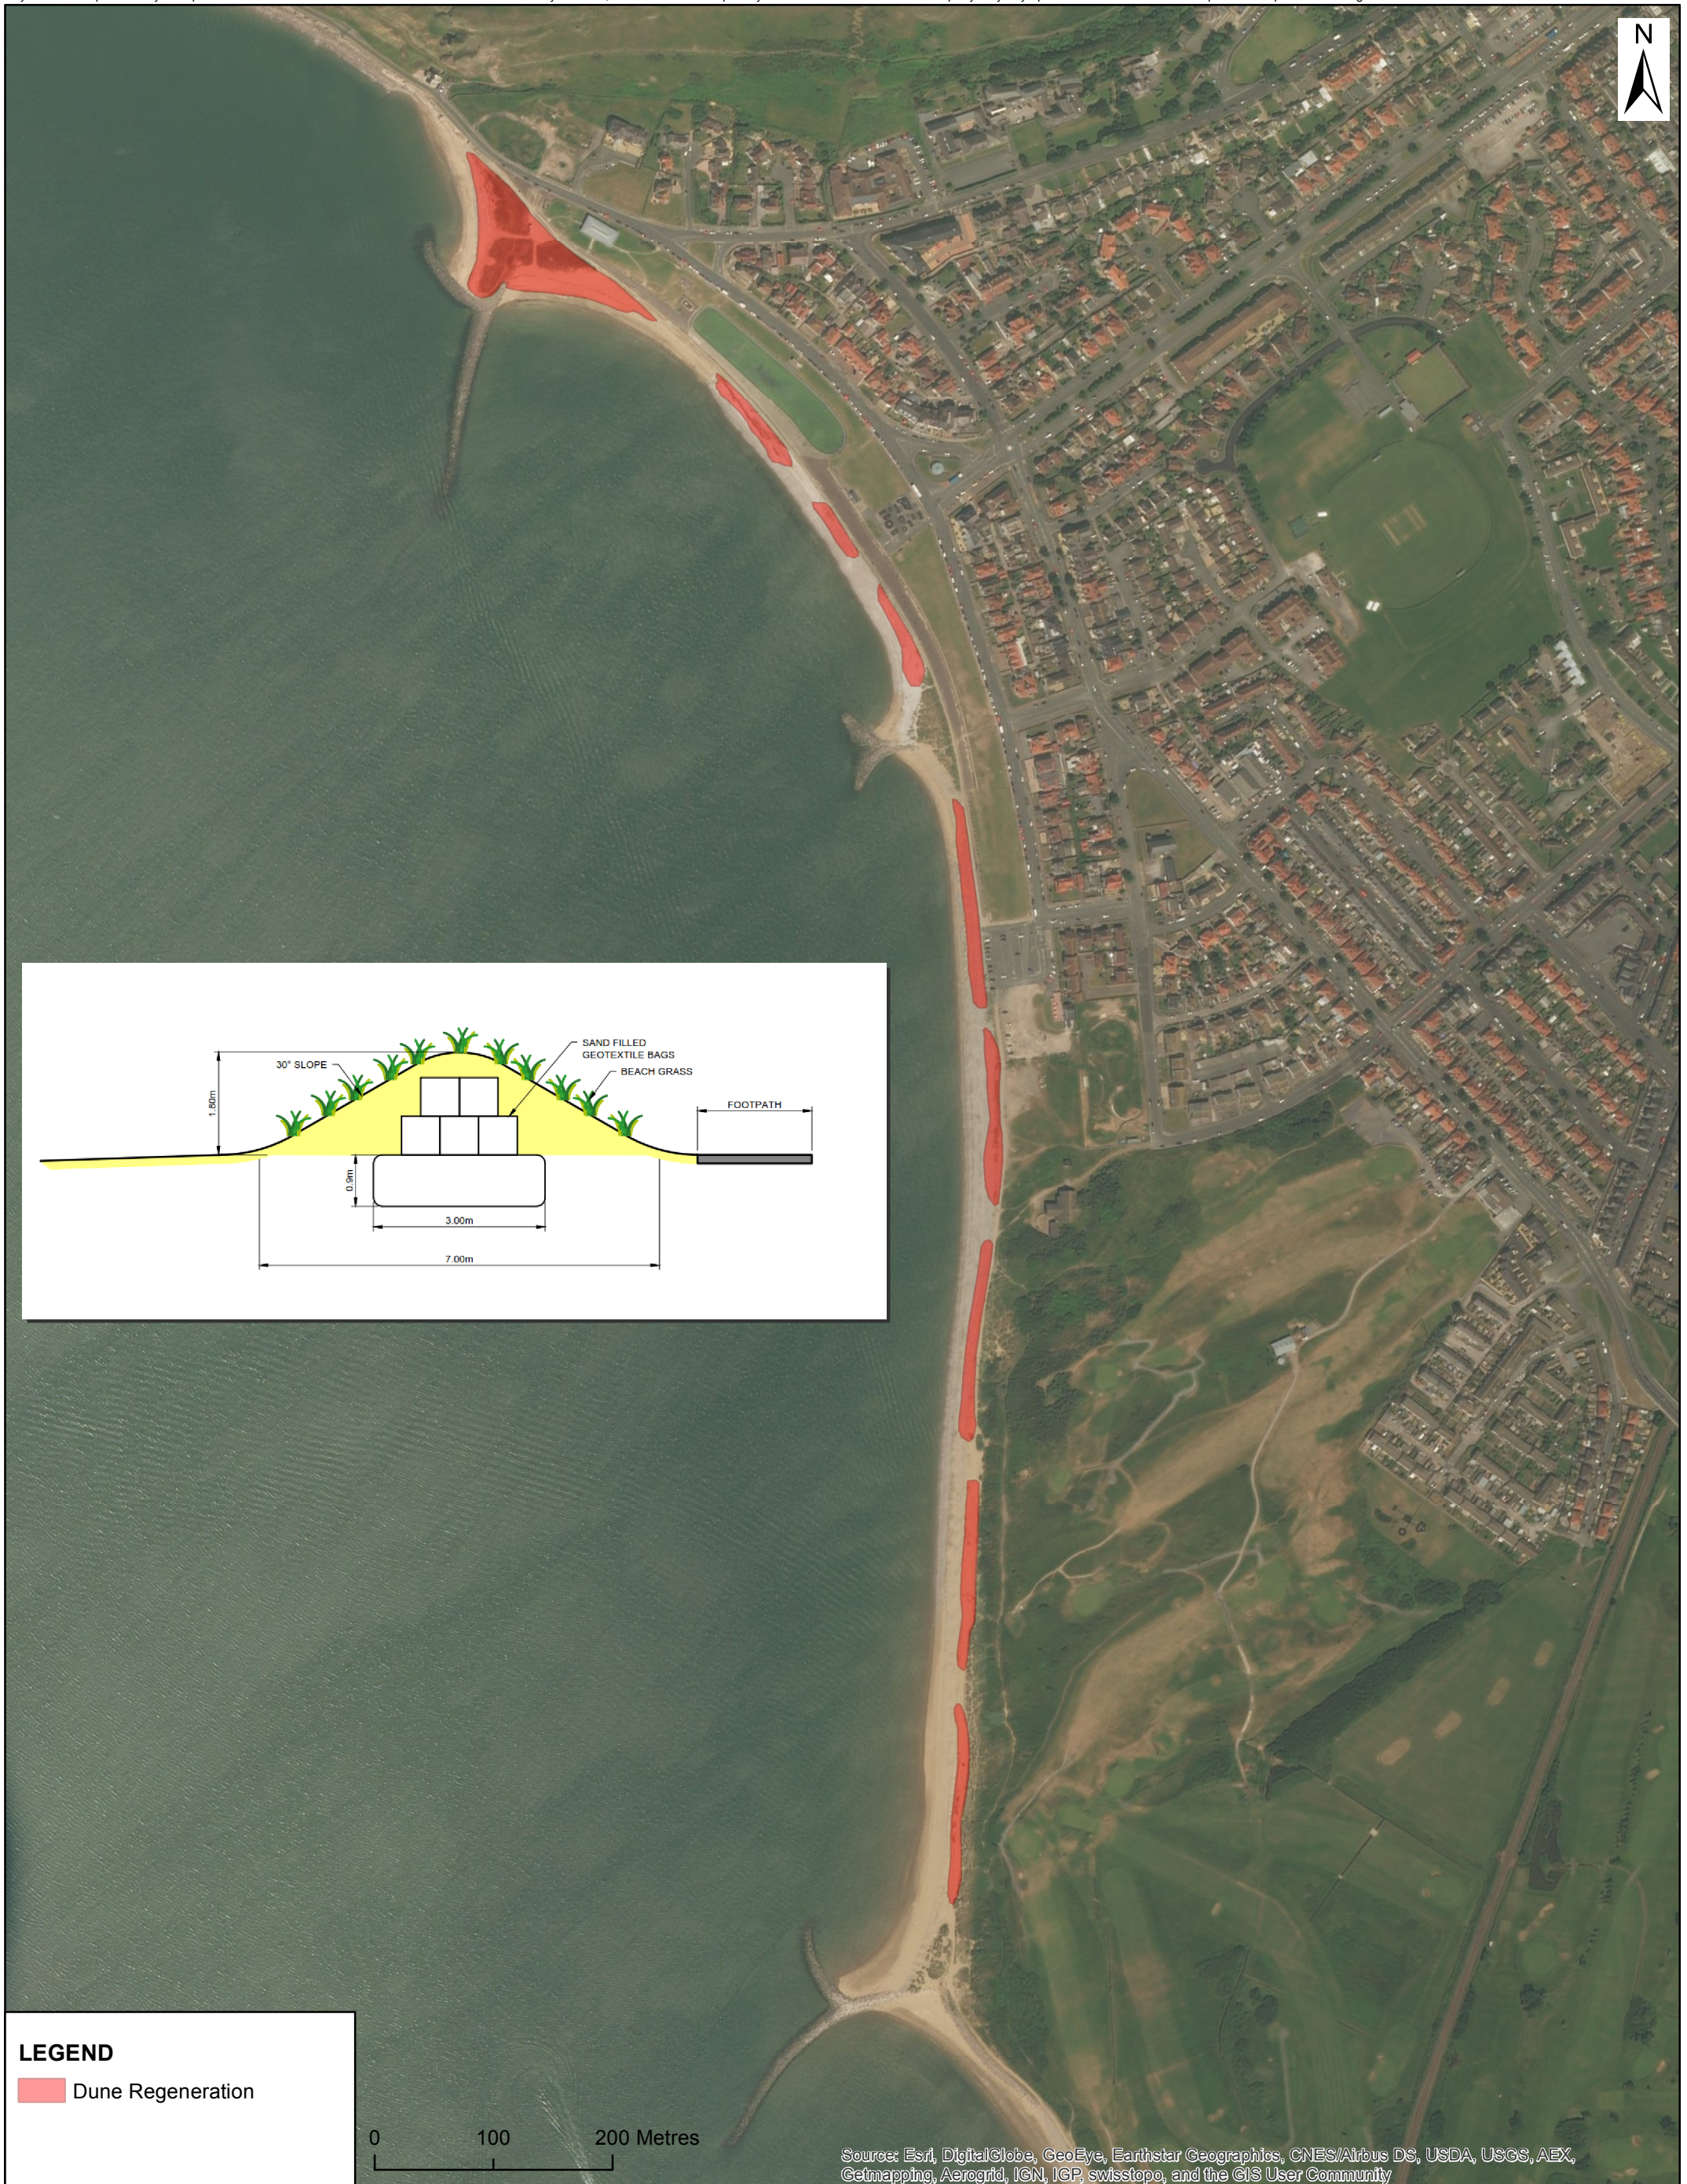
Copyright: © Crown copyright. All rights reserved 2016.	Client: CONWY COUNTY BOROUGH COUNCIL	Title: WEST BEACH: OPTION 2. DUNE REGENERATION	Sunley House 4 Bedford Park Croydon CR0 2AP Tel: +44 (0)20 8639 3500 Fax: +44 (0)20 8639 3599 www.aecom.com	Drawn: BM	Chk'd: DC
	Project: LLANDUDNO BMP AND CTFRA UPDATE			App'd: RR	Date: 10/11/2016
			Scale at A3: 1:5,000

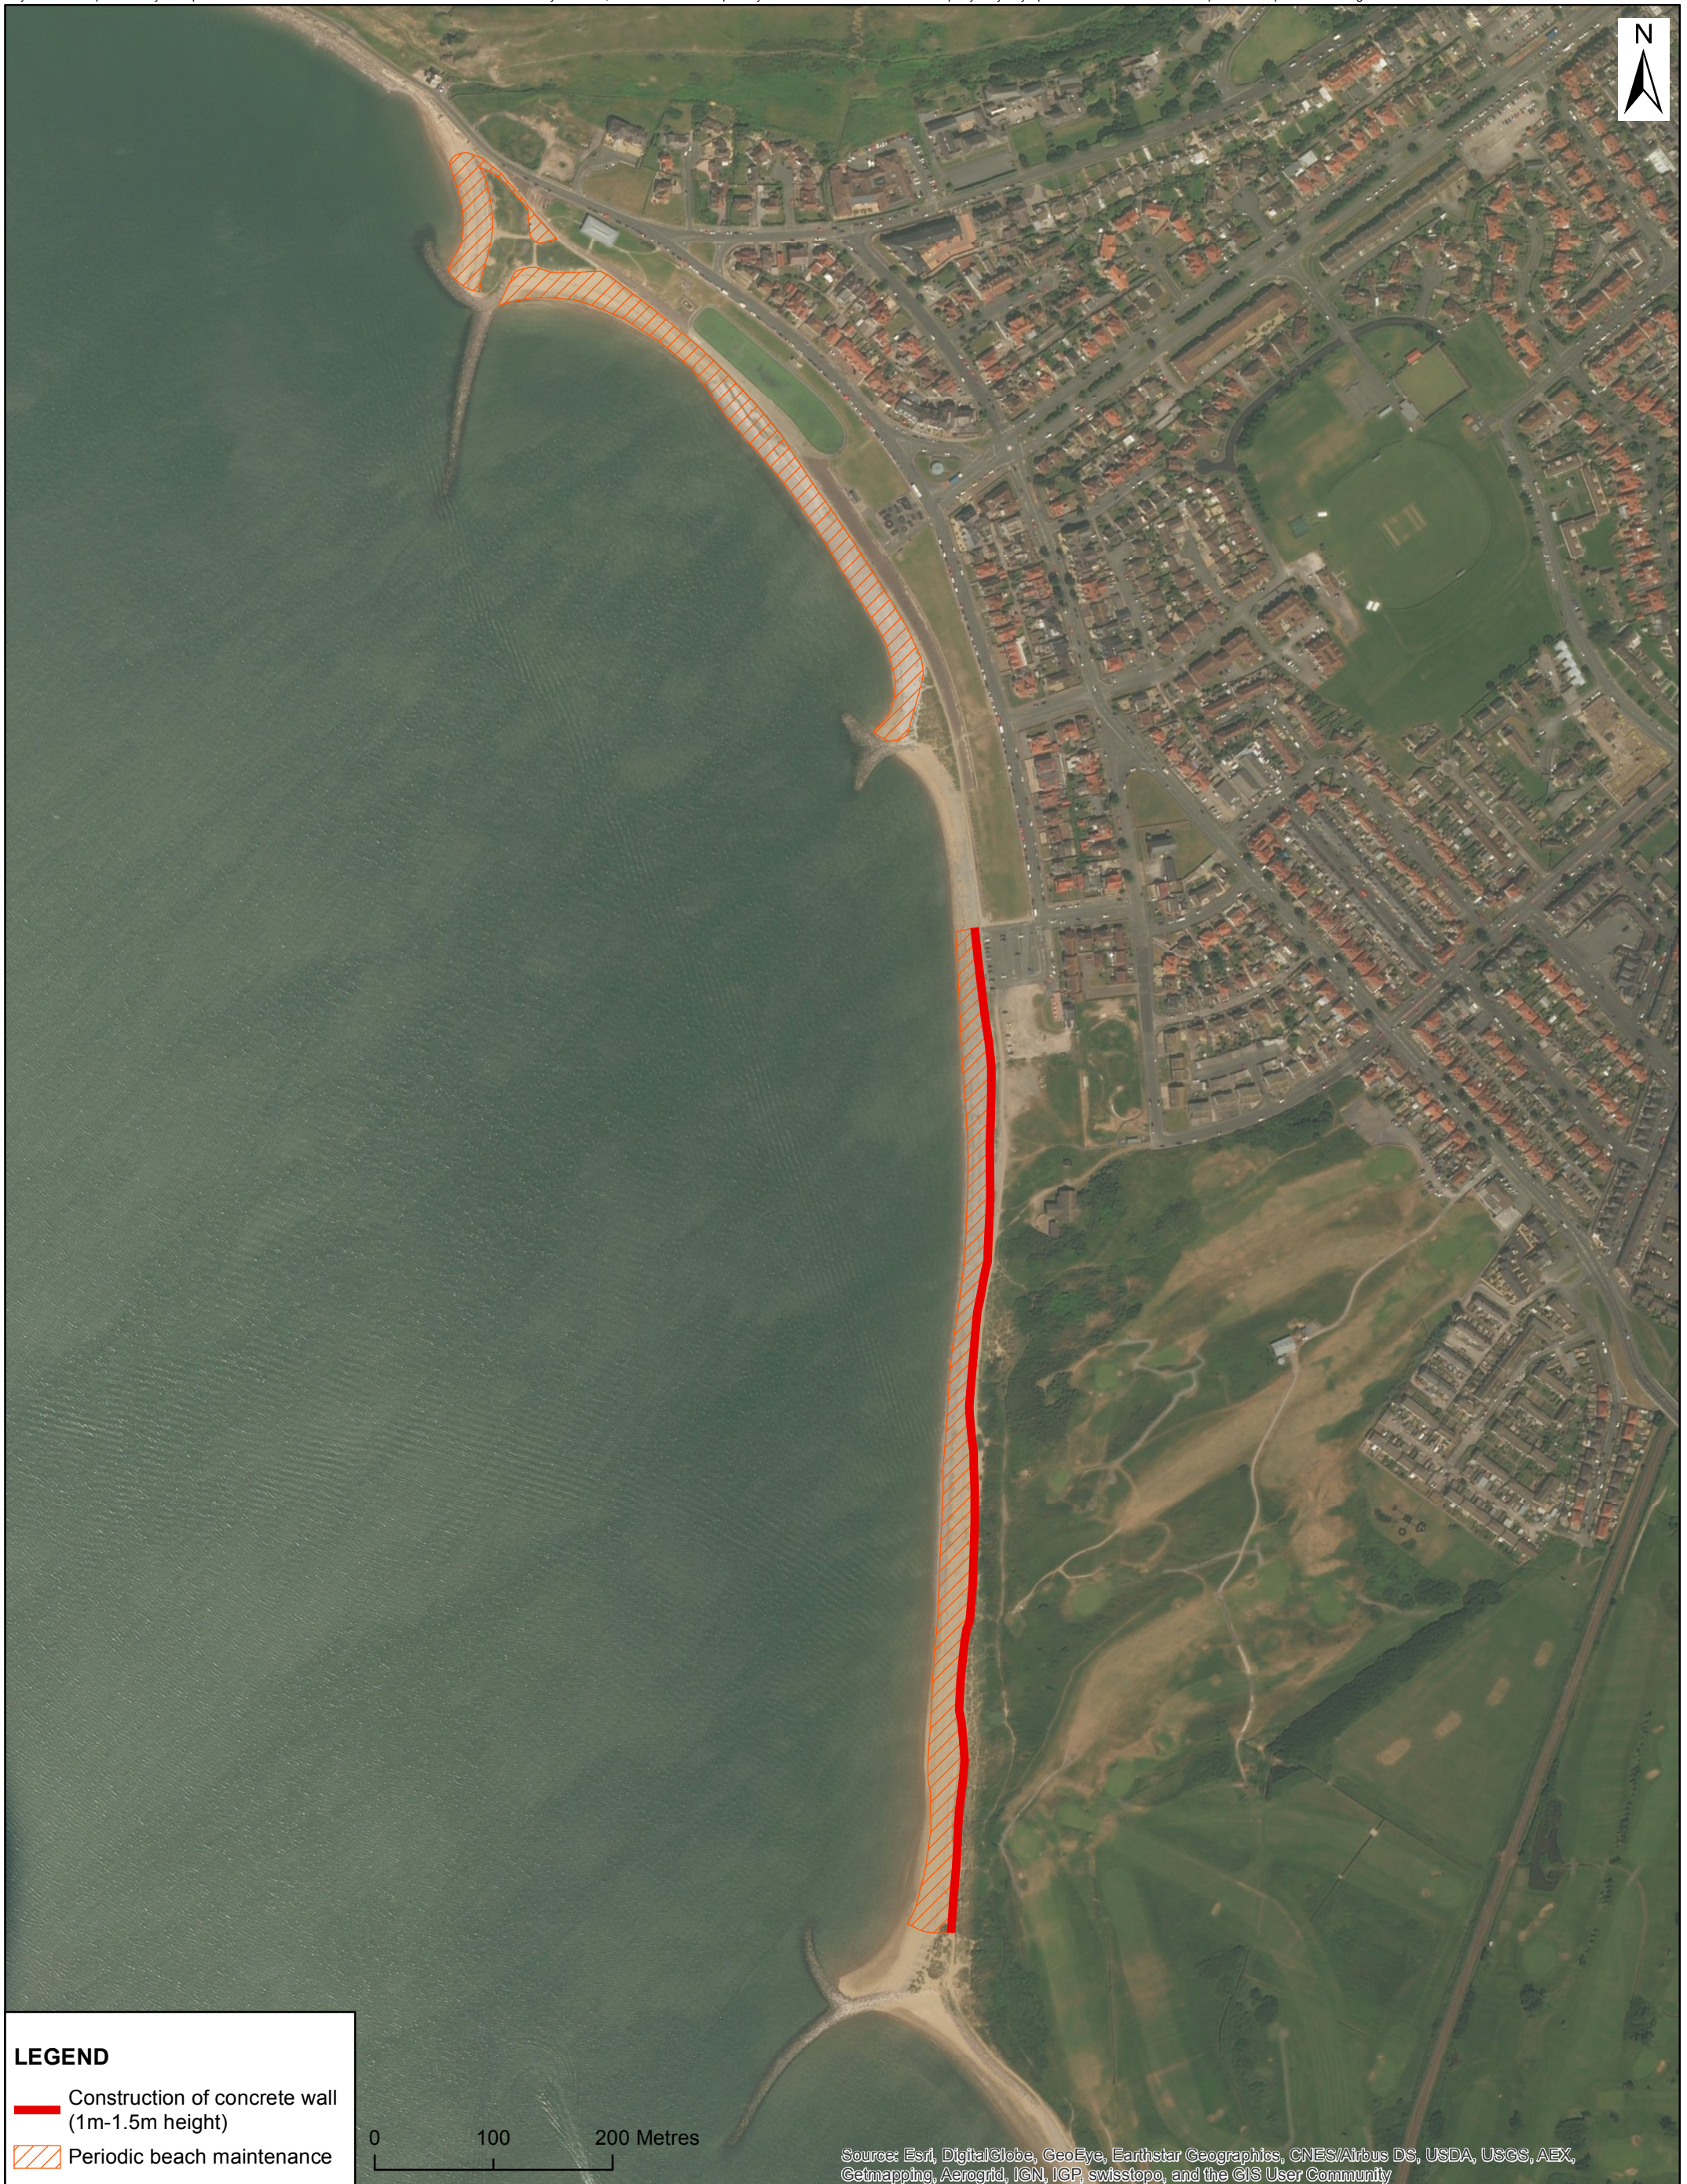
█ Construction of concrete wall (1m-1.5m height)

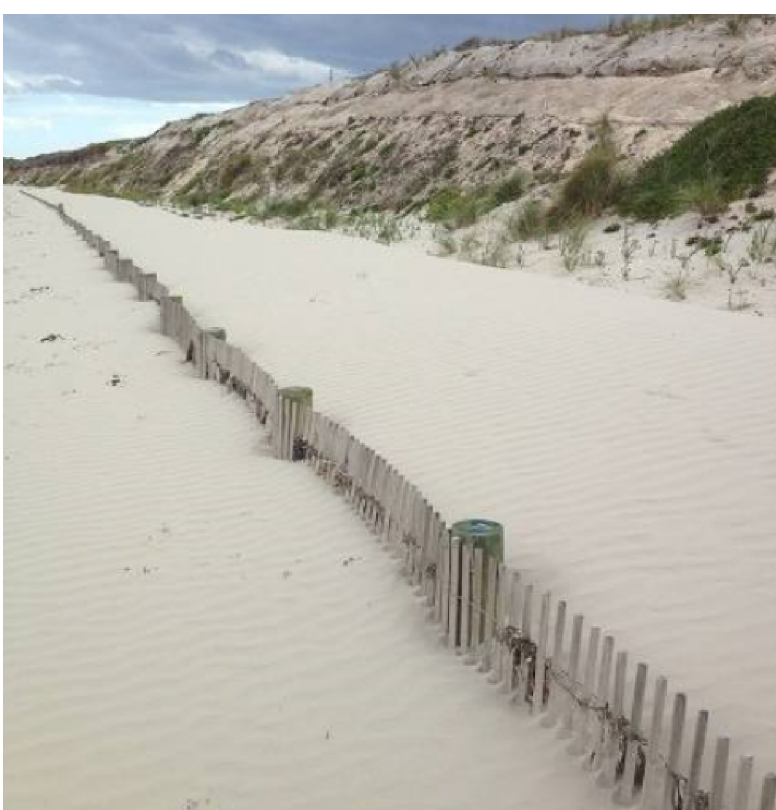
Typical Sand Trap

Copyright: © Crown copyright. All rights reserved 2016.	Client: CONWY COUNTY BOROUGH COUNCIL	Title:  WEST BEACH: OPTION 5. SAND TRAPS	 Sunley House 4 Bedford Park Croydon CR0 2AP Tel: +44 (0)20 8639 3500 Fax: +44 (0)20 8639 3599 www.aecom.com	Drawn: BM	Chk'd: DC
	Project: LLANDUDNO BMP AND CTFRA UPDATE			App'd: RR	Date: 10/11/2016
			Scale at A3: 1:5,000

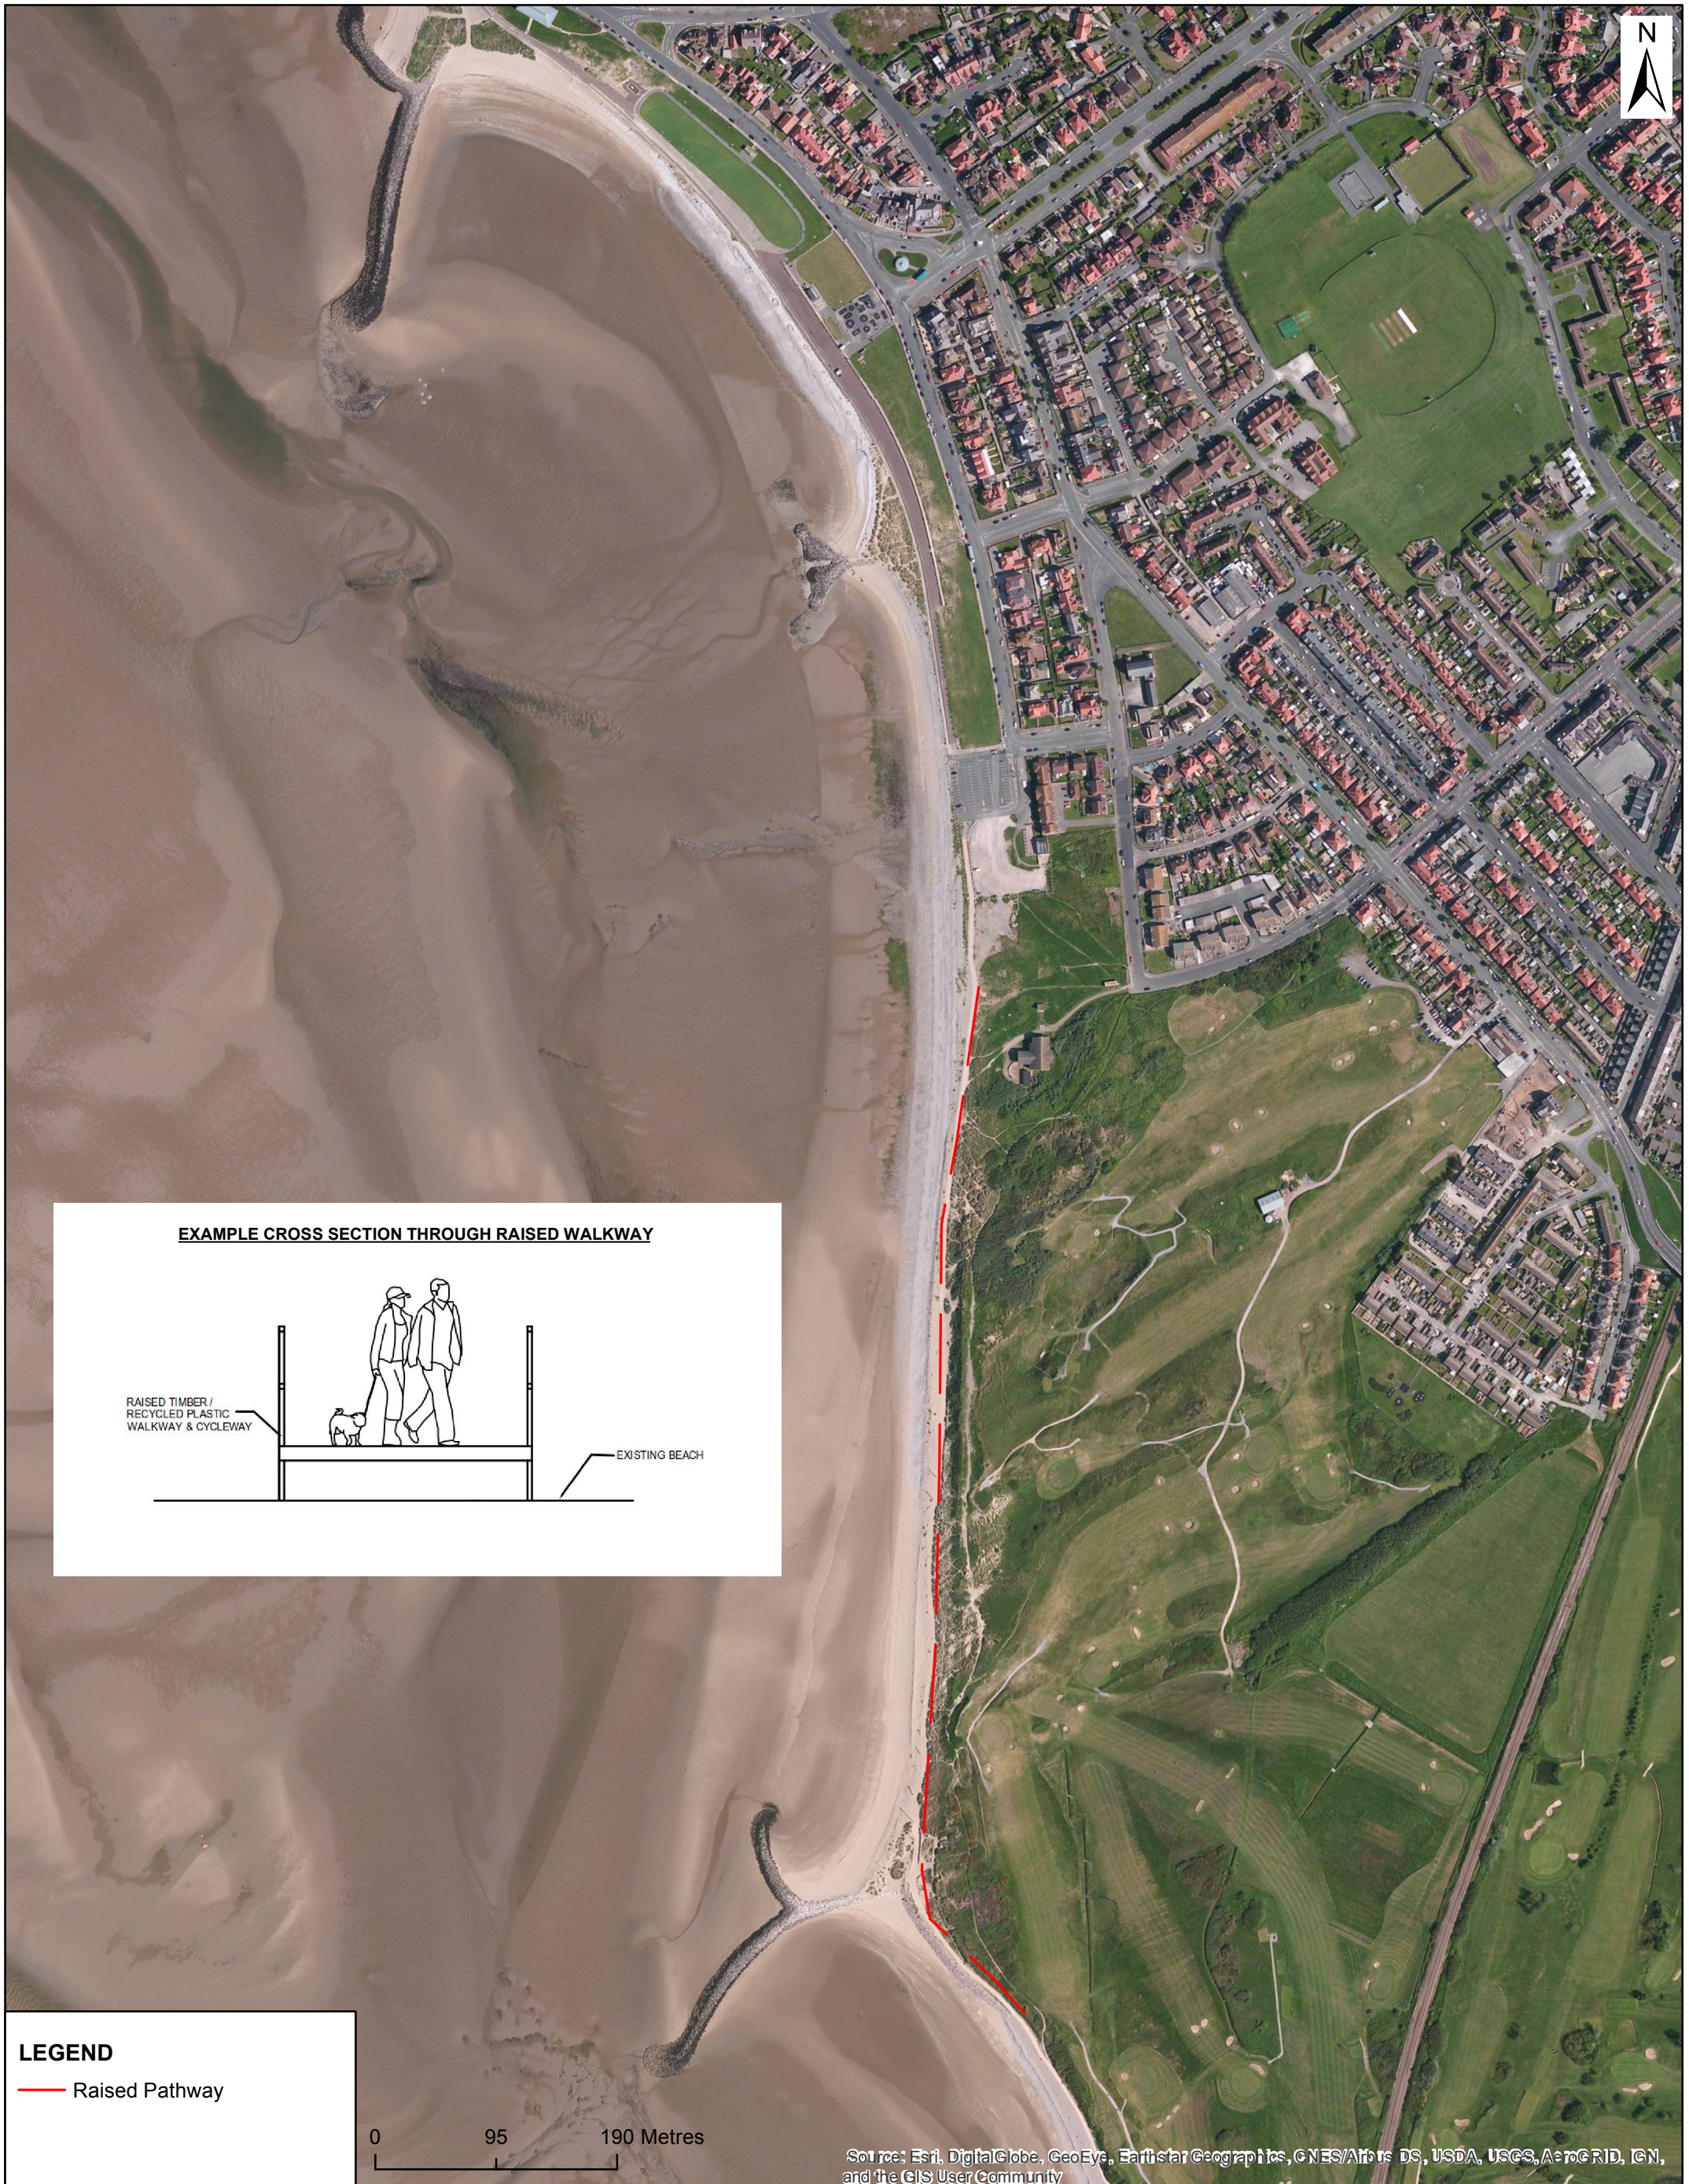
**EXAMPLE CROSS SECTION THROUGH RAISED WALKWAY**

Copyright: © Crown copyright. All rights reserved 2016.	Client: CONWY COUNTY BOROUGH COUNCIL	Title: WEST BEACH: OPTION 7. RAISED WALKWAY		Drawn: NC    Chk'd:
	Project: LLANDUDNO BMP AND CTFRA UPDATE			App'd:                      Date:
			Sunley House 4 Bedford Park    Tel: +44 (0)20 8639 3500 Croydon            Fax: +44 (0)20 8639 3599 CR0 2AP            www.aecom.com	Scale at A3:    1:4,680

This option involves constructing a raised timber walkway along the current cycle path route. This option will be raised above the current path level in order to avoid the accumulation of sand and material which currently obstructs the path route. It is assumed that the path will be approximately 300 mm above the existing ground level and not require a hand rail along the entire length although some sections may need a handrail on one or both sides. Kerb rails will be required for wheelchair safety and access steps or ramps may also be required. The structure can be constructed from timber or recycled plastic.

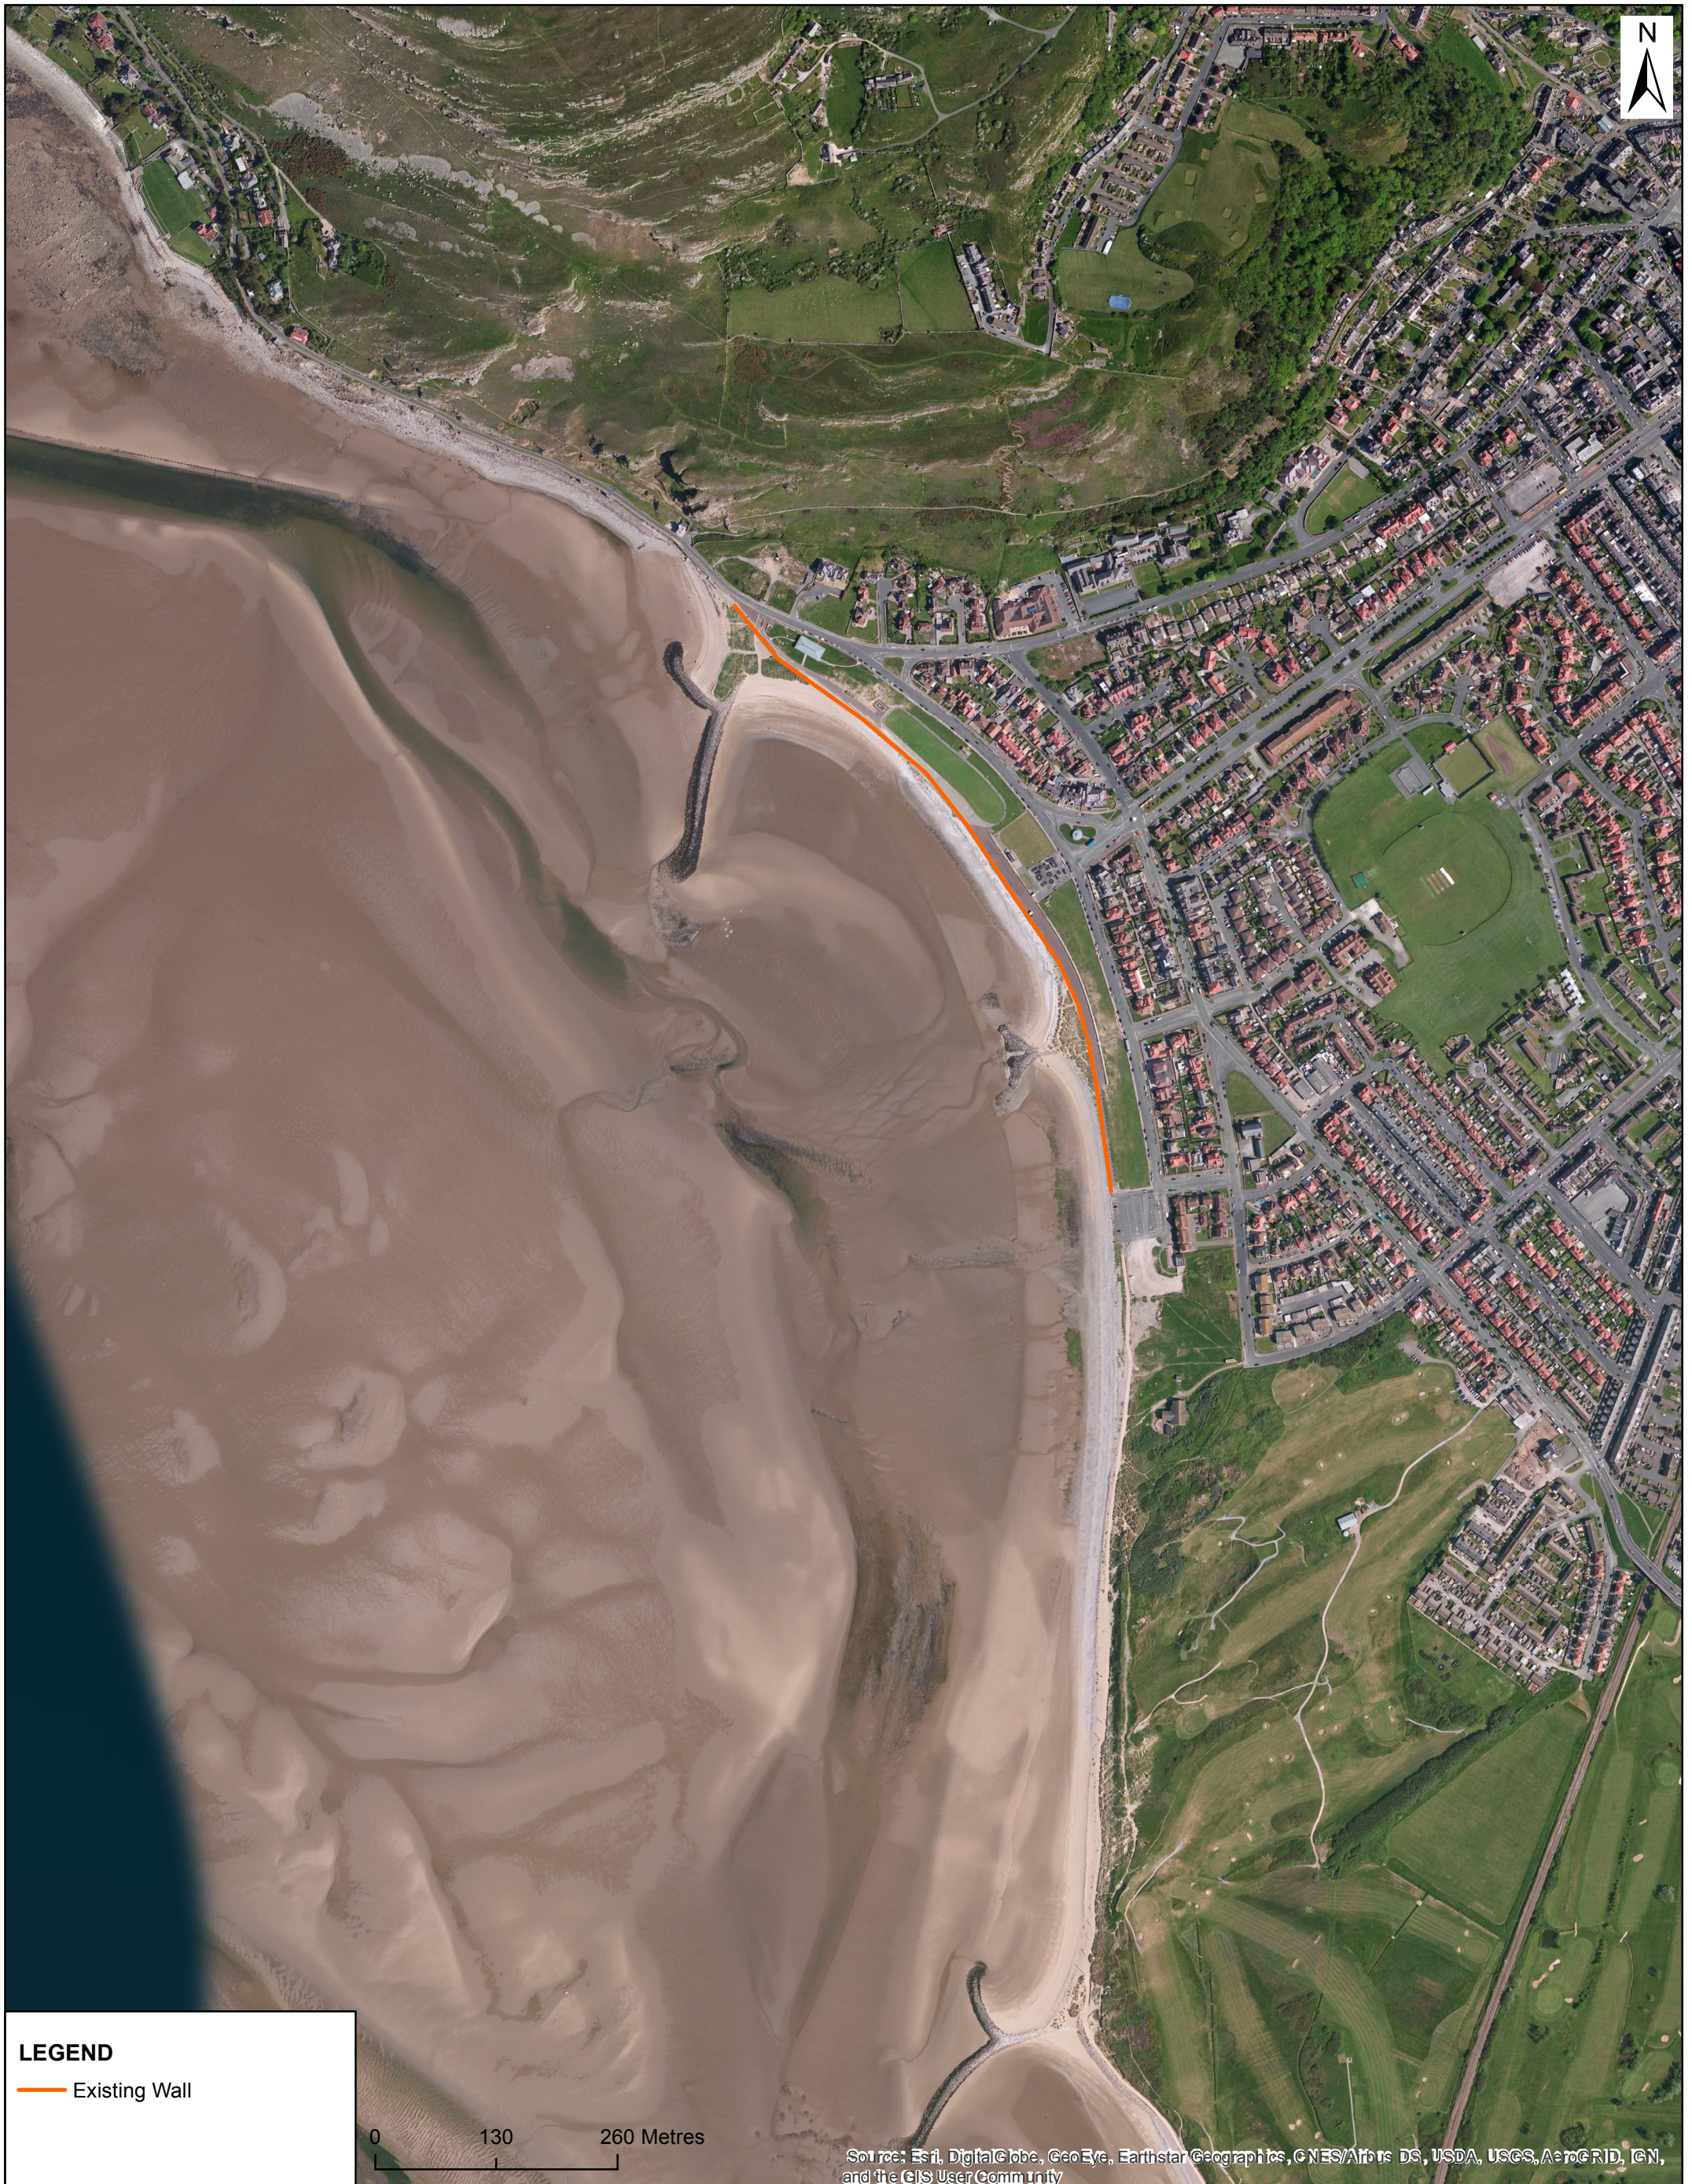
Copyright: © Crown copyright. All rights reserved 2016.	Client: CONWY COUNTY BOROUGH COUNCIL	Title: WEST BEACH: OPTION 8. EXISTING WALL REPAIRS / RAISING		Drawn: NC	Chk'd:
	Project: LLANDUDNO BMP AND CTFRA UPDATE			App'd:	Date:
			Sunley House 4 Bedford Park Croydon CR0 2AP Tel: +44 (0)20 8639 3500 Fax: +44 (0)20 8639 3599 www.aecom.com	Scale at A3: 1:6,389

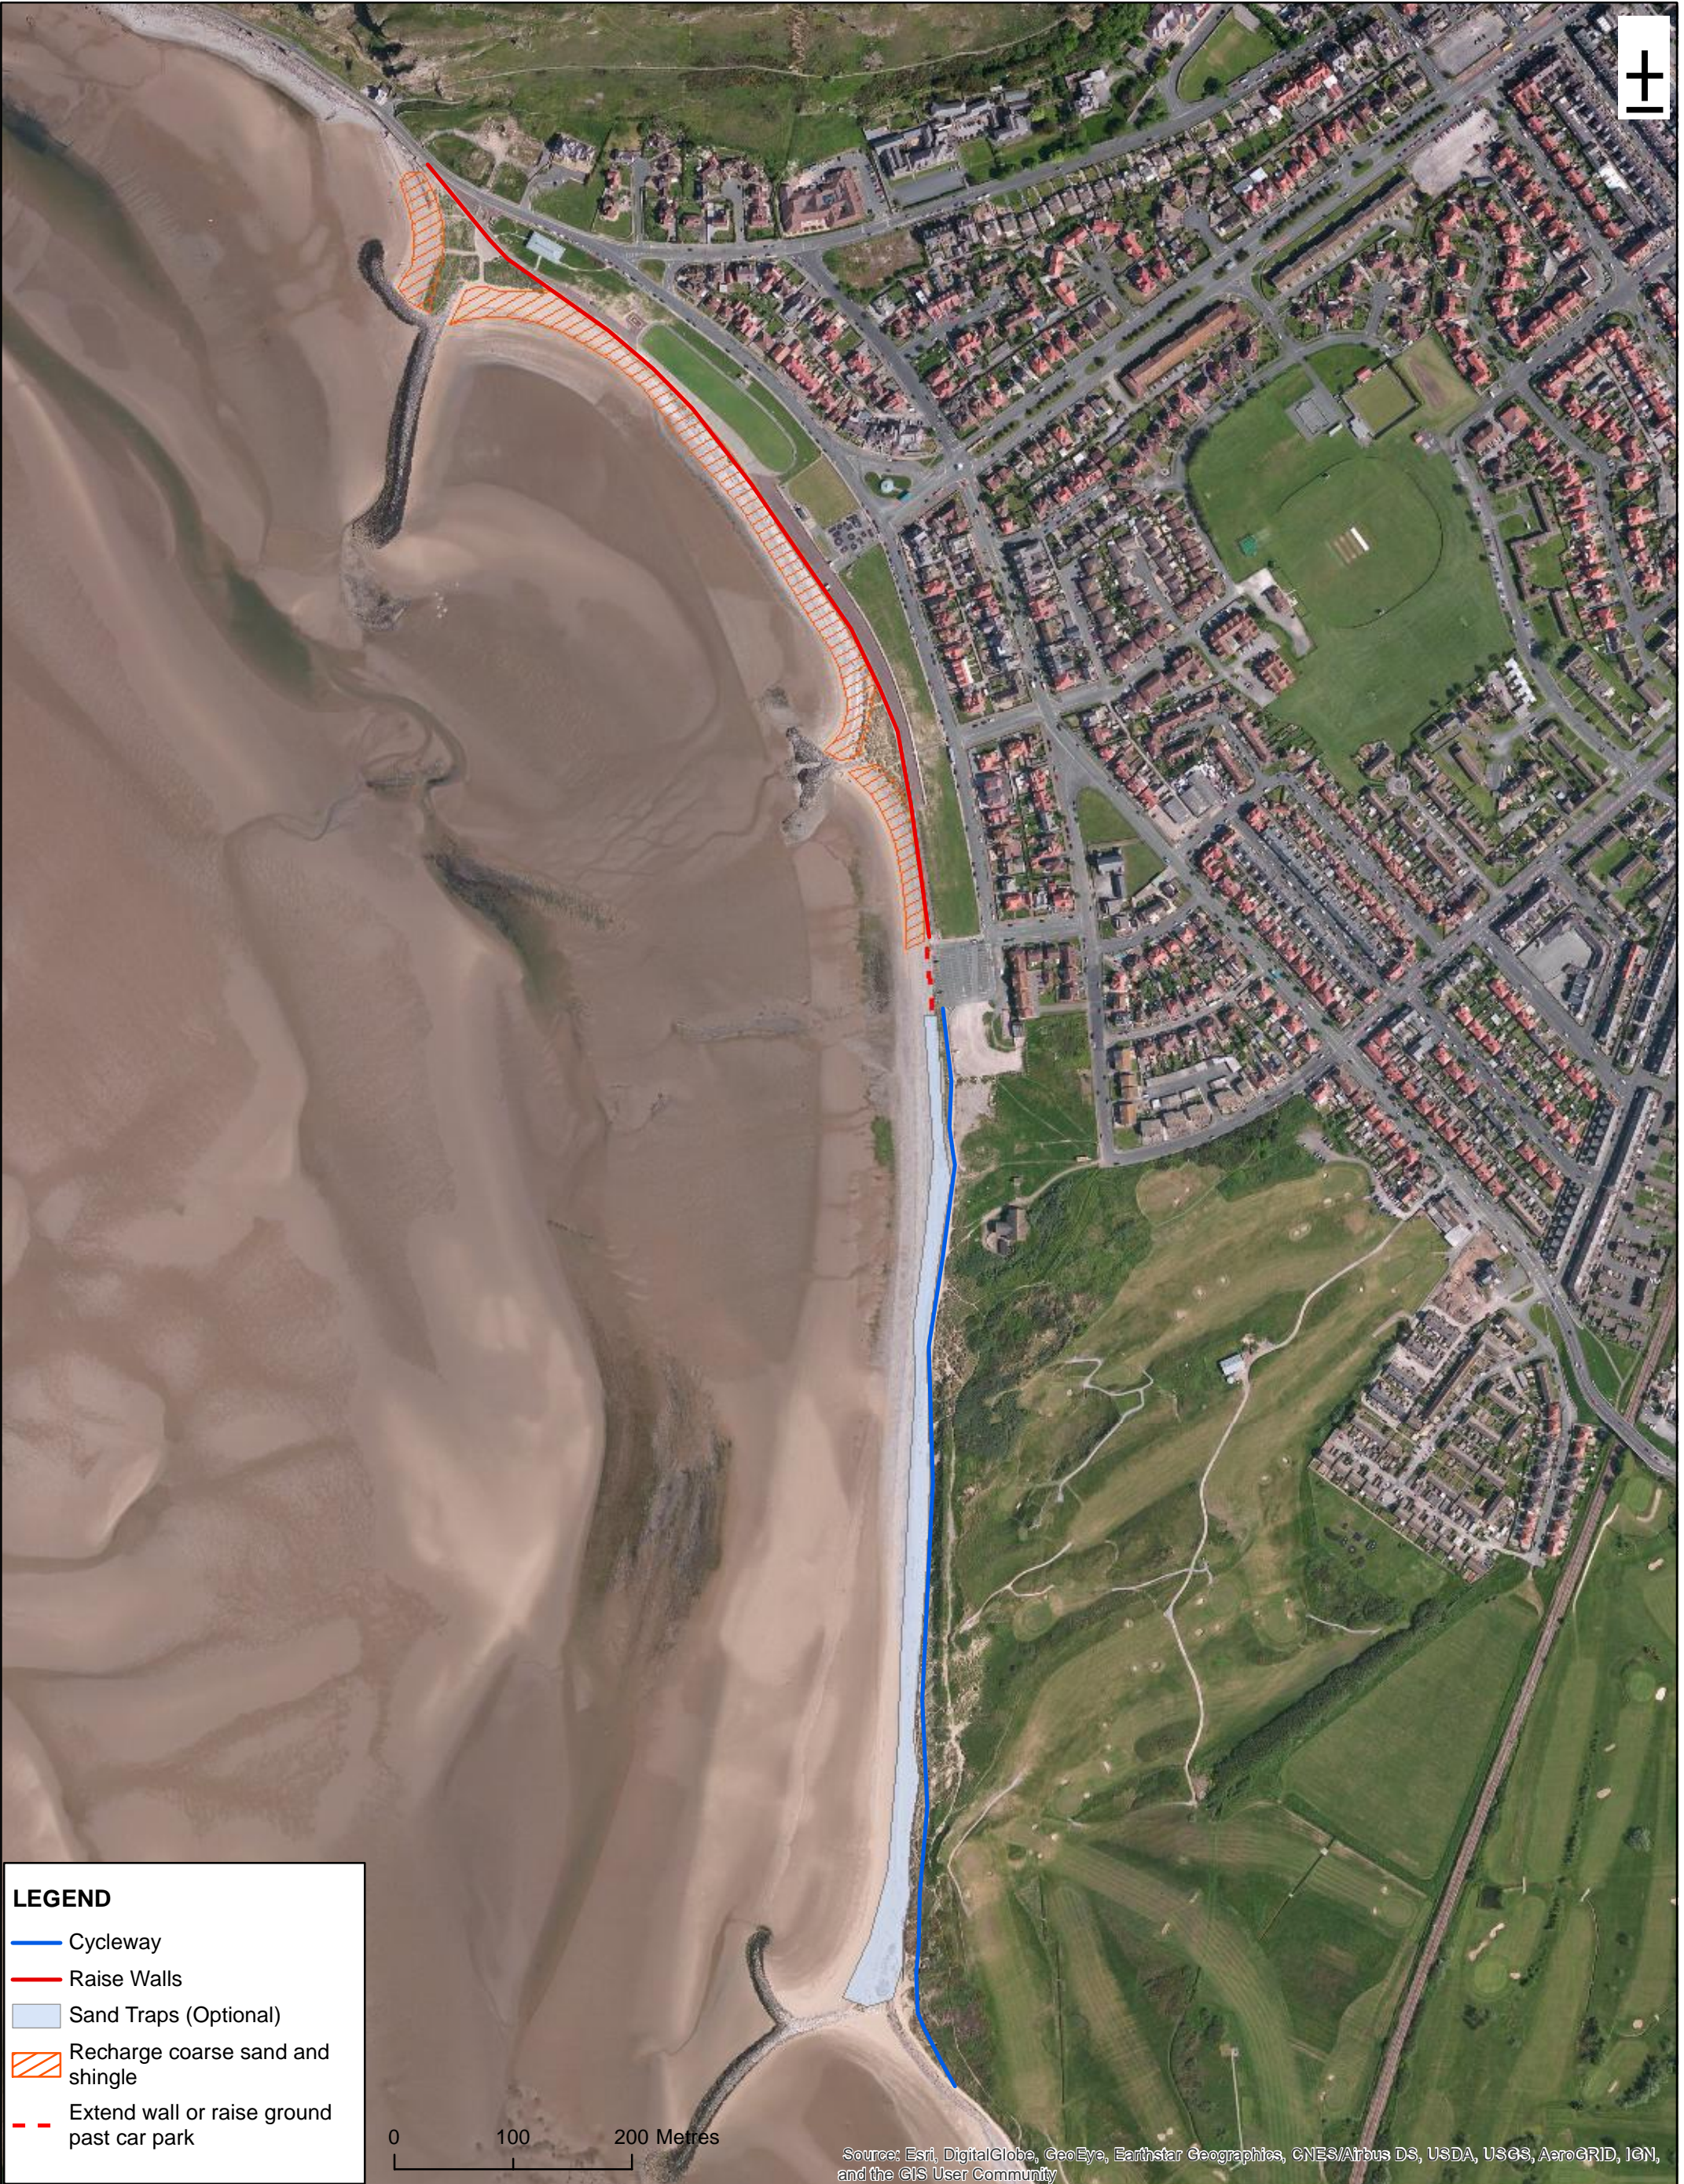
- Cycleway
- Raise Walls
- Sand Traps (Optional)
- Recharge coarse sand and shingle
- Extend wall or raise ground past car park

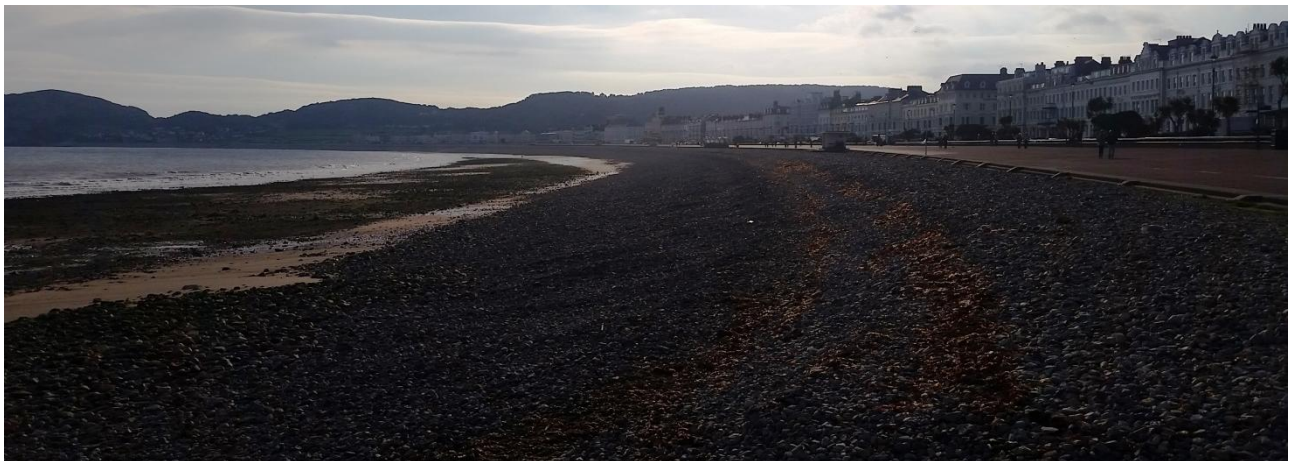
**Photo 2** View looking east towards the Little Orme Headland with the raised cobble/shingle berm pushed up to the Llandudno promenade on the right hand side.

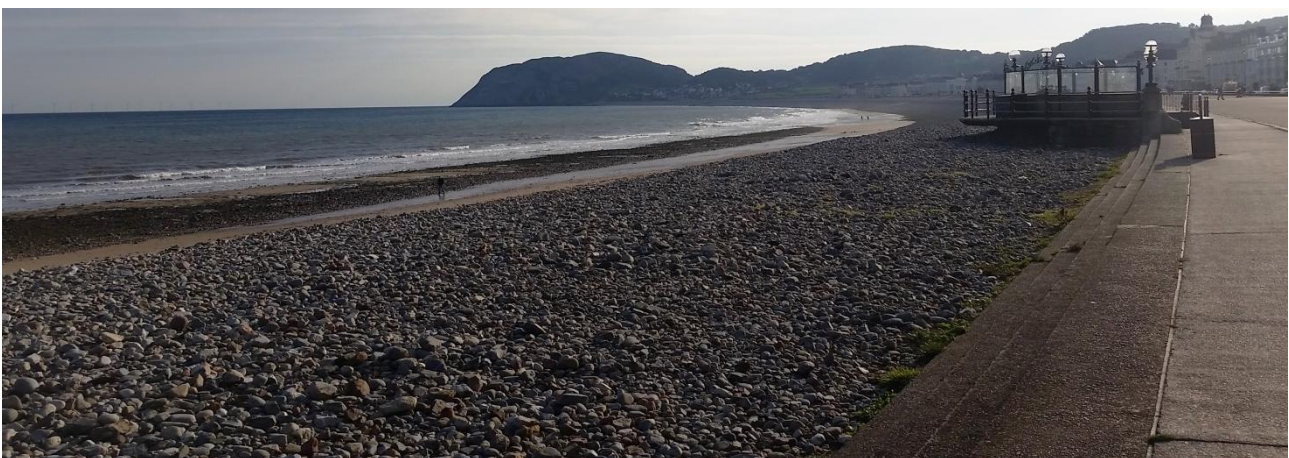
**Photo 3** View looking east towards the Little Orme Headland with the Craig-y-Don paddling pool and concrete stepped revetment up to the Llandudno promenade on the right hand side.

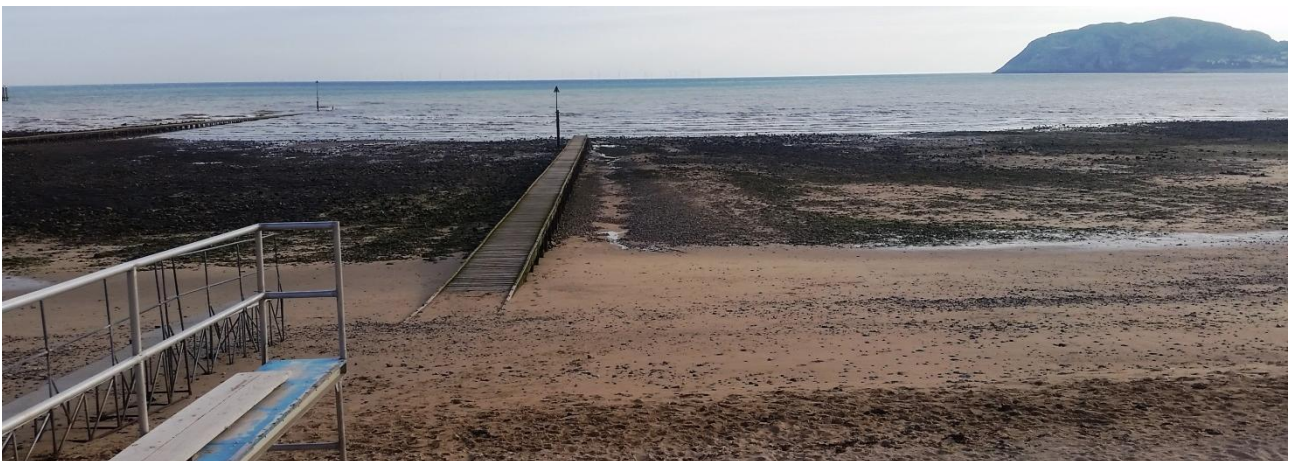
**Photo 5** Timber slip way with little evidence of any interruption of drift sediment transport.

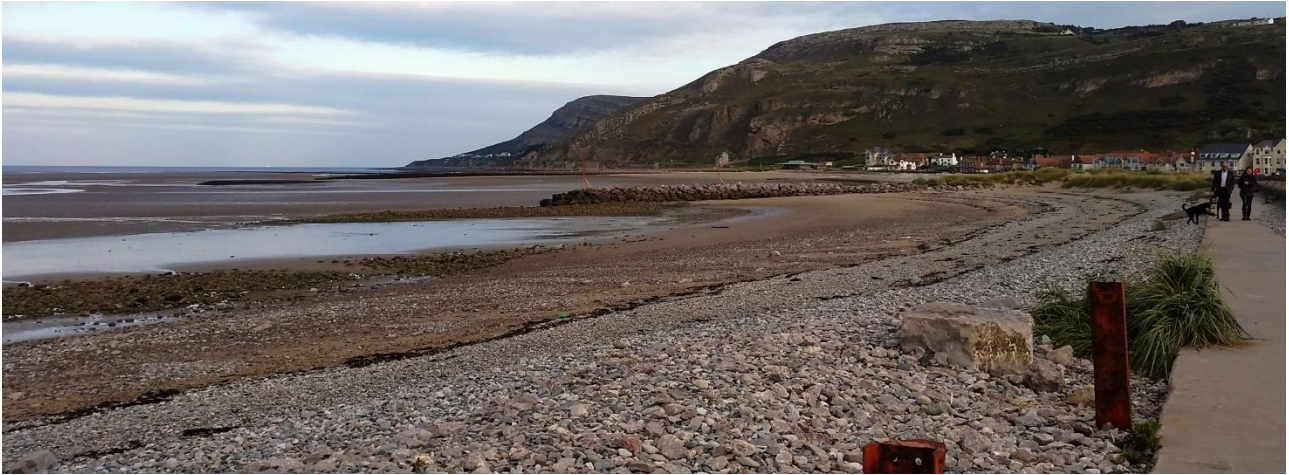
**Photo 9** View looking northwest towards the Great Orme Headland (SAC) across concrete revetment and upper shingle/cobble beach.
