# Llandudno Beach Management Plan

Appraisal of Options for the future management of  
Llandudno's Beaches

Conwy County Borough Council

Project Number: 60525387

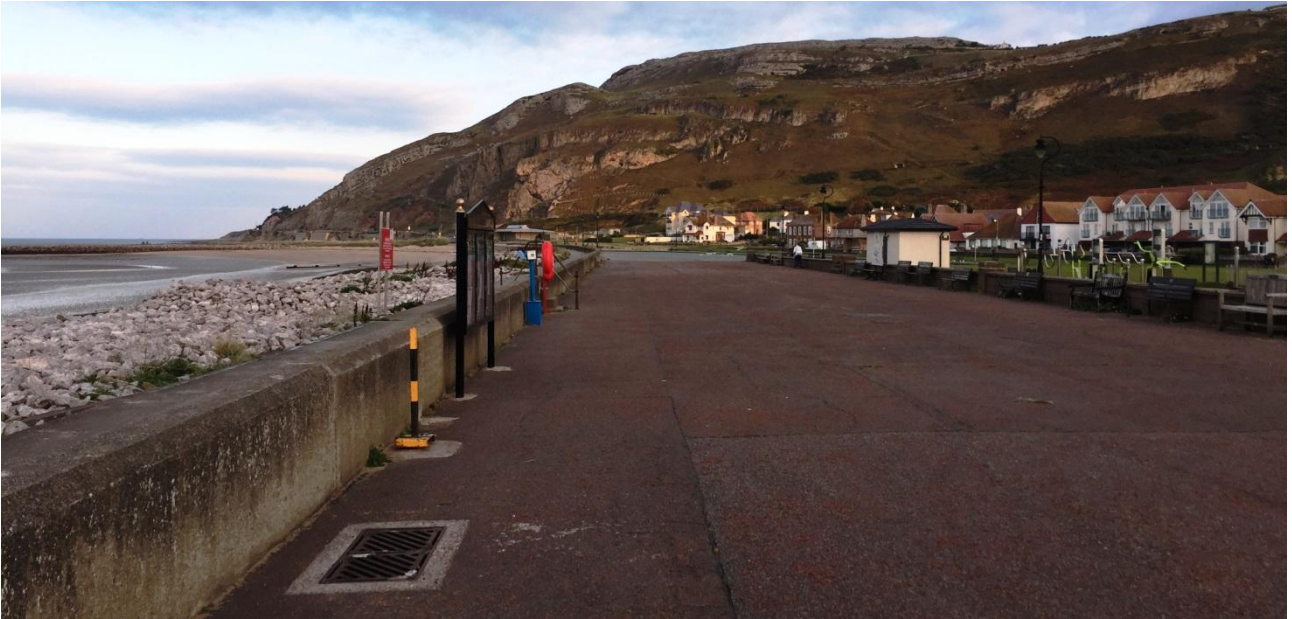
**Photo 12** Existing flood wall (with excess sand on the landward side in places), promenade, recreational open space with outdoor exercise equipment and sea fronting residential properties.

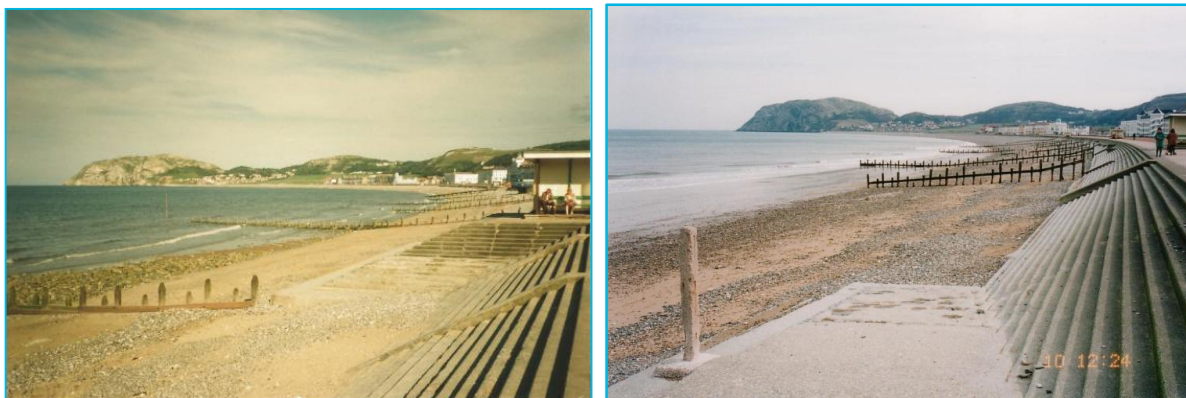
**Figure 2.4 – Stepped Revetment, Beach and Groynes 1987 (left) and 1995 (right)**

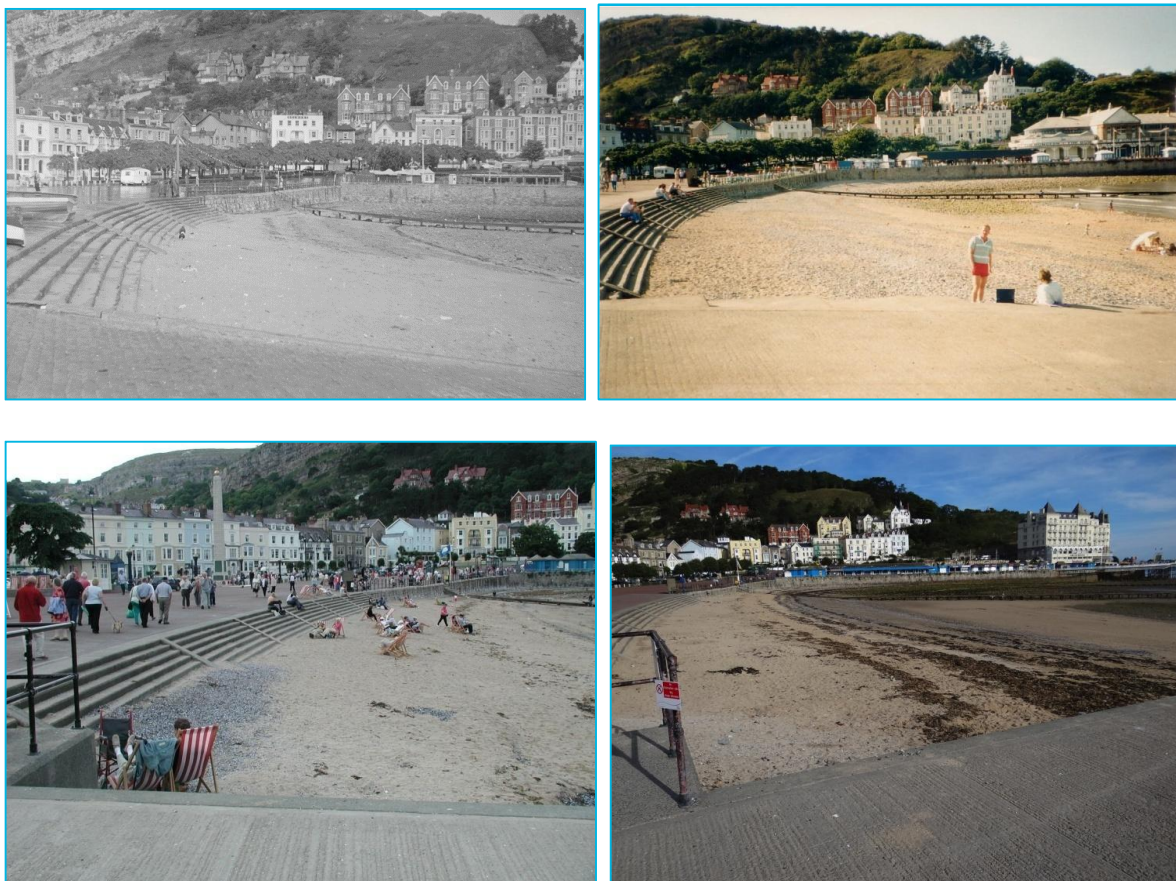
**Figure 2.5 – Children's Corner – Mid 20<sup>th</sup> century (top Left); 1987 (top right); 2003 (bottom left) and 2012 (bottom right)**

The section of frontage between the Trevor St slipway and the Pier wall, aka “Children’s corner” was not modified as part of the arrangements undertaken in 1996-2000. Wind blown sand retrieved from the West Shore has been intermittently tipped on the lower beach in the intervening period. In addition cobble and shingle material that has been moved westerly across the slipway has been separated out from the sand and recycled to areas east of the slipway. Generally across this area although cyclical change has taken place, overall conditions are not markedly different than 60-70 years ago (ref Figure 2.5).

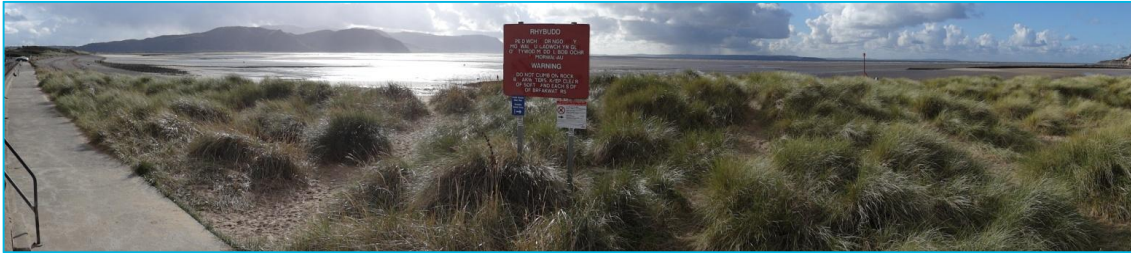
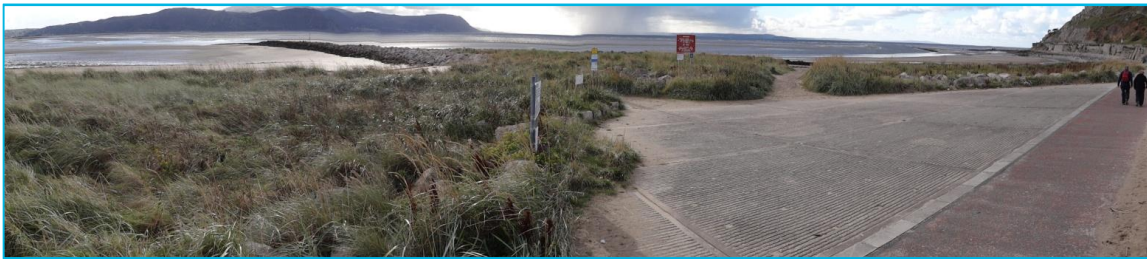
**Figure 2.8 – Development of dune features at West Shore (top – Lloyd St Groyne; bottom – Gogarth groyne)**

The breakwaters and recharge have been successful in reducing exposure conditions along the shoreline but have produced a perceived unwanted side effect of increasing wind blown sand from the upper beach across the immediate hinterland, which became a nuisance to property owners. This has produced localised dune features at the root of the Lloyd St and Gogarth breakwaters.

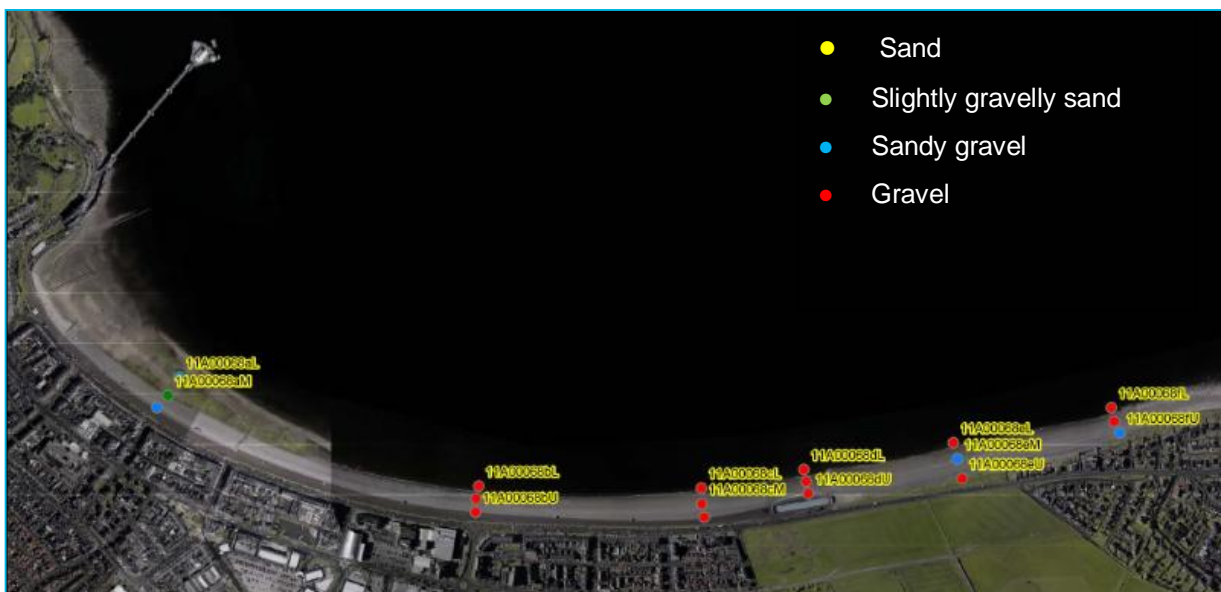
**Figure 2.18 – Sediment sampling locations and sediment types recorded – North Shore**

Sediment sampling was carried out as part of a regional study in 2014/15<sup>22</sup>. Details of the sediment types recorded are provided in Figure 2.18 and Figure 2.19 for North Shore and West Shore respectively.

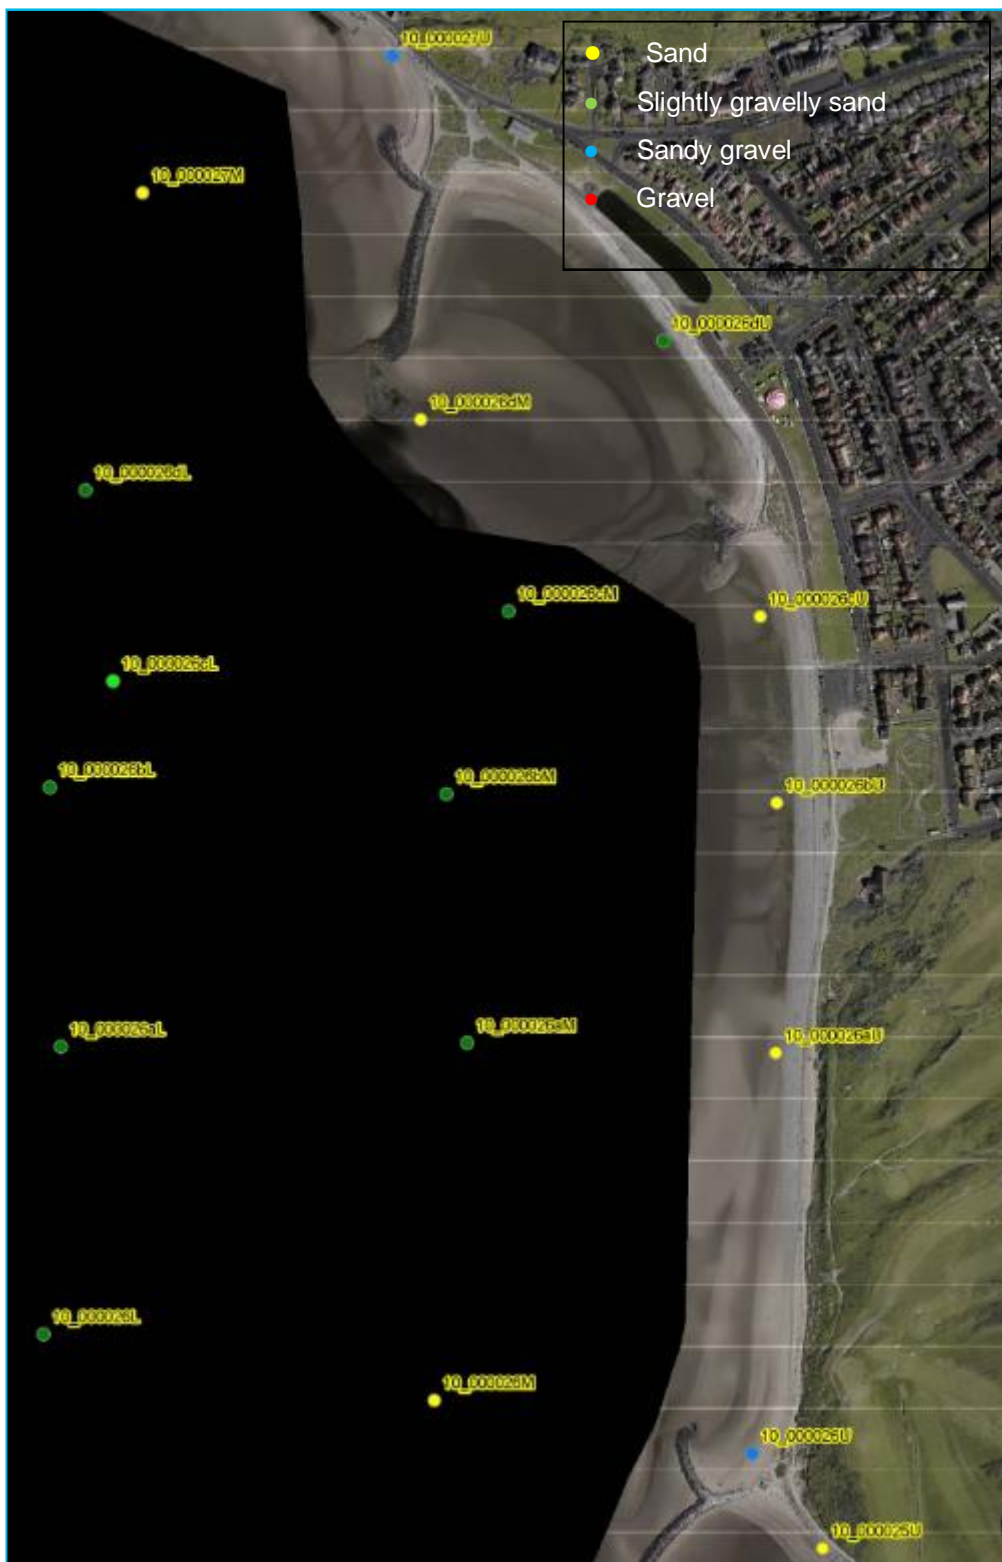
Figure 2.19 – Sediment sampling locations and sediment types recorded – West Shore

The upper beaches at West Shore comprise a mixture of natural sand and shingle mixed with artificial quarried shingle and cobbles. Sediments on the flatter lower beach are sand near the toe of the recharged beach but generally slightly gravelly sand further offshore. At North Shore the upper beach is a mixture of indigenous shingle with imported glacial gravel. The lower beach sediments are a mixture of sand, sandy gravel and gravelly sand. The lower beach is wider at the western end becoming narrower moving westwards.

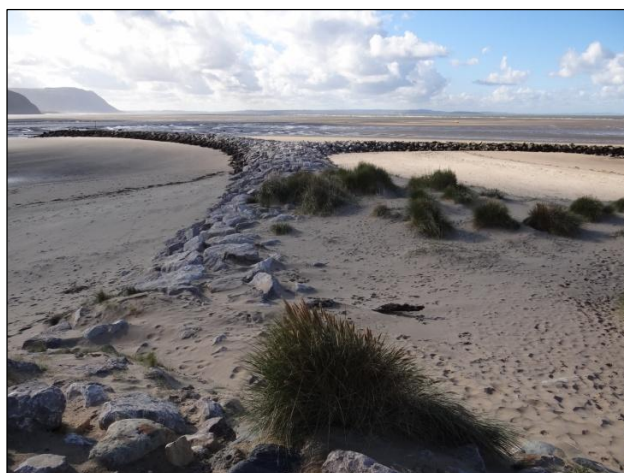
Frame CCBC\_ 121012\_109

14.17	7	2	<a href="#">12_109</a>	CC114	View from root of structure looking seaward along shore connected arm	On-going monitoring of defence condition and foreshore	Monitoring on-going Monitoring on-going

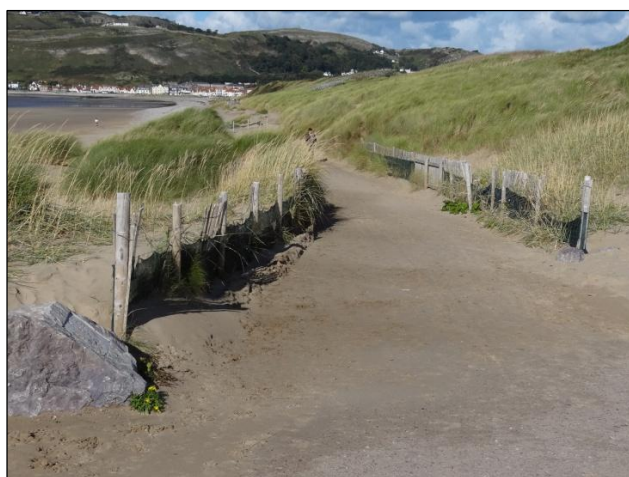
Frame CCBC\_ 121012\_110

14.19	3,26	2	<a href="#">12_110</a>	CC114	View from root of Cerrig Duon breakwater looking north	On-going monitoring of defence condition and foreshore. Wind blown	Monitoring and wind blown sand removal on-going

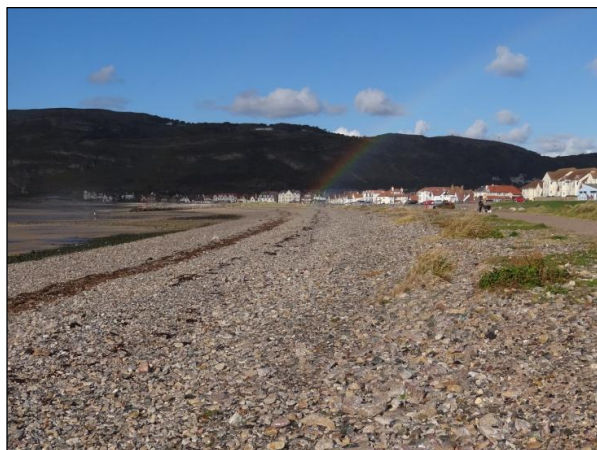
Frame CCBC\_ 121012\_126

Time	ST	Con	Photo Ref.	Position	Report/Description	Action Required	Action Implemented
14.53	2, 23	2	<a href="#">12_126</a>	CC117	View north across frontage from southern end	On-going monitoring of defence condition and foreshore. Wind blown sand removal	Monitoring on-going
14.58	2	2	<a href="#">12_127</a>	CC118	View south across frontage from northern end

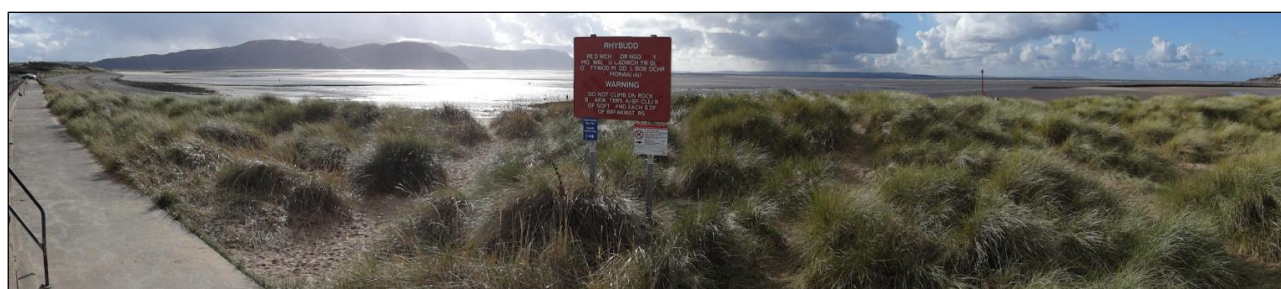
Frame CCBC\_ 121012\_131

Time	ST	Con	Photo Ref.	Position	Report/Description	Action Required	Action Implemented
15.06	1	2	<a href="#">12_131</a>	CC119	View seaward from sea wall at root of groyne showing embryo dune growth	On-going monitoring of defence condition and foreshore.	Monitoring on-going
15.08	7	2	<a href="#">12_132</a>	CC120	View from junction of arms looking along south west arm		
15.09	7		<a href="#">12_133</a>		View from junction of arms looking along north west arm		
15.09	20		<a href="#">12_134</a>		View of discharge of storm water outfall		
15.13	7	4	<a href="#">12_137</a>	CC120aa	Lloyd St Breakwater (Beach - North Arm)	Replace and re-fit armour blocks to breakwater toe	
15.12	7	4	<a href="#">12_136</a>	CC120ab	Lloyd St Breakwater (Beach - South Arm)

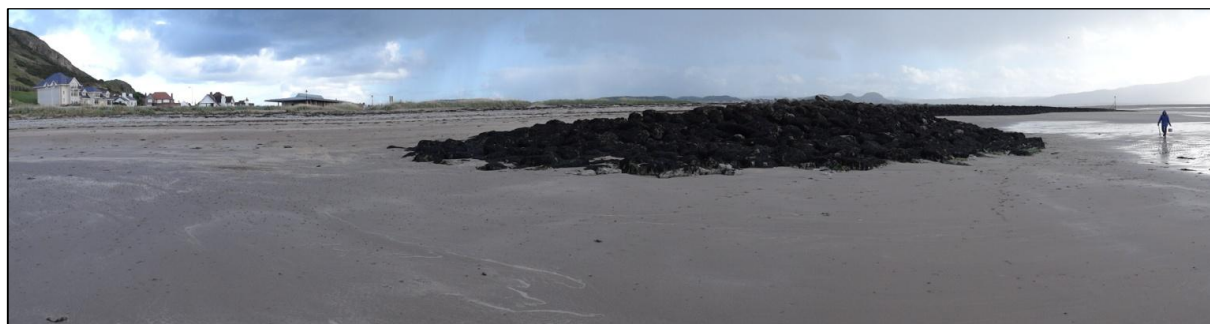
Frame CCBC\_ 121012\_151

heading arm		
15.31	1,7	2	<a href="#">12_145</a>	CC123	View from junction of arms along secondary arm		
15.31	7	2	<a href="#">12_146</a>		View from junction of arms along main wave arm		
15.33	7, 26	2	<a href="#">12_147</a>		View landward from junction of arms		
15.35	1	2	<a href="#">12_148</a>	CC123a	Offshore from main arm roundhead		
15.37	1,7	2	<a href="#">12_149</a>		Panorama of main arm roundhead.		
15.37	7	2	<a href="#">12_150</a>	CC123a	Main arm navigation marker beacon	Re-painting	
15.40	1,7	2	<a href="#">12_151</a>	CC123b	Outer 'Crotch' of breakwater arms	On-going monitoring of defence condition and foreshore	Monitoring on-going
15.43	1,7	2	<a href="#">12_151</a>	CC123c	Roundhead and upper beach at secondary arm roundhead

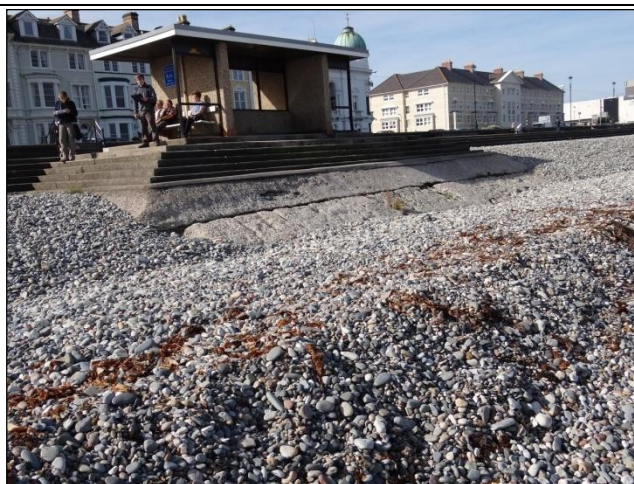
Frame CCBC\_ 120906\_050

10.14			2		3	<a href="#">06_050</a>	Beach loss around shelter
10.18	2	2	<a href="#">06_051</a>	CC146	View west along beach

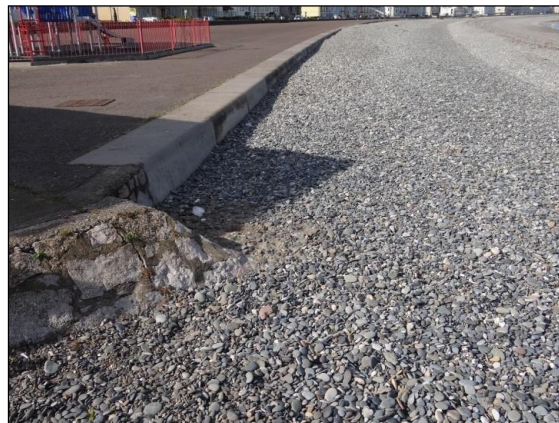
Frame CCBC\_ 120906\_057

10.23	2,8	2	<a href="#">06_053</a>	CC147	View west from change in front wall section	defence condition and foreshore
			<a href="#">06_054</a>		View east from change in front wall section	
10.28	8	2	<a href="#">06_055</a>	CC147a	Spalling to edge of beam at joint	
10.30	2,8	2,3	<a href="#">06_057</a>	CC148	View west from east end of frontage
