Environment, Roads & Facilities

Llandudno Beach Management Plan and Options Appraisal

CCBC Summary

August, 2017

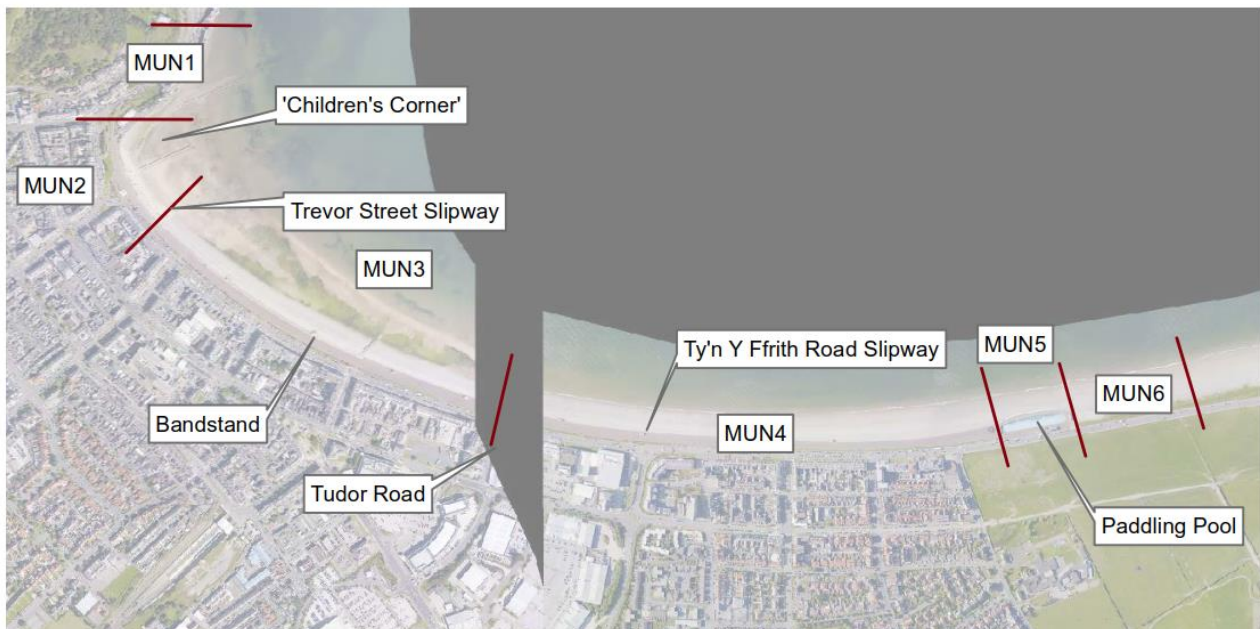
Fig1. North Shore Management Units

Aecom have sub-divided this section of coastline into 6 different Management Units for the purposes of this report and ease of referencing.

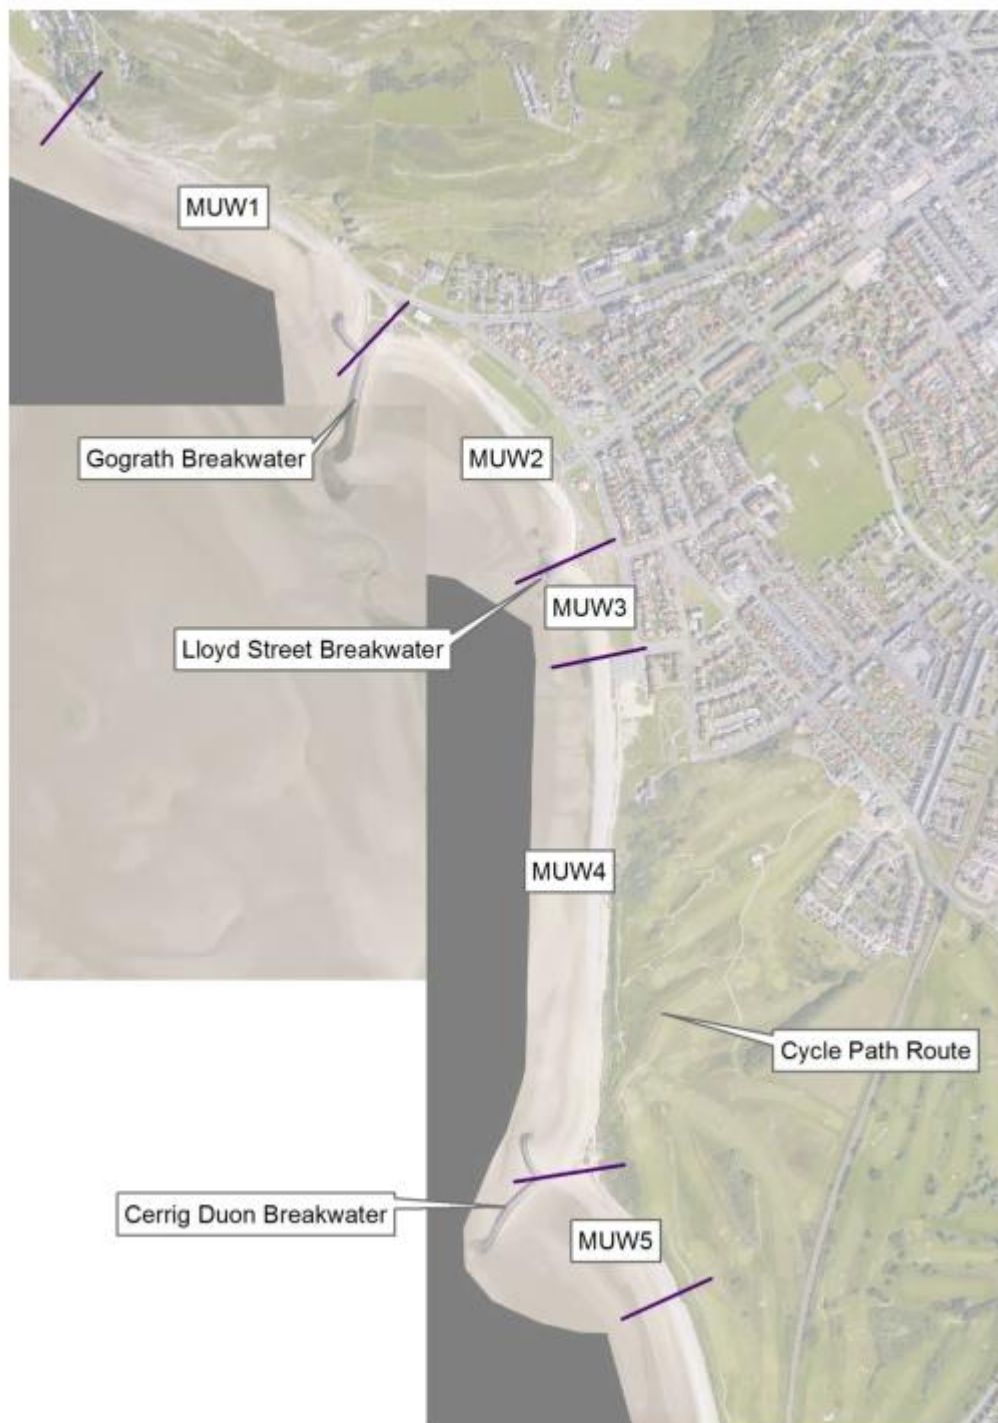
Fig2. West Shore Management Units

As with North Shore, the beach has been divided up into different Management Zones based on usage.

- MUW1 – Marine drive to Gogarth Breakwater
- MUW2 – Gogarth Breakwater to Lloyd St. Breakwater
- MUW3 – Lloyd St. Breakwater to Dale Road carpark
- MUW4 – Dale Road car park to Cerrig Duon Breakwater
- MUW5 – Immediately south of Cerrig Duon Breakwater

This is a narrow beach consisting of sand/shingle backed by a vertical wall which protects the roadway. Beach levels to be maintained to avoid undermining/failure of wall.
